# Compendium of Case Histories on Repair of Erosion-Damaged Concrete in Hydraulic Structures

## Reported by ACI Committee 210

*This report is a companion document to ACI 210R. It contains a series of case histories on hydraulic structures that have been damaged by erosion from various physical mechanical and chemical actions. Many of these structures have been successfully repaired. There were many examples to select from; however, the committee has selected recent, typical projects, with differing repair techniques, to provide a broad range of current experience. These case histories cover only damage to the hydraulic surfaces due to the action of water, waterborne material or chemical attack of concrete from fluids conveyed along the hydraulic passages. In addition to repairs of the damaged concrete, remedial work frequently includes design modifications that are intended to eliminate or minimize the action that produced the damage. This report does not cover repair of concrete damaged by other environmental factors such as freeze-thaw, expansive aggregate, or corroding reinforcement.*

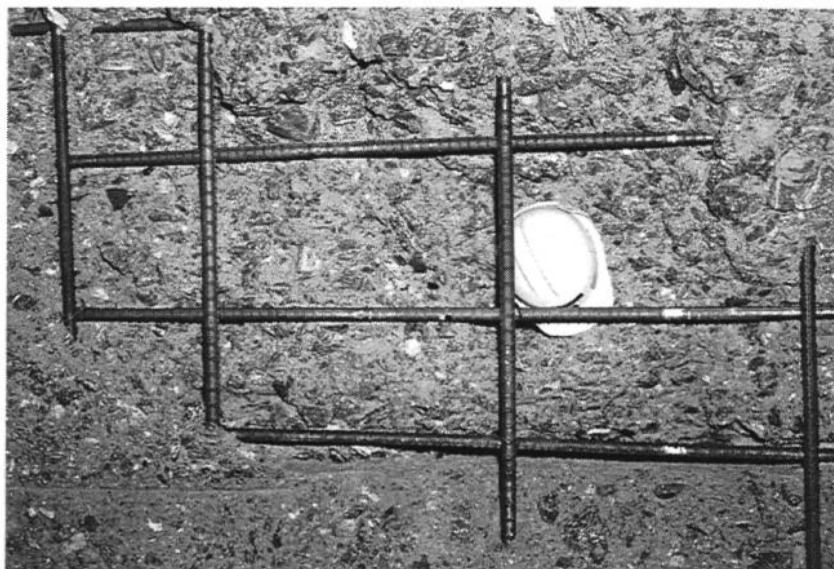
Inspection in 1973 showed minor concrete scaling of the concrete wall surfaces of Outlets 1 and 2. One year later, in 1974, serious erosion had occurred at wall surfaces of both outlets immediately downstream of the wall coatings, 50 ft from the tainter gate. Part of this wall area had eroded to a depth of 22 in., exposing and even removing some No. 9 reinforcing bars. In the wall surfaces downstream of Outlet 1 medium damage, up to 1 in. depth of erosion, also occurred in over 60 square yards of surface, bordered by lighter erosion. Every horizontal lift joint (construction joint) along the path of the jet, showed additional cavitation erosion.

*Fig. 2.1-Dworshak Dam. Detail showing depth of erosion behind reinforcing steel*

- Areas with heavy damage, with erosion greater than 2 to 3 in., were delineated by a 3-in. saw cut and the interior concrete excavated to a minimum depth of 15 in. ([Fig. 2.1](#) and [2.2](#)). Reinforcement was reestablished and steel fiber-reinforced concrete (FRC) was used as the replacement material.
- Areas with medium damage, where the depth of erosion was less than 1 in., were bush-hammered to a depth of  $\frac{3}{8}$  to 1 in. and dry-packed with mortar. The mortar, if left untreated, would easily have failed when subjected to the high velocity discharge.
- Areas with minor damage, surfaces showing a sand-blast texture, were not separately treated prior to polymer impregnation. The entire wall surfaces of Outlet 1 were then treated by polymer impregnation from the downstream edge of the existing epoxy mortar coating to a distance 200 ft downstream.

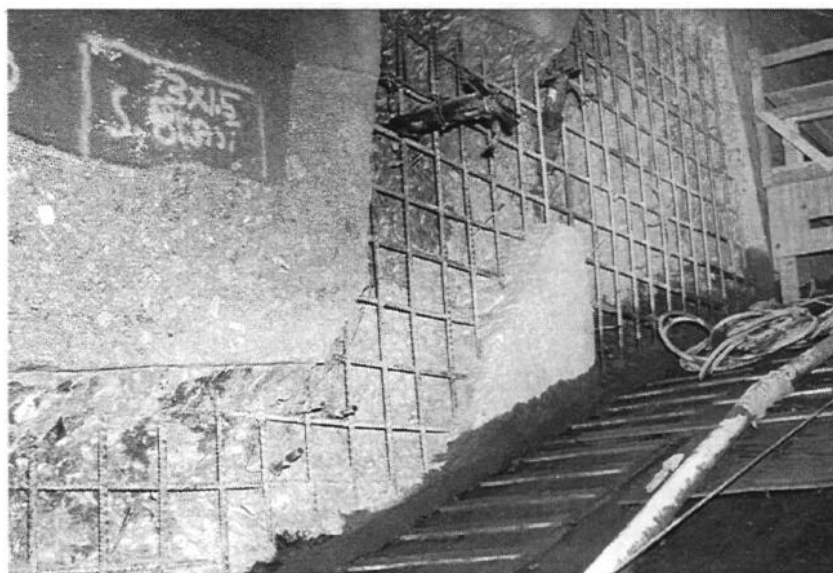
*Fig. 2.2-Dworshak Dam. Extent of outlet surface preparation prior to concrete and mortar placements*

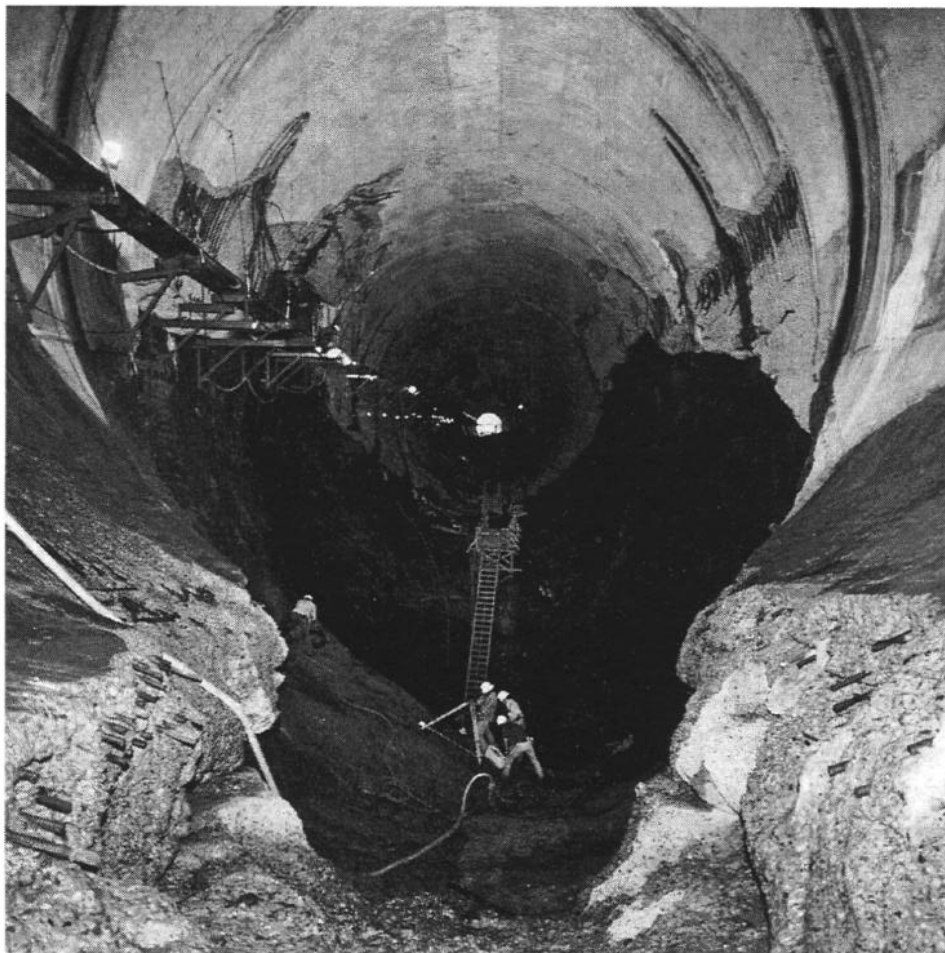
Extensive damage had occurred in and near the left tunnel elbow (Fig. 23). Immediately downstream from the elbow, a hole (35 ft deep, 134 ft long, and 50 ft wide) had been eroded in the concrete lining and underlying sandstone foundation. Other smaller holes had been eroded in the lining in leapfrog fashion upstream from the elbow.

Fig. 2.3-Glen Canyon Dam. Erosion of spillway tunnel invert and sandstone foundation rock downstream of the elbow

The repair work was accomplished in six phases: 1) removing loose and defective concrete lining and foundation rock; 2) backfilling large cavities in sandstone foundation with concrete; 3) reconstructing tunnel lining; 4) grinding and patching of small defective areas; 5) removing about 500 cubic yards of debris from lower reaches of tunnel and flip bucket; and 6) constructing an aeration device in the lining upstream of the vertical elbow.

Sandstone cavities were filled with tremie concrete before the lining was replaced. About 2000 cubic yards of replacement concrete was used. The aeration slot was modeled in the Bureau of Reclamation Hydraulic Laboratory to ensure that its design would provide the performance required.

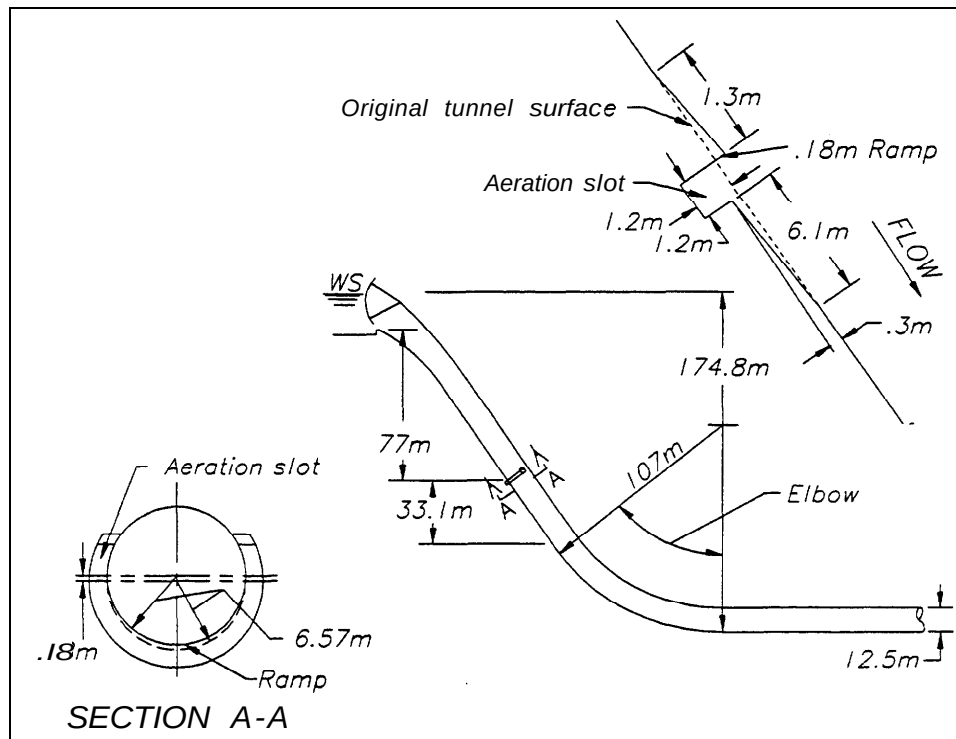
Fig. 2.4-Glen Canyon Dam. Diagram of new tunnel spillway air slot

The aeration slot was constructed on the inclined portion of the tunnel approximately 150 ft upstream from the start of the elbow. A small 7-in-high ramp was constructed immediately upstream of the slot. The slot was 4 by 4 ft in cross section and extended around the lower three-fourths of the tunnel circumference (Fig. 2.4). All repairs and the slot were completed in the summer of 1983.

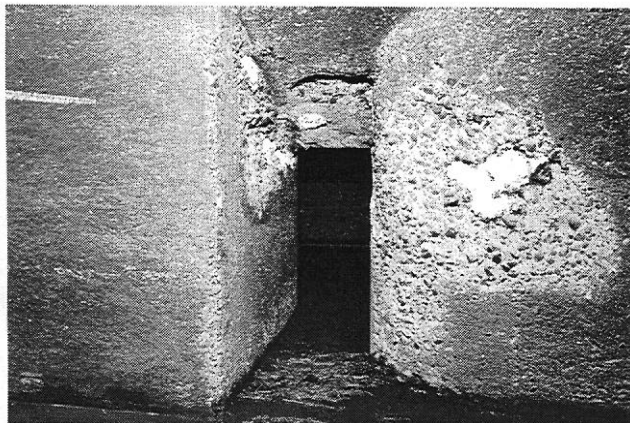
The repairs to the portal surfaces and tie-in gallery surfaces performed poorly. After 1 year of service, approximately 40 percent of the epoxy paste had failed; and after 3 years, nearly 100 percent has failed. Concrete erosion in these areas has subsequently increased to depths of 6 to 8 in. in the tie-in gallery and up to 5 to 6 in. on the two most downstream portal surfaces.

**Fig. 2.5—Lower Monumental Dam. Cavitation erosion of navigation lock portal surfaces**

Paste epoxy was applied to the concrete surfaces transitioning to feather edges along the perimeter of the patches. Cavitation eroded the concrete adjacent to the feather edges as well as eroding the thin epoxy edges (Fig. 2.5). These new voids undermined the new, thicker epoxy, and at some point caused another failure of the leading edge. As the leading edge void increased in size, the failure progressed until little epoxy was left in the repaired area. After erosion of the epoxy patch material, no further concrete erosion has occurred. It appears that the eroded configuration of the surface is hydraulically stable.

Patch-type repair procedures are not sufficient for this structure because erosion is initiated at the edge of the new patch. Eventual repairs will replace larger areas of the concrete flow surfaces and will include substantial anchoring of new materials.

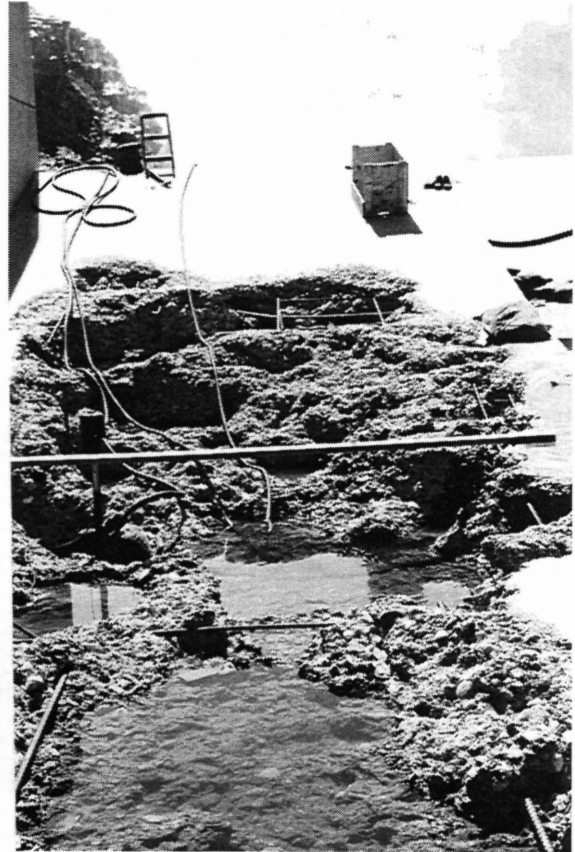
The concrete invert and side piers, which separate each of the six flip lips suffered extensive erosion soon after the start of operations in 1955 (Fig. 2.6). 3/4-in.-thick steel plates were anchored to the piers and invert areas just downstream of the manifold gates. These steel wall plates became severely pitted, as did the downstream concrete flip lip invert surfaces. In 1968, the damaged plates were again repaired by filling the eroded areas with stainless steel welding, and grouting behind the plates. Deteriorated concrete on the flip lips was removed and additional steel plates were installed over those areas. This also failed and repairs commenced again. Deep areas of cavitation damage in the invert and piers were filled with concrete. New 1/2-in.-thick plates were installed. These were stiffened with steel beams welded on 5-ft centers in each direction. Deep anchor

Fig. 2.6-Lucky Peak Dam. Cavitation erosion of flip lip surface

In 1974, it was recommended that the outlet be restudied hydraulically. That year, remaining plate material was removed. Cavities were found penetrating the invert and through the piers and into the adjacent outlet invert. These voids were crudely filled with FRC in a “field expedient” manner. Much of this FRC was placed in standing water with little quality control, while adjacent bays were discharging.

The side piers were redesigned and replaced to provide vents that would introduce air to the underside of the jet just downstream of the gates. This modification was intended to prevent additional invert erosion. However, major modifications to the gates and gate frames were necessary if cavitation erosion was to be eliminated. These modifications were not made since future powerhouse construction would reduce and nearly eliminate the need to use the outlet, reserving the structure for emergency and special operations use only. Steel lining on the piers was strengthened and replaced. Stiffened steel plates, 1 $\frac{1}{4}$ -in. thick, were installed on the piers and invert. Mortar backfill was pumped behind the invert plates and new concrete placed between pier plates.

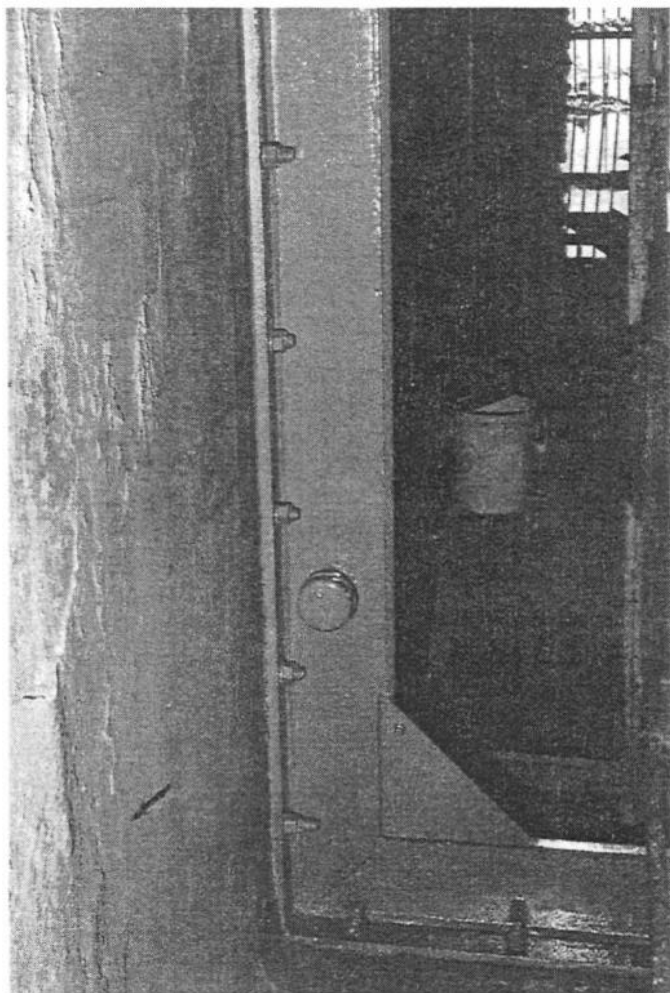
Fig. 2.7-Terzaghi Dam. Downstream detail of constrictor ring
