# REPAIR & REHABILITATION II

# Repair & Rehabilitation II

ACI Compilation 20

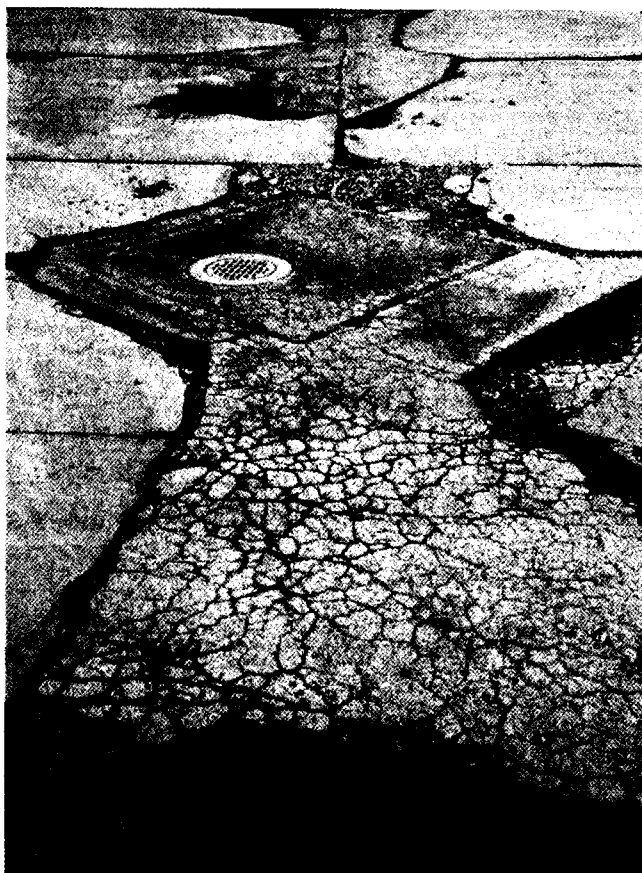
The study of the parking slab included visual observations, materials evaluation, nondestructive testing, and a review of original construction documents and field reports. Results indicated that the principal deterioration mechanism was the saturation of concrete surfacing caused by poor drainage along the interface between concrete topping and insulation. This led to damage by frost action that was so severe that many of the joint seals were rendered useless by the third and fourth winters.

Joint sealant failure caused rapid saturation of many slab areas as water entered the slab-joint system, became entrapped atop the protection layer, and rapidly saturated joint faces, causing progressive damage to adjacent surface areas.

(left) Original condition of parking slab.  
(above) Suitability of the filter/separation layer in the drainage net system was evaluated in a trial installation.

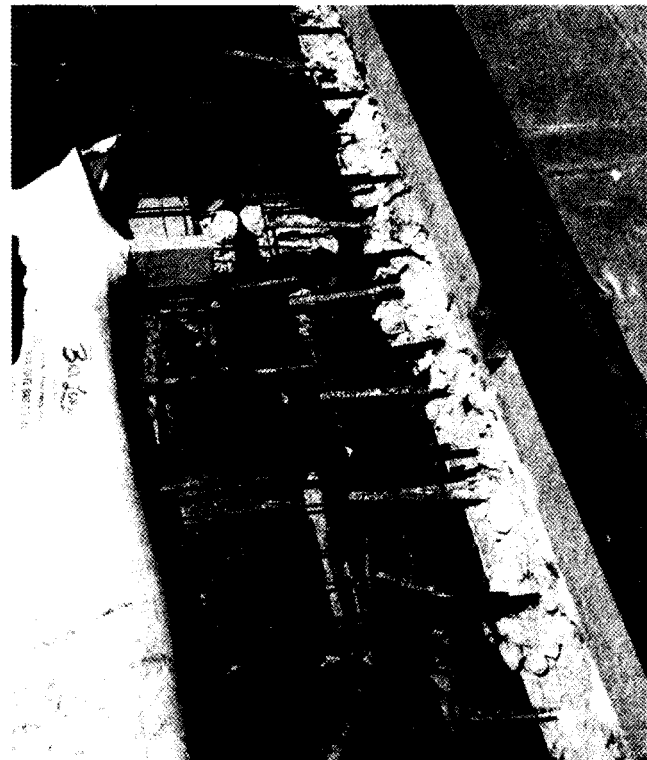
Damage to concrete parapet walls at the base of the slab was also

found at isolated locations and a special closure detail was worked out to tie the new topping slab system to the existing parapet wall without unnecessarily damaging or disturbing the wall, which carried the building facade. Salvaging the existing wall realized considerable cost and time savings, while maintaining the building's outward appearance.

(bottom left) Spot repairs were made to less than 10 percent of the membrane surface.

(middle right) The insulation and protection layers and geonet underdrain were placed.

(bottom right) Damage to concrete parapet walls required a special closure detail to tie the new topping slab system to the wall.

Once the insulation was removed, the membrane was inspected for damage, and spot repairs (on less than 10 percent of the surface) were performed. Exposure of the membrane to the elements during reconstruction was mini-

With membrane repairs complete, the insulation and protection layers and geonet underdrain were placed. Formwork was then installed for concrete replacement using a strip method to provide proper control joints in the concrete topping. Strip edges became construction and/or isolation joints depending on the section encountered.

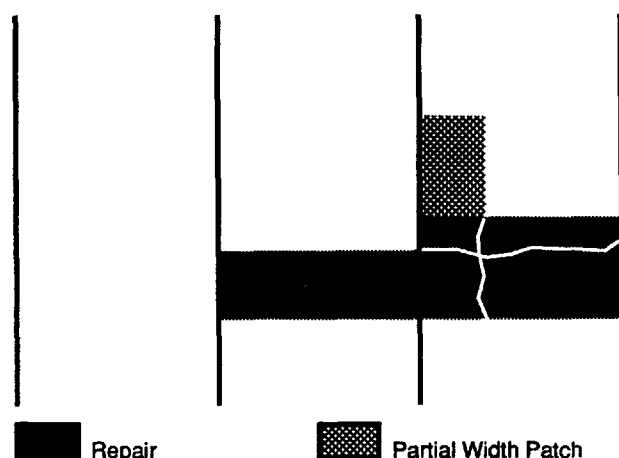
Fig. 1—Example of slab cracking resulting from jackhammer removal methods.

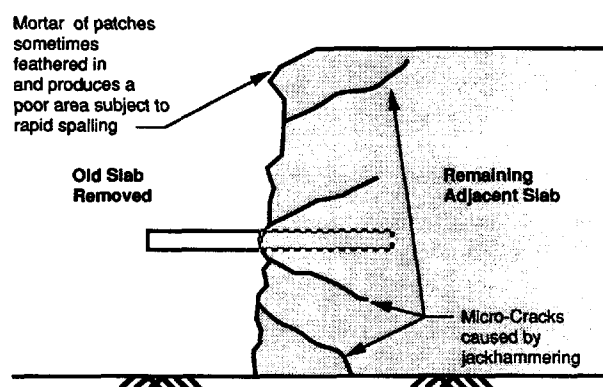
Fig. 2—Effects if repairs in adjacent lane joints do not line up.
