# IN-PLACE PERFORMANCE OF POLYMER CONCRETE OVERLAYS

# **In-Place Performance of Polymer Concrete Overlays**

This paper reports on the condition of a post-tensioned parking garage that was repaired in 1983 using a thin mma polymer concrete overlay. An earlier paper reported on the garage condition, repair methods and materials (1). Comments will be made on the overlay wear, cracking, bonding to the substrate, continued corrosion of embedded reinforcing steel, and surface delaminations after 13 years of service. Comparisons of conditions in 1981 and 1995 are also made. Comments on the success of the application with respect to structural integrity and material durability are made at the end of the paper.

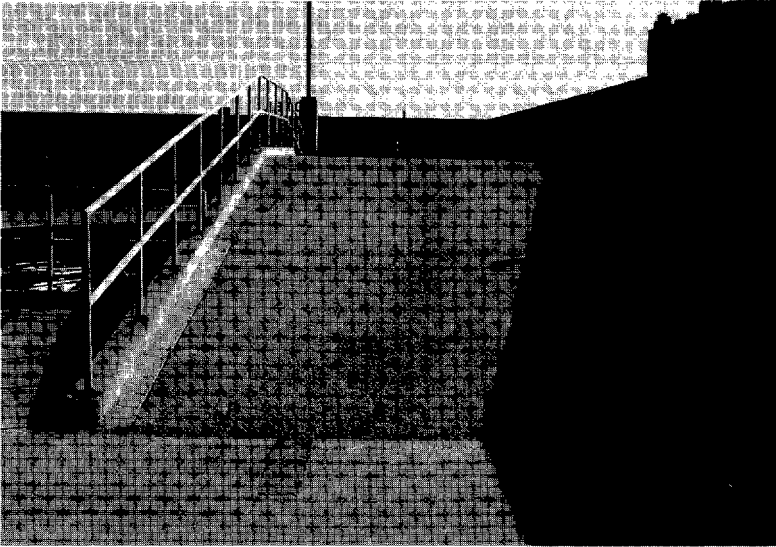
In 1981, the garage was only 6 years old and had already shown a number of deterioration signs. In the 1981 condition assessment, freeze-thaw damage was seen to exist at many locations on the floor slab concrete. One of the more heavily scaled areas at the roof level is shown in Fig. 2. The heavy scaling was attributed to a lack of air entrainment in the concrete.

Fig. 2—Freeze thaw damaged concrete

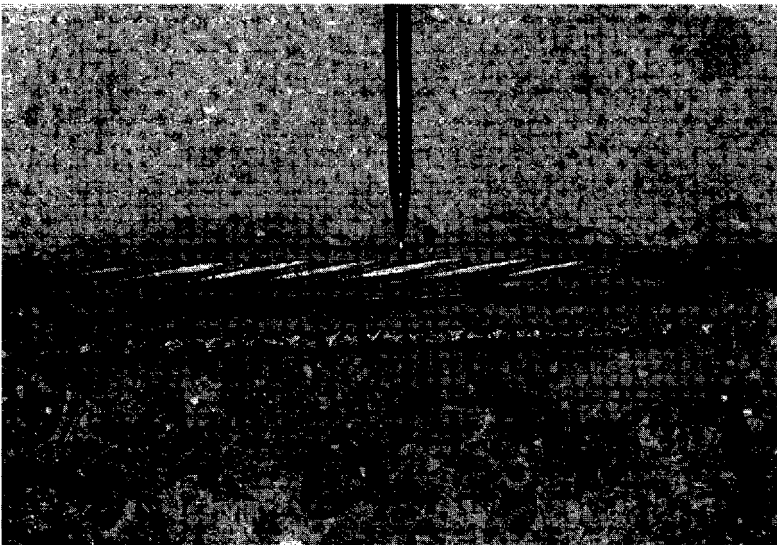
Exposed corroding steel deformed reinforcing bars and post-tensioning tendons were also frequently found. The exposed reinforcement resulted either because the reinforcement was never covered with concrete or the shallow cover over the deformed bars had spalled because the bar had corroded. A frequently identified condition is shown in Fig. 3 where the post-tensioning tendon sheathing is shown to be torn and the post-tensioning tendon lies directly adjacent to a reinforcing bar. The tendon typically was exposed because of the corroding deformed bar, although none of the post-tensioning tendons had fractured at the time of the 1981 condition survey.

Fig. 3—Corroding, deformed bar and exposed, corroding post-tensioning tendon

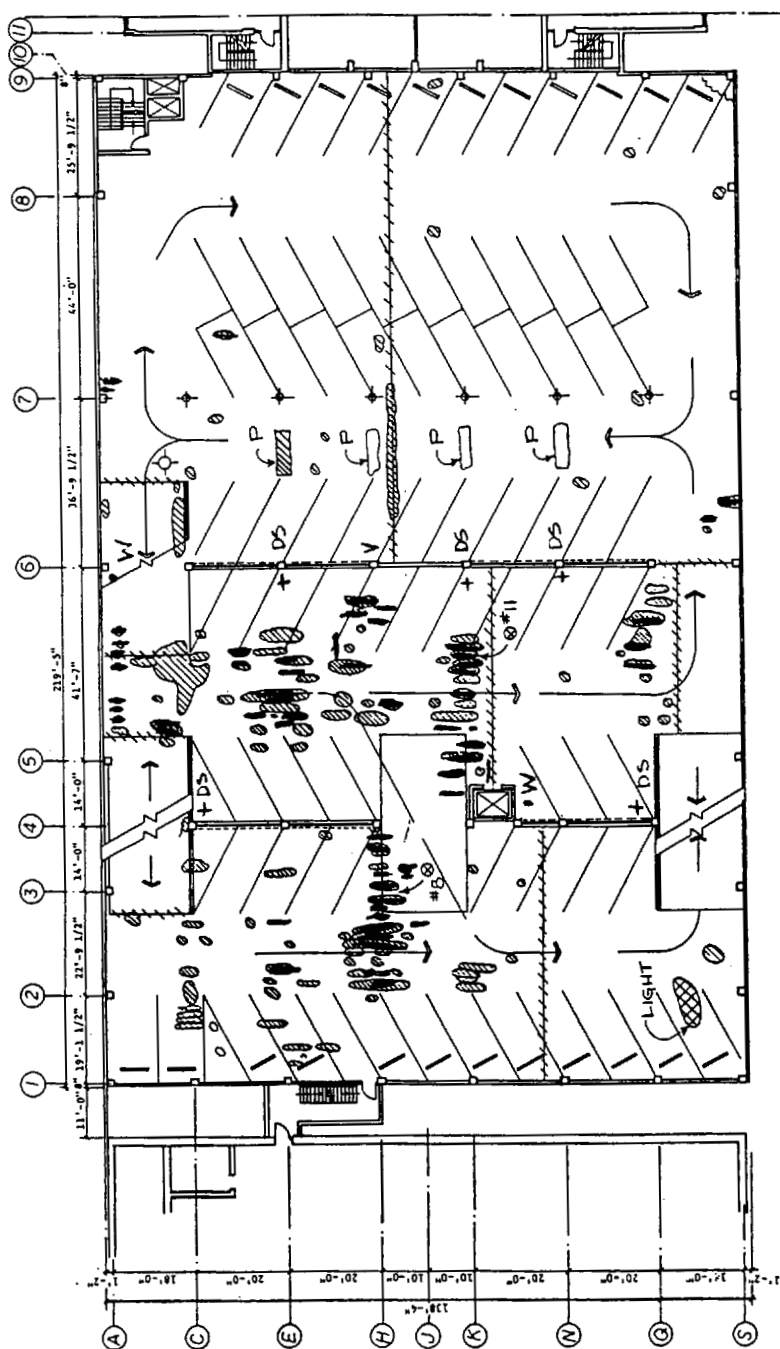
Fig. 4—Deck slab with numeruos delaminations and exposed reinforcements

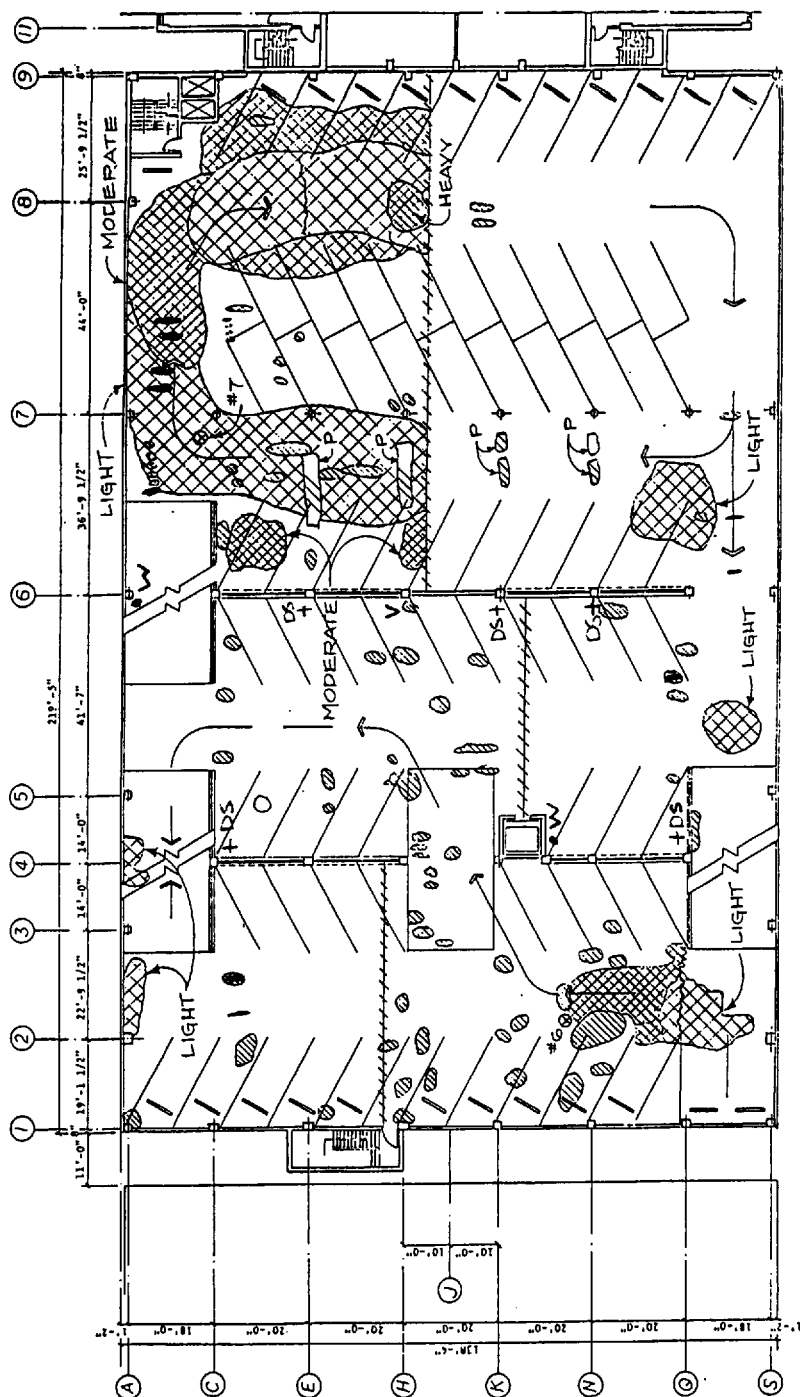
reinforcing bars were found in the negative bending moment regions of the sloping slab surfaces. In Fig. 5, considerable freeze-thaw damage exists in the concrete on the flat portion of the level and primarily on the west side of the structure. Delaminations and exposed reinforcing bars in both of these figures were predominantly on the sloping surface of the garage floor. The flat portion of the structure was relatively free of corrosion deteriorated concrete but was found to be more influenced by water that ponded on poorly air-entrained concrete causing freeze-thaw deterioration.

Fig. 5—Deck slab with surface scaling

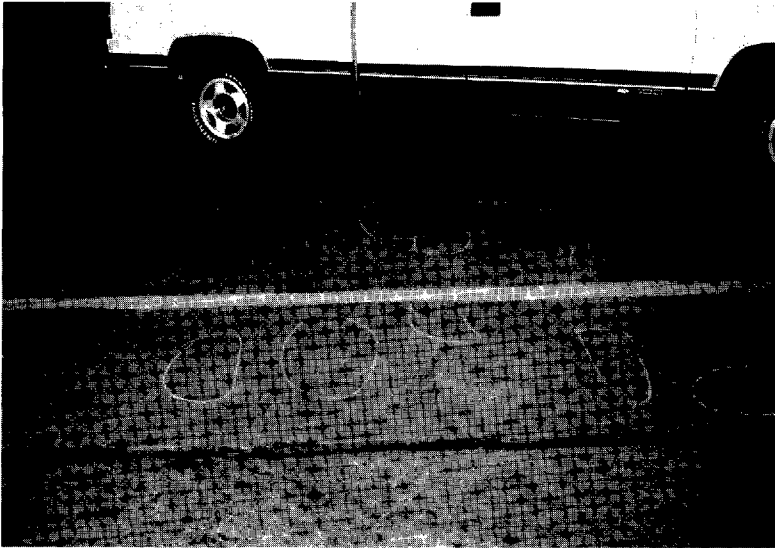
Observations of Conditions at 13 Years -- The heavy traffic at the entrance level, which originally had an elastomeric membrane and was completely overlaid, had not experienced any significant wear. To the authors' knowledge, leaks through that level existing before the overlay was installed have not reappeared after the level was overlaid. Above the entrance level, to the authors disappointment, the overlay areas, particularly in the sloping ramp portion of the garage and in some of the flat areas, contained overlay delaminations. In Fig. 9 is shown a portion of one of the overlay areas with the delaminations highlighted.

Fig. 9—Delaminations in mma polymer concrete overlay
