**Seismic Rehabilitation of RC Bridges by Using FRP and SRP:  
Case Study of a Bridge in the South of Italy**

**Synopsis:** The paper deals with a rehabilitation case study on a pre-stressed concrete (PC) bridge (named “Torrente Casale”), located in the south of Italy (on the Salerno-Reggio Calabria highway). The bridge, built in the '70s, was enlarged in 2001 in order to satisfy the new traffic demand. A seismic assessment of the bridge resulted necessary in order to verify its capacity to sustain both gravity and seismic loads. Both destructive and non-destructive tests have been performed in order to evaluate concrete and steel reinforcement mechanical properties. A theoretical analysis was performed, showing that the bridge piers existing cross section and internal reinforcement were not adequate to satisfy the seismic actions. Thus, two rehabilitation systems were investigated: a) an innovative technique based on the combined use of Fibre Reinforced Polymer laminates (FRP) and Steel Reinforced Polymer spikes (SRP), b) a traditional rehabilitation technique (i.e. RC jacketing). The design assumptions and calculations for the rehabilitation as well as the comparison between the

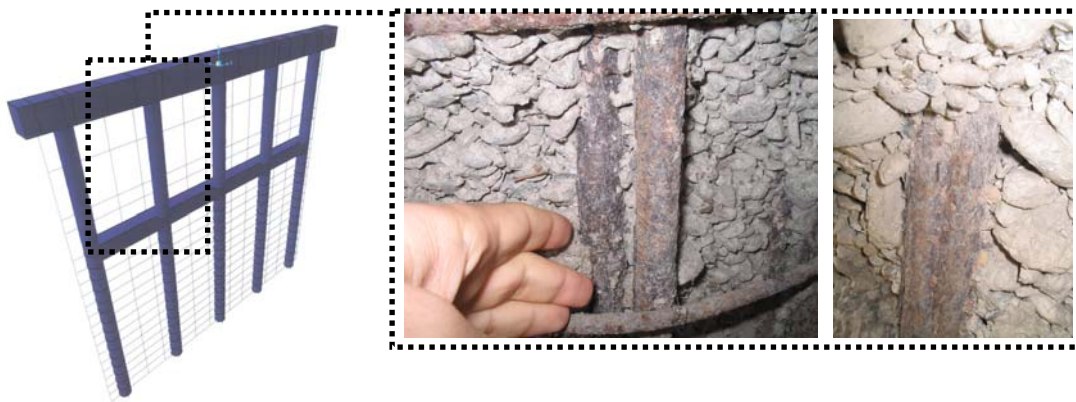
**Fig. 5**—Carbonation phenomena, absence of binder and higher maximum diameter of the rubble

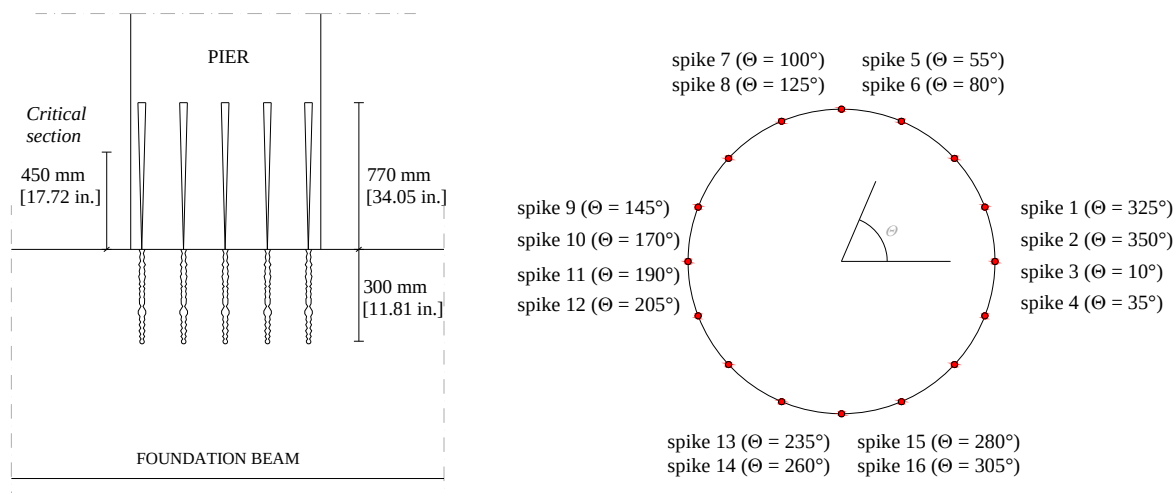
Fig.12—SRP spikes application

The SRP spikes were located in appropriate holes realized drilled the beam foundation (pier bottom cross-section) and the cap beam (pier top cross-section) ensuring a bond length equal to 300 mm [11.81 in.]. The bond length was computed according to the following equation (extracted from EC2<sup>11</sup>):

where  $\phi$  is the SRP diameter,  $f_{fd}$  is the SRP delamination strength and  $f_{u,res}$  is the epoxy resin tensile strength. Sixteen spikes were used, placed around the piers cross section inside the holes before mentioned (see Figure 12). SRP spikes were supposed to be applied on the pier bottom cross-sections starting from the foundation beam to 770 mm [30.32 in.]. Such a length was computed in order to fully cover the critical zone, where demand is higher than capacity, equal to a height of 450mm [17.72 in.] from the foundations. Adopting a bond length equal to 300 mm [11.81 in.], a total length was assumed equal to 1070 mm [42.12 in.]. The same configuration was adopted for pier top cross-sections, starting from the cap beam. CFRP sheets were applied in order to prevent SRP spikes buckling due to cyclical loads. Considering that the bridge is exposed to aggressive environment, durability issue is the driving design criterion and thus, carbon fibres have been selected and preferred to glass fibres. In particular, uniaxial CFRP laminates characterized by 900 gr/m<sup>2</sup> density, 0.13 mm/ply [0.005 in./ply] dry fibres thickness, modulus of elasticity about 230000 MPa [3285714 psi] and tensile strength equal to 4830 MPa [69000 psi] were used. Two CFRP layers were adopted to wrap the piers ends; each layer was applied by using two sheets (height of 400 mm [15.74 in.] each) with an overlap length of 30 mm [1.18 in.], see Figure 13. They were designed in order to avoid the existing steel vertical reinforcement and SRP buckling, improve the concrete behavior and to avoid the slip of existing steel reinforcement in RC piers at the locations of lap splice (note that the overlap between the foundation beam reinforced bars and the pier reinforced bars was equal to 650mm [25.59 in.]). The number of CFRP layers used to confine the member cross sections was computed taking into account the buckling of longitudinal bars, by applying the CNR<sup>13</sup> formula, reported in the following:

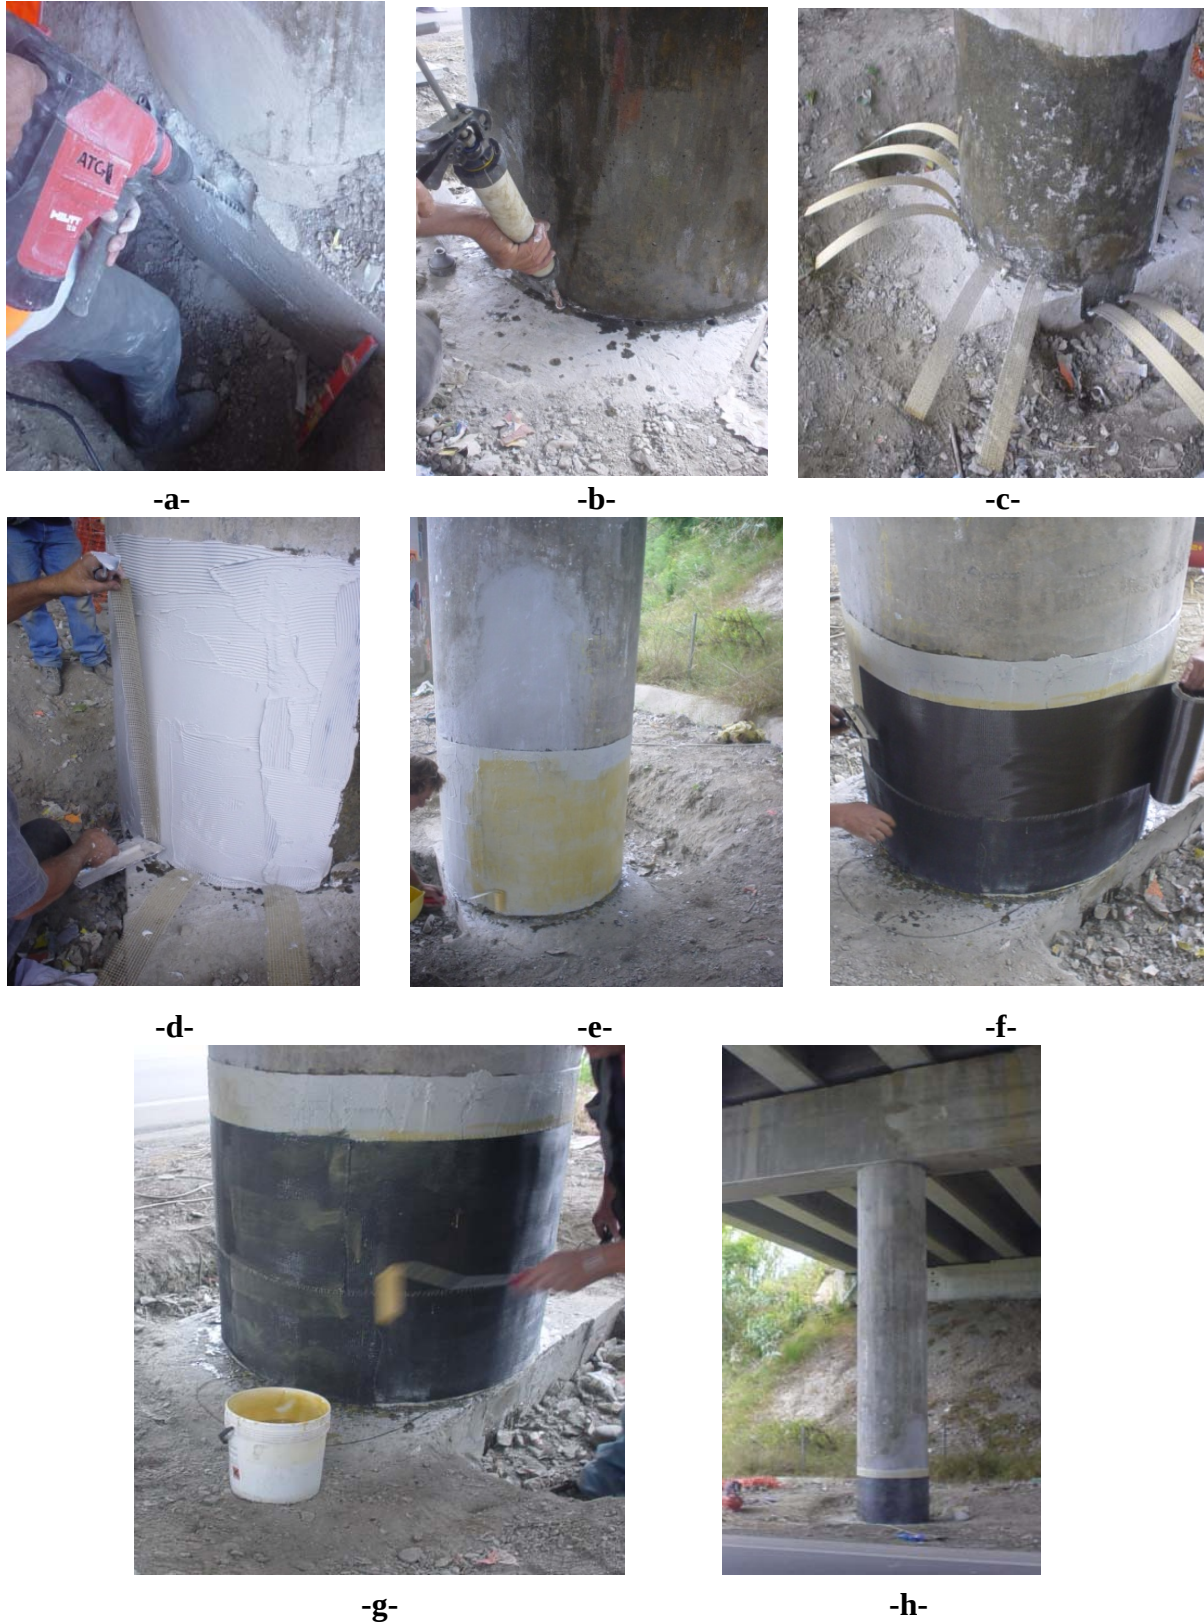
**Fig.19**—Innovative materials intervention: application phase

The innovative solution was selected for this particular case study; the main steps installation procedures are reported in the following. Prior to laminates installation, unsound concrete was removed in all zones of the elements where crushing was detected; then the original cross-sections were restored using a non-shrinking mortar. In addition, all the holes caused by destructive tests realized on the bridge were epoxy-injected. Then, according to the design provisions, the holes were made at the ends of the piers by using a suitable hammer, reaching an appropriate hole deep (see Figure 19-a). Once primer was applied on the pier surfaces (see Figure 19-b) and the pier holes were filled by using epoxy mortar (see Figure 19-c). The SRP strips total length is equal to 1150 mm [45.28 in.]; 380 mm [14.96 in.] of the SRP strips total length were rolled at the end in order to realize the spikes that were put into the holes. The free parts of the SRP strips were rested on the ground (see Figure 19-c). An epoxy mortar layer was applied on the piers surface and the free parts of the SRP were placed on them, ensuring the adhesion between the mortar and the SRP strips; moreover the direct interaction between the SRP and CFRP was avoided in order to prevent corrosion phenomena (see Figure 19-d). Then, an epoxy resin layer was applied on the piers (Figure 19-e) and the first CFRP ply was wrapped on the piers surface (Figure 19-f). This procedure was repeated for the second layer. Another layer of mortar was applied on the last laminate coat in order to protect the rehabilitation system from environmental effects. Typical FRP installation procedure was made to realize the shear strengthening system, by rounding the corner to avoid stresses concentration. The procedure was repeated to install three FRP sheet layers.

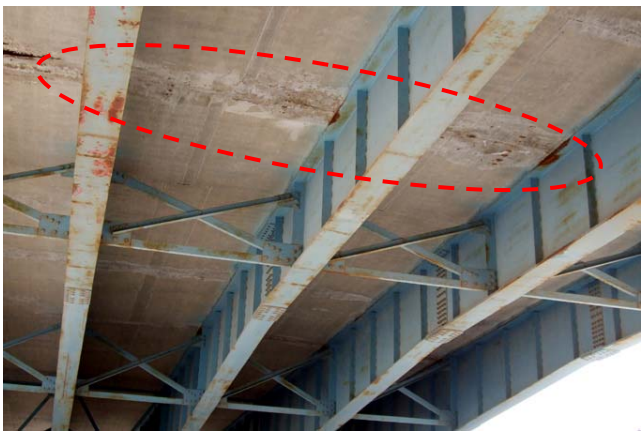
Fig. 3—Deteriorated bridge deck at I-29 and 52<sup>nd</sup> S., Fargo, ND

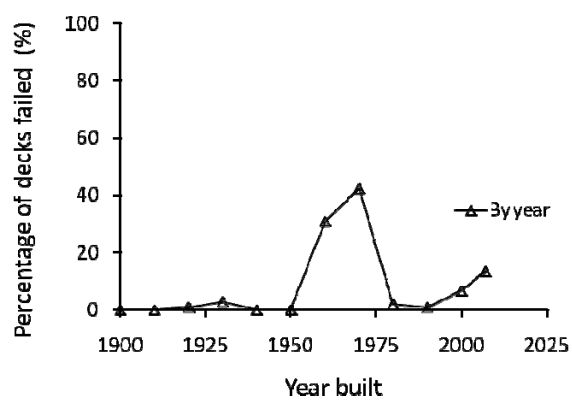
Fig. 4—Bridge decks failed

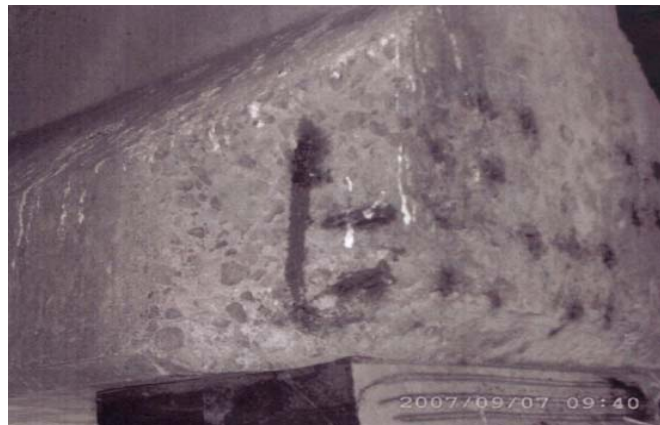
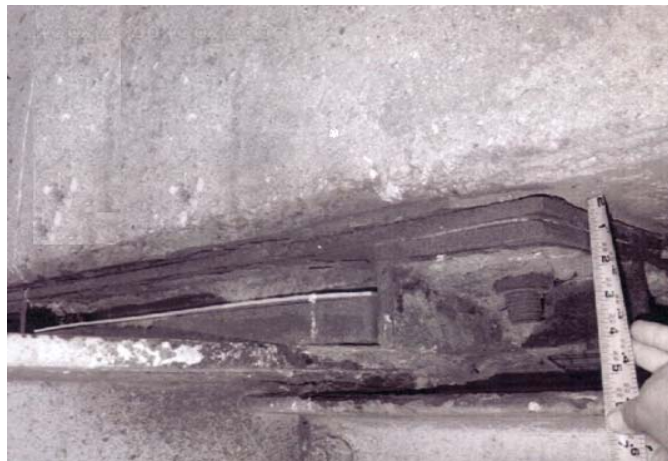
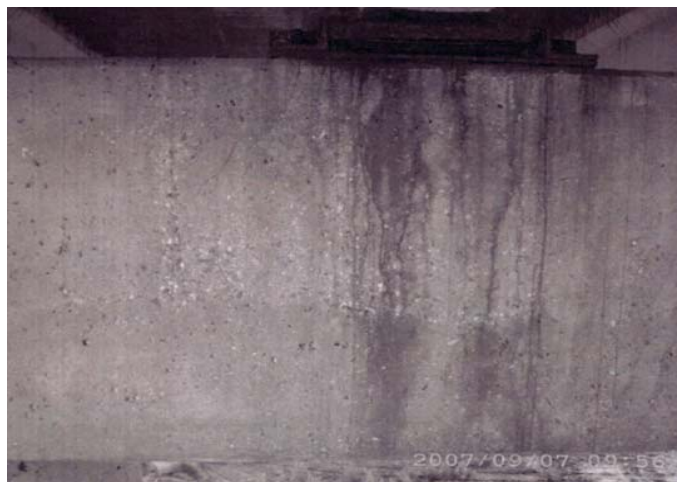
**Fig. 9**—Deterioration of the 12<sup>th</sup> Ave. N. bridge; (a) deterioration of girder; (b) corroded bearing; (c) deteriorated pier-cap concrete (courtesy of NDDOT)

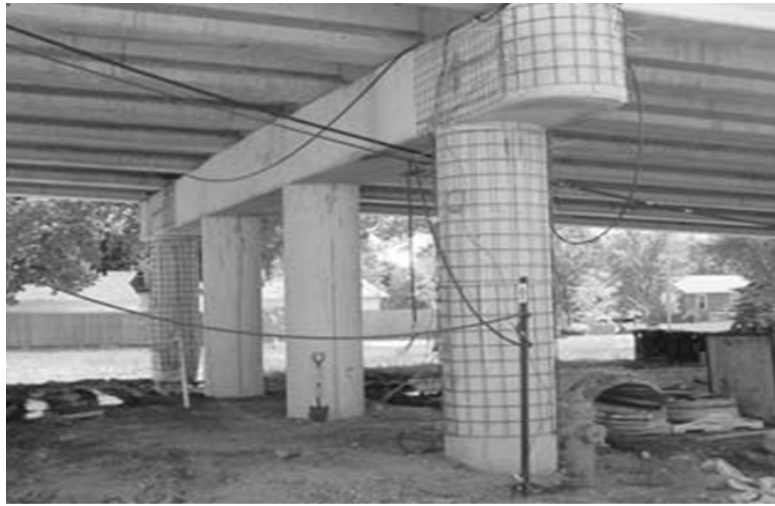
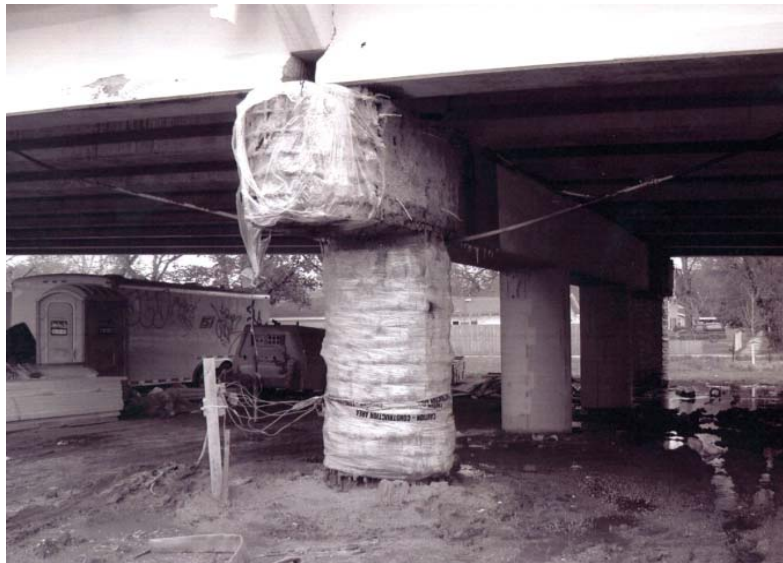
**Fig. 11**—Electrochemical Chloride Extraction; (a) Steel woven wire mesh connected with low voltage current; (b) the wired mesh covered with plastic sheets (courtesy of NDDOT).

Electrochemical Chloride Extraction (ECE) was used to remove the chloride from the concrete. The principle of the ECE method is that hydroxyl ions are generated to separate chlorides from reinforcing bars by applying an electric field between the concrete and the bars. ECE applied to a vertical or overhead surface typically employs a steel anode fastened to the concrete. Titanium anodes are generally specified for architectural applications where rusting of the anode is unacceptable. A spacer is used to keep the anode from being in direct contact with the concrete, allowing room for the electrolyte media between the anode and the concrete. The electrolyte media usually consists of a sprayed cellulose fiber mixture, which is easily applied to vertical and overhead surfaces. The electrolyte media is designed to retain moisture. The system is then wrapped with plastic to help retain moisture, and is continuously wetted. The treatment duration is typically 6 to 8 weeks, after which all materials are removed from the concrete surface. When steel anode is used there will be some rust staining. Abrasive blast cleaning is generally specified to remove the rust staining and prepare the surface for the application of an appropriate sealer or coating. Figure 11 shows a maintenance operation using the ECE method for the piers of the 12<sup>th</sup> Ave. N. Bridge. Wire mesh was wrapped around the area to be treated (after preparatory measures and repairs have been completed). The surface was then sprayed with a fiber mixture (similar to wet newspaper), after which the ECE process was started.

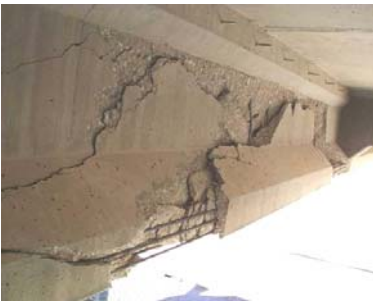
**Case 1** – Figure 2a shows the first impact damaged beam in Texas repaired using CFRP. The exterior beam was hit by an overheight vehicle, severely fracturing the entire web and bottom flange between two interior diaphragms. Only one of the 44 prestressing strands (3/8 in. dia. (10 mm)) was severed by the impact. The remaining strands all retained their original tension. A girder with this level of damage would normally be replaced. TxDOT engineers felt that wrapping the repair area with CFRP could add tensile strength, shear strength, and robustness to the repair. A cost and time comparison was made between repair and replacement. The repair option was selected after the comparison indicated that repairs could be made in one forth the time and for half the cost of replacing the beam.

a) The impact damaged beam.

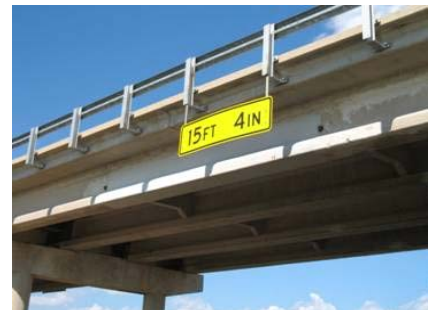
c) The repaired beam after 5 years later.

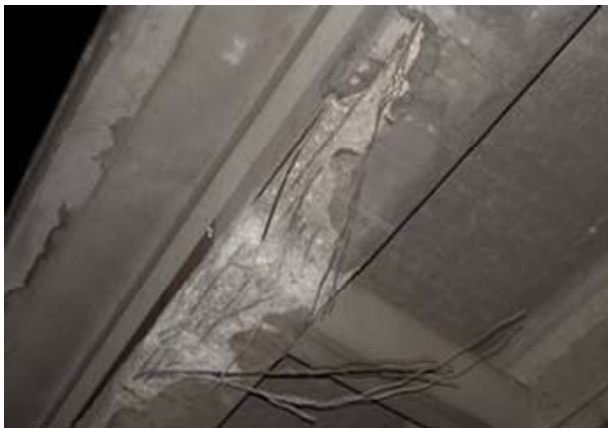
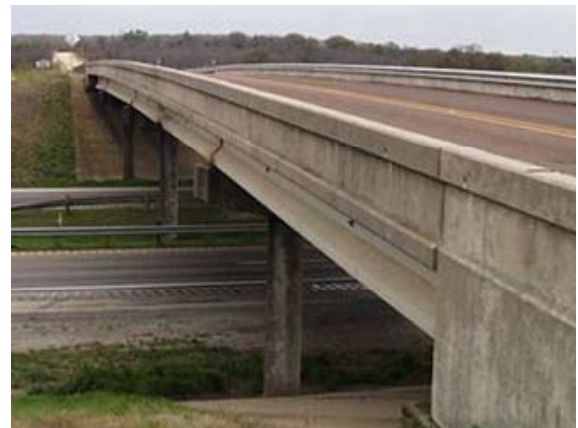
**Case 2** – TxDOT engineers have also used CFRP as tensile reinforcement to offset lost prestressing strands severed by impacts. One such case occurred in March, 2004 and is shown in Figures 3 and 4. Eight of the 32-½ in. (13 mm) diameter prestressing strands in the impacted beam were severed. The damaged area was limited to 8.5 ft (2.6 m) or 1/10 of the span length. The damaged beam had no additional deflection due to the loss of strands – an important indication that lateral support from the diaphragms and deck allowed the superstructure to redistribute the stresses to undamaged beams. The spalling and eight severed strands are clearly seen in Figure 3. TxDOT personnel determined that the beam was repairable using CFRP and a strand splicing system previously evaluated by a TxDOT research project<sup>12</sup>. The design called for splicing five of the eight severed strands and using CFRP as supplemental tensile reinforcement to offset the three un-spliced strands. All eight severed strands were not spliced because the splicing devices had to be staggered to facilitate concrete placement, which requires removal of more sound

**Fig. 3**—impacted in 2004
