# Experience of Fires in Concrete Structures

by A. K. Tovey and R. N. Crook

# Fires During Nuclear Power Plant Construction

# Old Flames Speak Well of Young Concrete

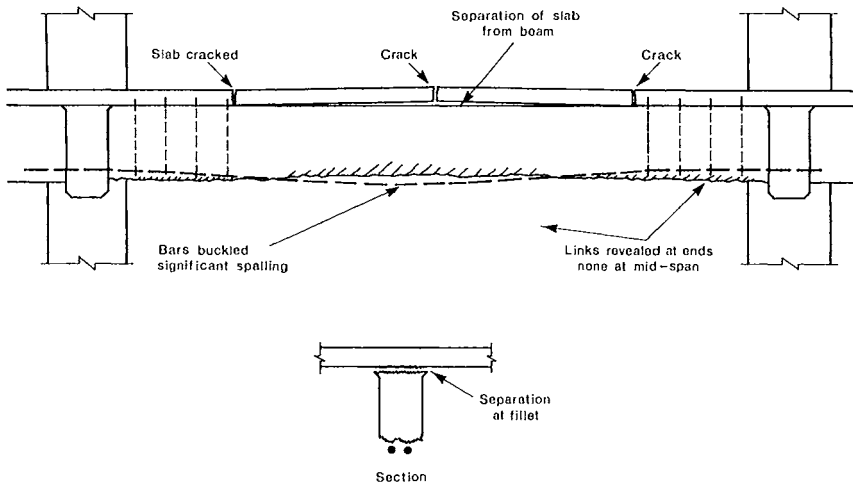
An example of the information that is being obtained may be illustrated by reference to Figure 1. This shows an example of damage to the main structural beams to an in situ reinforced concrete warehouse built around 1930. The fire occurred in 1983 and there was noticeable separation of the floor slab and buckling of the main reinforcing bars over the central section of the beam. The omission of stirrups over the central section has clearly demonstrated a detailing deficiency. Such details would not generally be permitted under our current UK Codes but, despite this, the structure adequately withstood the fire. It is clear that examination of such cases can identify structural deficiencies and hence, when appropriate, be used to modify the Code provisions.

Fig. 1—Effect of unrestrained bars and slab

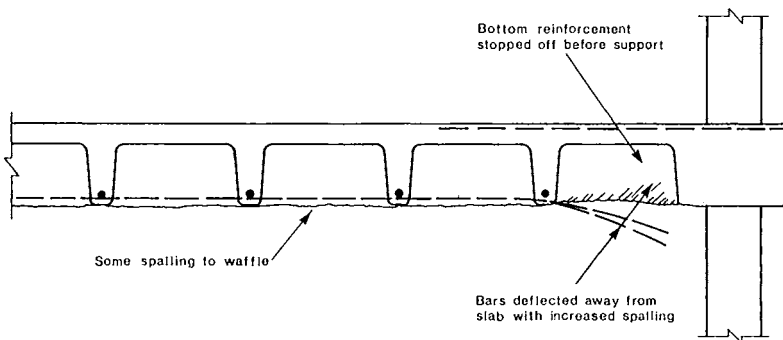
Another case which illustrates a detailing deficiency is shown in Figure 2. In this case, the structure consisted of a continuous reinforced concrete waffle floor slab that was detailed to cater for the appropriate negative and positive bending moments along the span. In accordance with the bending moment envelope, the bottom reinforcement can be stopped short of the spans. This is adequate for strength conditions but the effect of the fire caused the unsupported bottom bars to buckle away from the support zone. The Joint Report (1) recommends that 50% of the bottom reinforcement should continue to the support and that 20% of the top bars should be continued across the span. Again, the structure performed adequately in the fire but had all reinforcement be taken to the support then the element would ultimately have performed better and there would probably have been less spalling and damage.

Fig. 2—Effect of non-support of bars at end of waffle slab

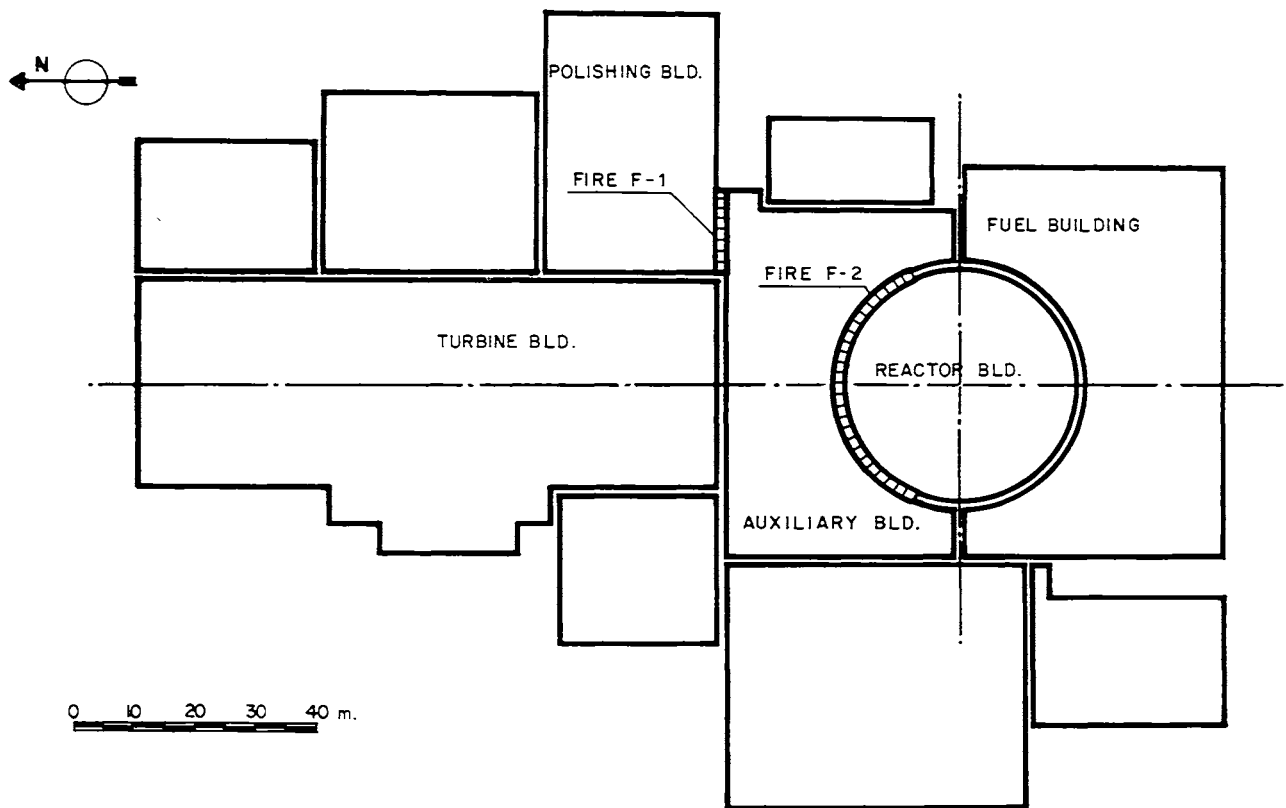
The fires occurring in the BWR type Nuclear Power Plant (Fig. 1) corresponded to the ignition of the vertical formwork materials between walls (Fig. 2), due to incandescent particles, coming from welds or oxyacetylene cuts, falling on them. The fire was produced in the junctions between buildings when the second wall which forms the junction was being prepared for concreting. The fires caused a local elevation of the temperature in the concrete of the wall already built and in the reinforcement steel bars of the wall that was going to be concreted. The aim of the analysis was to ascertain if the materials of the affected areas were still suitable from the engineering and design viewpoint or if they should be demolished and replaced.

Fig. 1—BWR plot plan—affected zones by fires

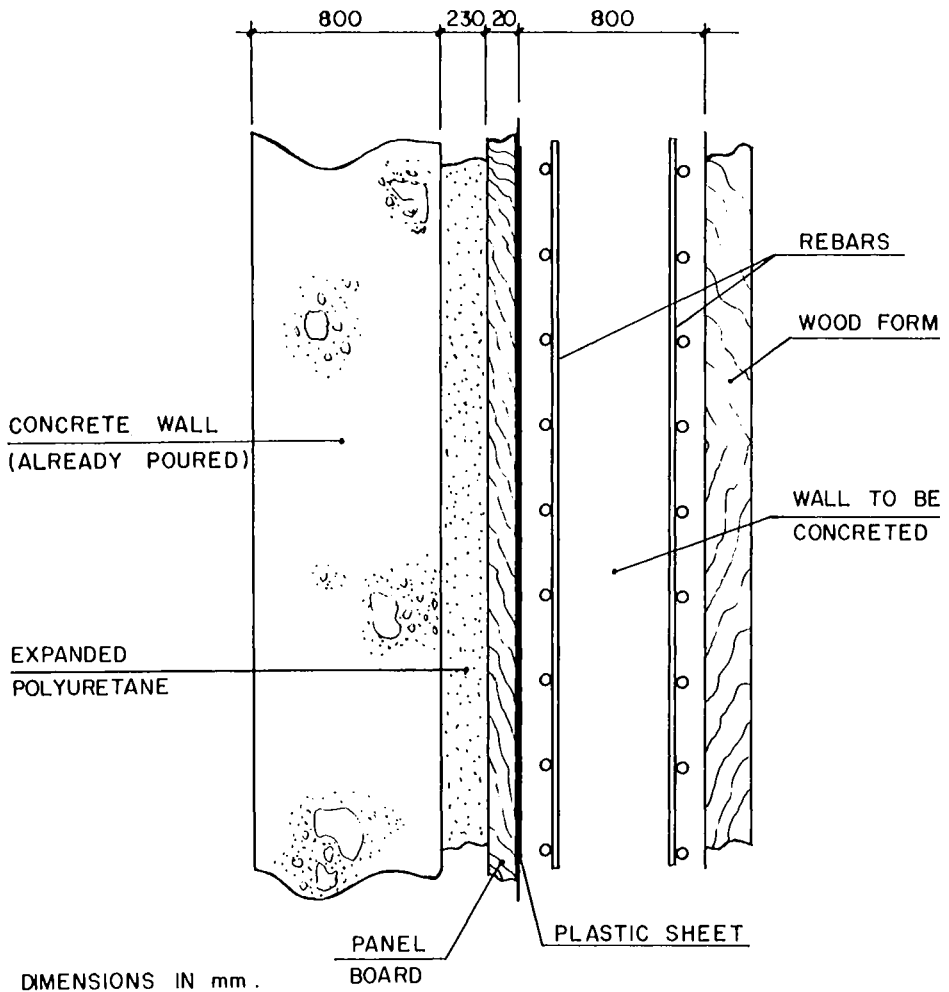
Fig. 2—Typical section between walls with forms

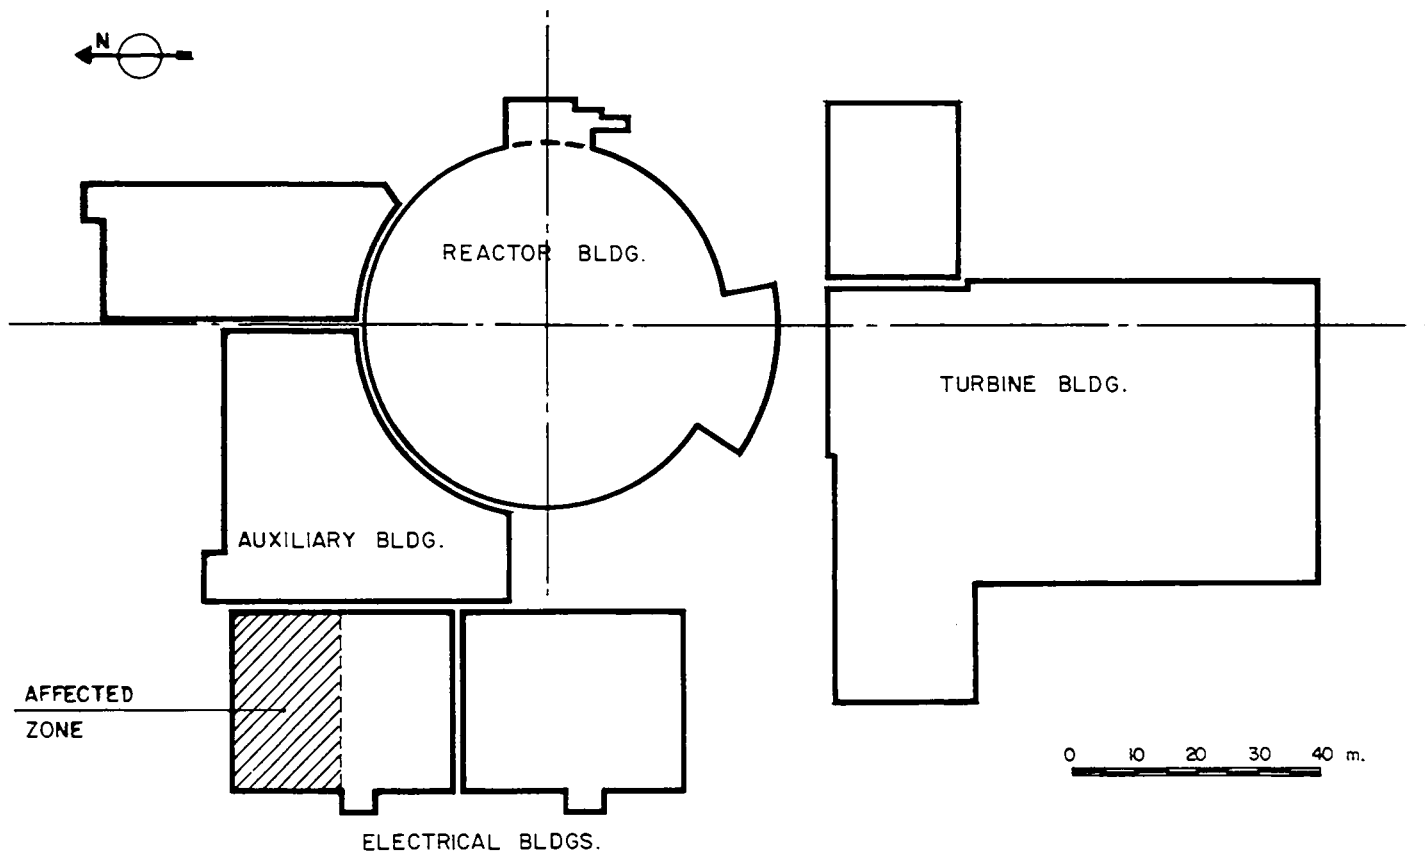
The fire which occurred in the PWR Nuclear Power Plant in 1983 affected the Electrical Building (Fig. 5), where the formworks between the 7th and 8th floors burned. As a result of the visual inspection, the analysis was aimed at determining the areas to be demolished.

Fig. 5—PWR plot plan—affected zone by fire

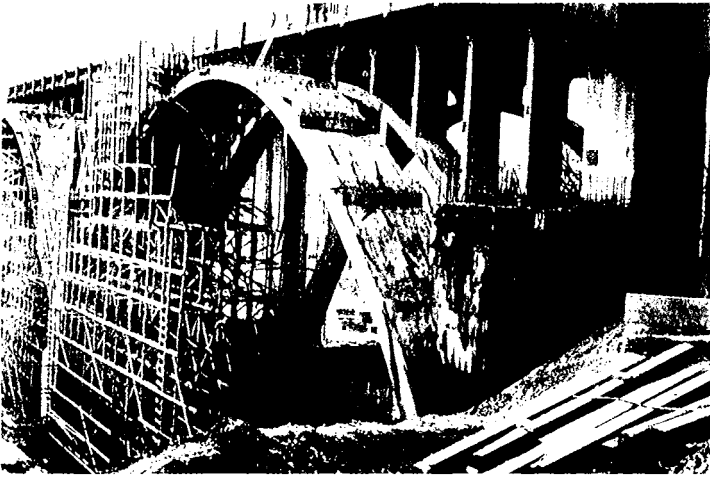
On March 24, 1959 a construction fire, fueled by straw insulated wooden formwork and timber falsework, seriously damaged the reinforced concrete arches and abutment of a highway bridge that was being widened, Fig. 1 shows the scene on the morning after.

Fig. 1—Scene after the fire (1959)

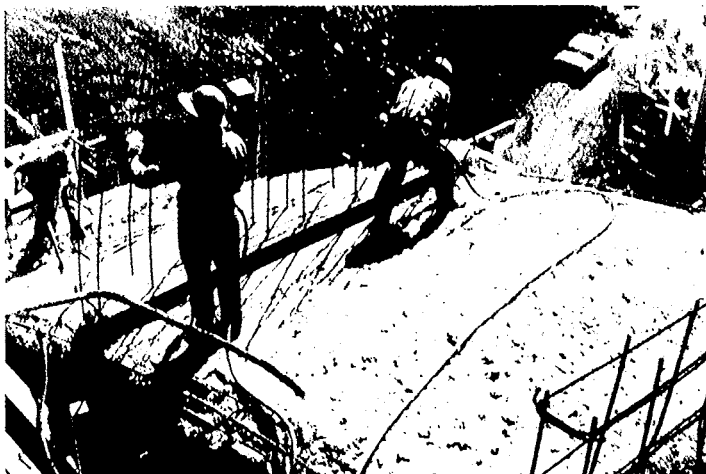
Fig. 3—Preparatory work on the 19-day-old concrete arch (1959)

After removal of loose and suspect concrete, both the young and old concrete sections remaining were rebuilt with shotcrete. Following final cleanup by sandblasting, a small gauge wire mesh was attached to the existing concrete by ramsets. The shotcrete was then formed against edge strips and lightly trowelled to the intended section and 25 mm minimum cover over the reinforcing steel. The shotcrete was then wet cured for 7 days. As shown in Figs. 4 and 5, the work was carried out with care for quality and appearance.

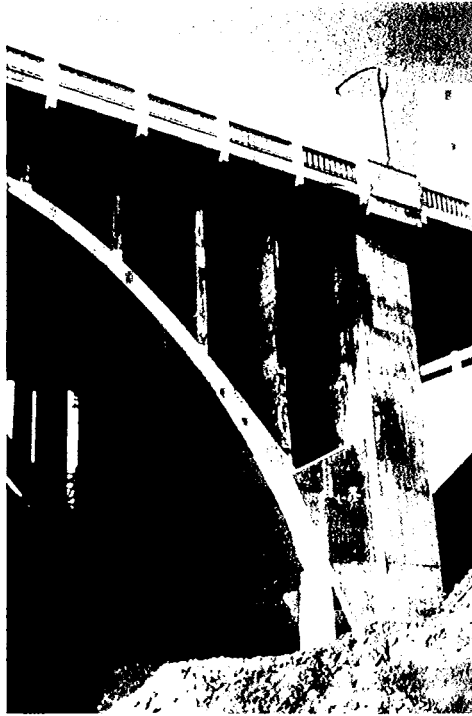
Fig. 5—Completed structure showing part of the repairs and strengthening (1959)

The 19 day old concrete was about 3 months old when repaired and it has been continuously in an open, south-facing exposure, including many cycles of freezing and thawing, ever since. Parts of the substructure have been subjected also to brine runoff from deicing salt applied to the highway above each winter. As a result of adding the new arch, the repaired 20 year old concrete became one of the inner arches that were protected to some extent from the weather. The common strengthening of the old and new arch springings seen in Fig. 5 was later backfilled and protected from the elements.
