# A Crane Gear Failure Analysis – Case Study, Observations, Lessons Learned, Recommendations

by: R.J. Drago, Drive Systems Technology, Inc.

**American Gear Manufacturers Association**

## TECHNICAL PAPER

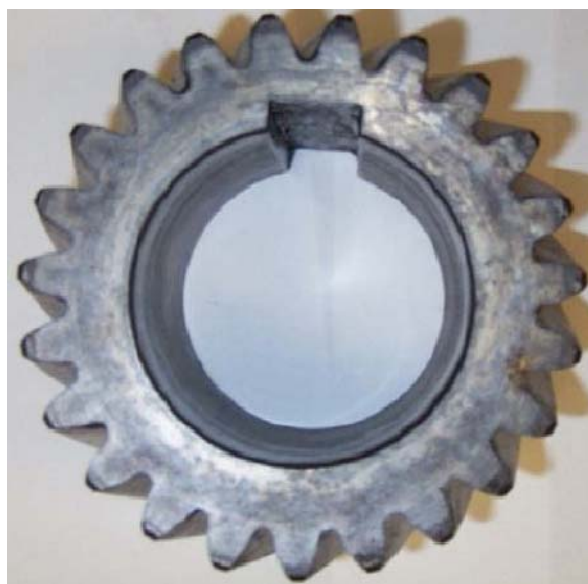
Subsequent to securing the site, as the gearbox was being examined, it was discovered that the object that the mechanic saw in the gear mesh was a piece of key stock. Examination of the gearbox continued in an effort to determine the source of the key. The spur pinion was found to be a shell design, similar to that shown in Figure 2, which is press fit on the output shaft of the primary drive gearbox. A keyway in the bore of the pinion accepts a key that provides torque transmission from the shaft to the gear. This is the key that became entrapped in the gear mesh.

**Figure 2 - Shell Pinion With Keyway**

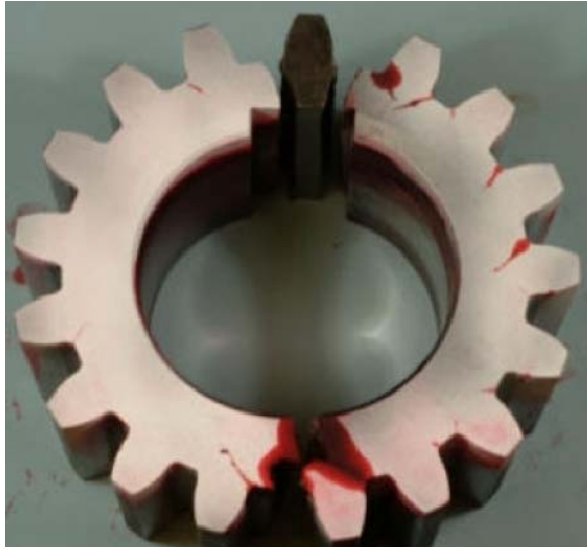
The pinion that was installed in the failed gearbox, Figure 3, experienced a tooth fracture failure. Examination of this pinion shows clearly that it cracked through the rim, at the keyway.

**Figure 3 - Failed Final Drive Spur Pinion**

While the failure itself is due to fatigue, it is very important to note that the mode of failure, cracking through the rim rather than a tooth fracture, is the primary cause of the loss of torque transmission capability of the pinion when the crack progressed. This is a clear instance of a thin rimmed gear failure by cracking through the rim. In addition, careful examination of the keyway shows that the corners of the bottom of the keyway are quite sharp with virtually no significant radius present. This condition exacerbates the thin rimmed configuration and provided a very definite crack progression path.

Careful examination of the stress wave forms in Figure 5 shows that both the magnitude and the position of the maximum range of stress changes as the rim gets thinner. The results of these changes result in a change in failure mode (i.e. crack propagates through the rim rather than through the tooth base) and an increase in stress level. Considering this scenario, it is easy to understand how the shell pinion failure shown in Figure 3 occurred.
