# Helicopter Accessory Gear Failure Analysis Involving Wear and Bending Fatigue

by: G. Blake and D. Schwerin,  
Rolls-Royce Corporation - Transmission and Structures

**American Gear Manufacturers Association**

## TECHNICAL PAPER

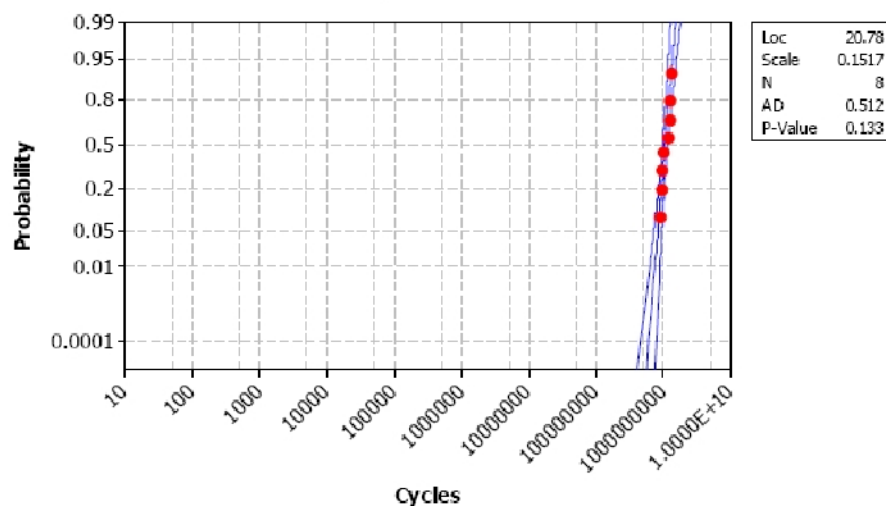
**Figure 2. Probability of failure vs. spare drive gear life**

Eight events occurred over a three-year period. Five of the eight were from the same fleet. The eight failures are detailed in Table 1. A lognormal probability plot was created to show the scatter in the failure data. The bending fatigue failures occurred beyond ten million cycles and within a small range of cycles as shown in Figure 2.

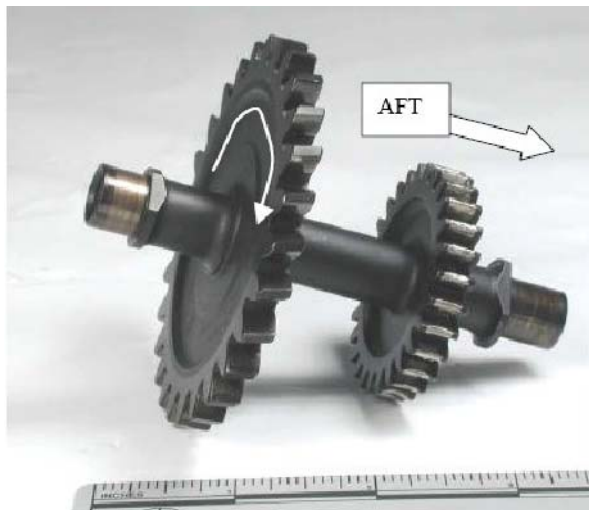
**Figure 3. Failed pinion**

Photos of sample post failures of the pinion and spare drive gear are shown in Figures 3 and 4. These photos are typical of all the failures that occurred. A fatigue origin in the root radius area is shown in Figure 5 and the detached teeth collected post failure are shown in Figure 6.

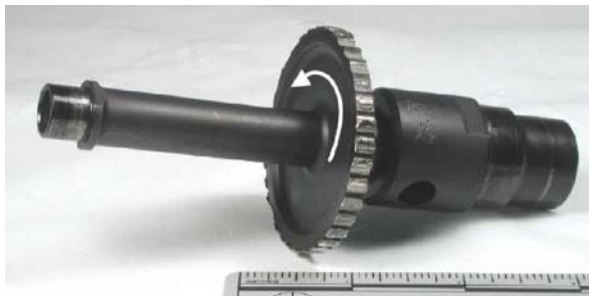
**Figure 4. Failed spare drive gear**

The initial indication to the pilot was generator output failure. Additionally, two aircraft had chip light indications just prior to landing. Two others had chips discovered on the magnetic plug when troubleshooting the cause of a generator problem. One aircraft had a chip light during the mission (chip detectors had large and numerous chips when examined after flight – the engine was removed and replaced). The sixth event occurred before take off with mission equipment on and blades in flat pitch position. In all cases, the aircraft generator drive shaft and spare drive gearshaft in the accessory gearbox (AGB) turned freely. Each failure resulted in all gear teeth being fatigued or milled off the spare drive gear (Figure 4).
