# The Effect of Start-Up Load Conditions on Gearbox Performance and Life - Failure Analysis and Case Study

by: R.J. Drago, Drive Systems Technology, Inc.

This paper addresses the issue of start up loading and its effect on the performance of a series of gearboxes in an industrial application by way of a specific case study. A description of the failures that occurred and the test program and results that led to a definition of the root cause of the failures and a path of correction are also presented.

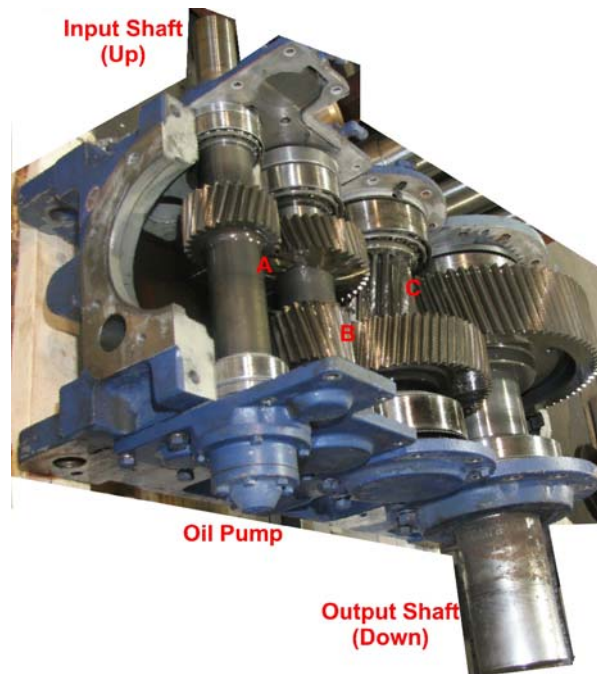
**Figure 5. Triple reduction gearbox (shown in normally installed attitude)**

A failure was reported in the low speed gear set of a triple reduction, single helical gearbox, Figure 5. The gearboxes are used in an Air Cooled Condenser (ACC) facility at a power plant and had been in service for about four years at the time this investigation was initiated.

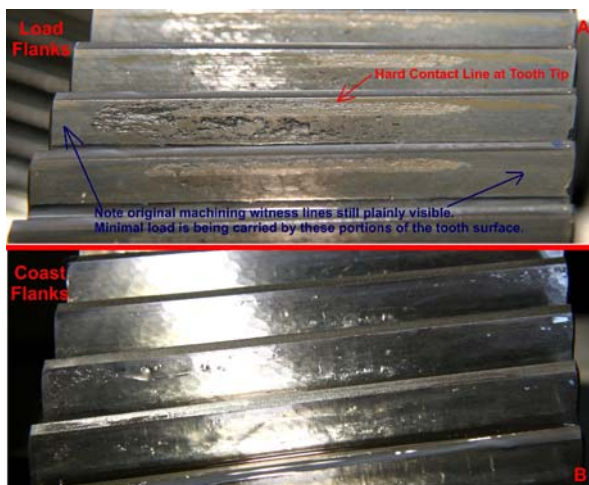
Figure 6. Low speed gear

Initial evaluation of the gearbox indicated that the primary damage was on the low speed gear set. The high speed and intermediate gear sets did show some damage but it was largely consequential. The low speed gear, Figure 6, exhibited a very hard line of contact near the tip of the tooth. This hard, localized region of contact indicates that the tooth did not have sufficient profile modification for the applied loading. The shape of the damaged area suggests that the gear set had some crowning (probably applied to the pinion) to accommodate misalignment. The damage pattern observed on the gear tooth loaded flanks, however, is slightly heavier on the left end of the face (Figure 6). The relatively short area of damage indicates that the crown applied to the low speed gear mesh is likely to large for the applied loading. This tends to concentrate the load in the center portion of the face while unloading the ends of the face. This increases the localized stresses in the heavy contact region. This is very apparent on the loaded tooth flanks shown in Figure 6.

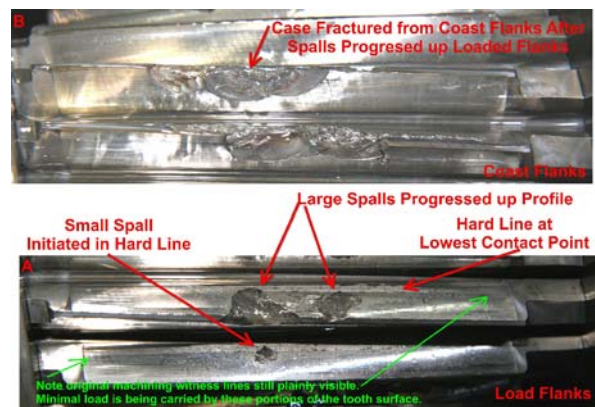
Figure 7. Low speed pinion

The location of the damage observed on the low speed pinion, Figure 7, corresponds to the damage observed on its mating gear; however, the level of damage on the low speed pinion is much more severe than that on the mating low speed gear. Since the pinion sees many more cycles than the pinion, the disparity in the level of damage is expected. The location of the very hard line of contact near the tips of the gear teeth corresponds closely to the similar hard line of contact at the lowest contact point on the pinion teeth. As noted above, this hard contact indicates a lack of adequate profile modification on the pinion or gear or both.

The specific failure mode observed on the pinion is spalling which is a type of surface durability distress. Specifically, spalling is a fatigue mechanism that occurs when very high local stresses initiate cracks at or near the tooth surface. These cracks progress into hard case on the tooth surface and progress up along the tooth surface from the lowest contact point in the direction of sliding on the tooth surface. As the cracks progress, material on the tooth surface is “undermined” and eventually relatively large, somewhat fan shaped pieces of tooth surface are liberated. This mechanism is clearly shown in Figure 7. As the cracking progresses through the carburized case on the loaded flanks of the teeth, it eventually propagates across the tooth thickness, generally fairly close to the tips of the teeth and fractures the entire case off the tooth, even extending back onto the coast flanks. Essentially, the carburized case is “peeled” from the loaded and unloaded tooth flanks. More detail on this failure mode will be presented below.
