08FTM05

# Gear Failure Analysis Involving Grinding Burn

By G. Blake, M. Margetts, and  
W. Silverthorne, Rolls-Royce

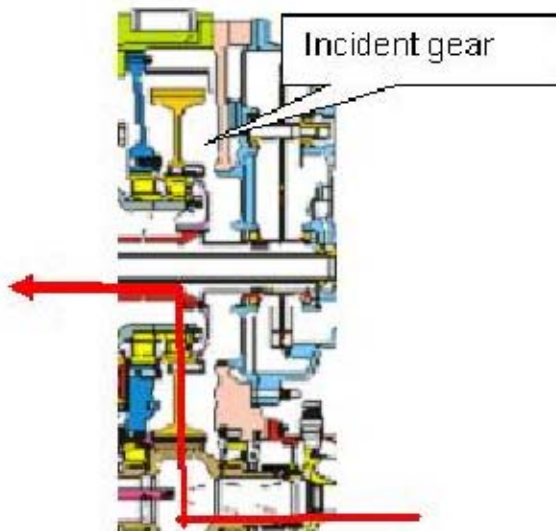
**Figure 1. Partial illustration of gear train showing torque path**

A partial illustration of the gear train and the incident gear is shown in Figure 1. The failed gear and mating pinion are carburized, ground, and shot peened AMS6265. The engine torque path is also shown in Figure 1.

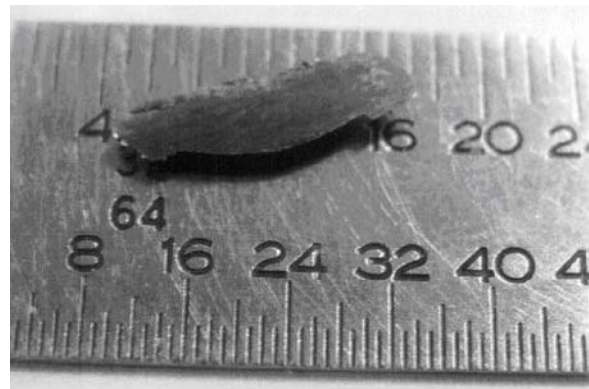
**Figure 2. Debris found on chip detector**

The ground crew first removed the chip detector and found a large sliver of material clinging to the end. The size of the sliver is shown in Figure 2. Typically, wearing or pitting components will generate very fine particles, that when mixed with oil create a paste. The paste is what most technicians expect to find when investigating a chip light indication. The size of the debris found on the plug was cause for removal of the gearbox.
