09FTM12

# The Anatomy of a Micropitting Induced Tooth Fracture Failure – Causation, Initiation, Progression and Prevention

by R.J. Drago, R.J. Cunningham,  
and S. Cymbala, Drive Systems  
Technology, Inc.

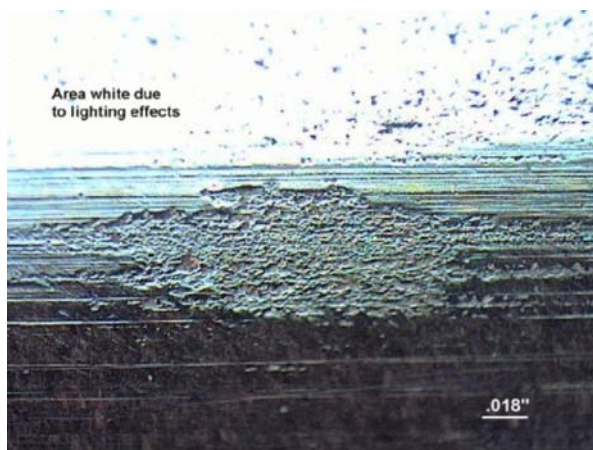
**Figure 1. Typical micropitted region**

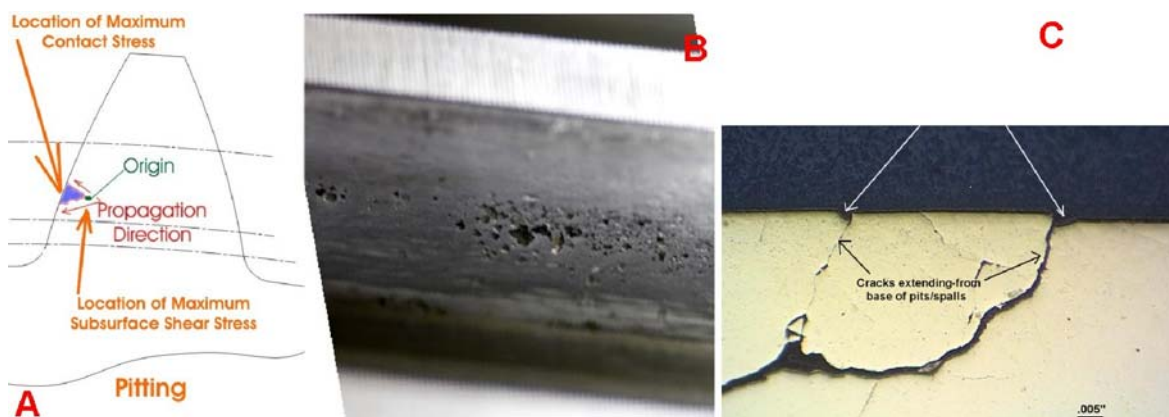
Until fairly recently, surface durability of gears has been defined by macroscopic pitting (macropitting) in which a crack initiates at a subsurface location where the shear stress exceeds the shear allowable, Figure 2A. When such a crack propagates to

the tooth surface, a small piece (or, more often, several small pieces) of material, Figure 2C, are liberated leaving an inverted cove shaped defect, as shown in Figure 2B.

Figure 2. Classical macro pitting fatigue

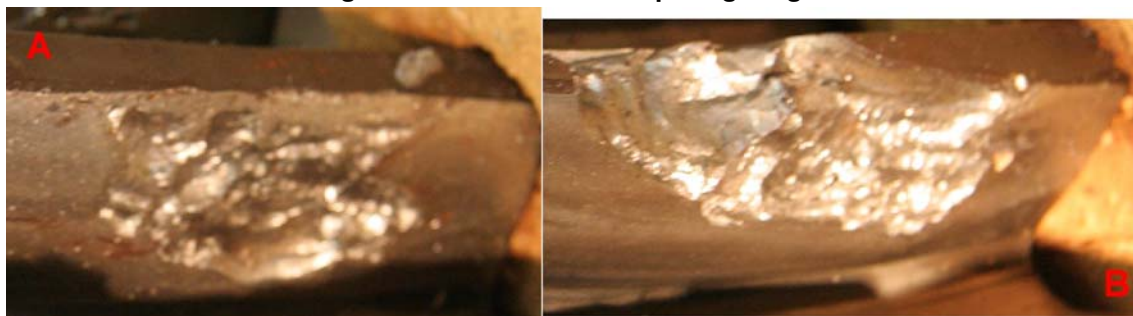
As this process is repeated, more and more pits appear and eventually the tooth surface is heavily damaged, as Figure 3A shows. Eventually, if the loads are high enough, the pitting damaged region of the tooth acts as a significant stress concentration and bending fatigue failure of the tooth may occur through the pitted region, as shown in Figure 3B.

Figure 3. Heavy pitting often leads to local tooth fracture
