10FTM03

# A Novel Approach to the Refurbishment of Wind Turbine Gears

By M. Michaud, REM Surface  
Engineering, G.J. Sroka and  
R.E. Benson, REM Research  
Group

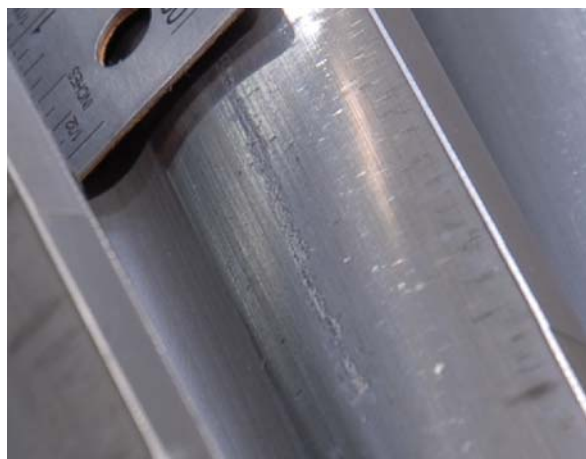
Figure 1a. Micropitting or gray staining on gear flanks

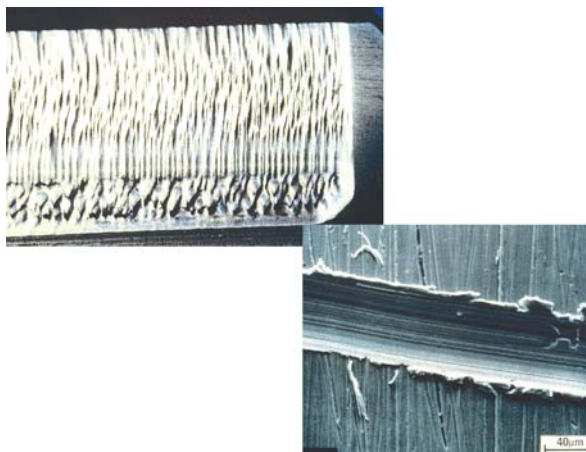
Figure 1b. Heavy abrasive wear on gear flank and a SEM image of trail left by an abrading particle [4]

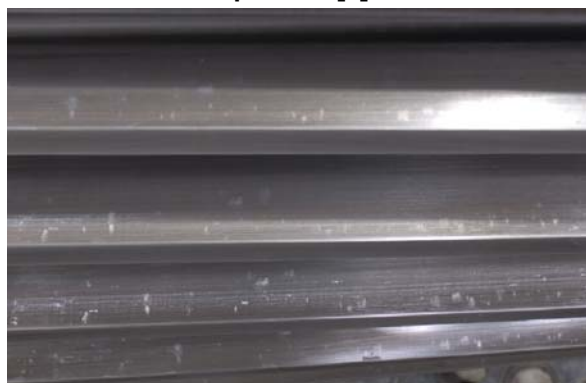
Figure 1c. Foreign object debris (FOD) damage
