## **Gear Failure Analysis and Lessons Learned in Aircraft High-Lift Actuation**

By A. Wang, S. Gitnes,  
L. El-Bayoumy and J. Davies,  
MOOG Inc. Aircraft Group

## **Abstract**

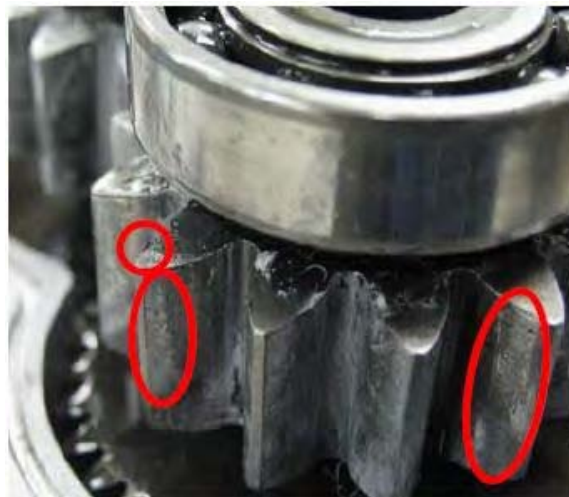
An offset gear set with one bearing very close to one end of the gearbox and another support far at the other end is shown in Figure 6. This is a very special layout, and is not the normal offset gearbox straddle mounted between two bearings. One can calculate the face load distribution according to AGMA [9]. Because of the deflection, gears are edge loaded and pitted as shown in the figure. To solve the problem, the gears need to be crowned to accommodate this misalignment. The face width is 0.80 inch. The total slope including the deflection and manufacturing errors is 0.0048 in/in. After solving the equations as discussed in [7], the crowning radius is 91 inch, and the crowning center is at the end of the tooth. A contact stress of 266 ksi is calculated under the max tangential load of 1000 lbf. From Figure 7, we can see that the crowning has eliminated the pitting problem, so that the full tooth is now sharing the load.

**Figure 6. Damaged gear without crowning [7]**
