13FTM15

# **White Structure Flaking in Rolling Bearings for Wind Turbine Gearboxes**

By H. Uyama and H. Yamada,  
NSK Ltd.

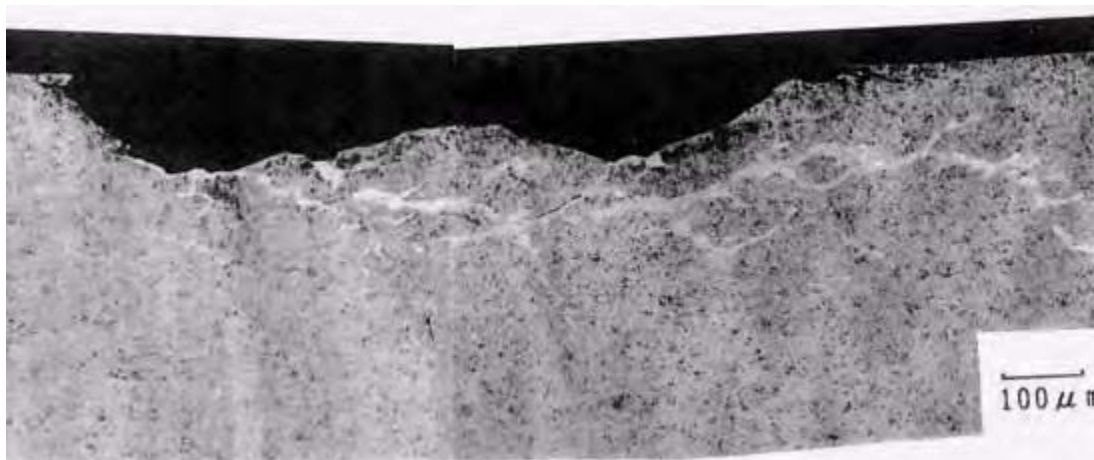
Figure 1. An example of the cross section of white structure flaking in an automotive electrical accessory bearing [3]

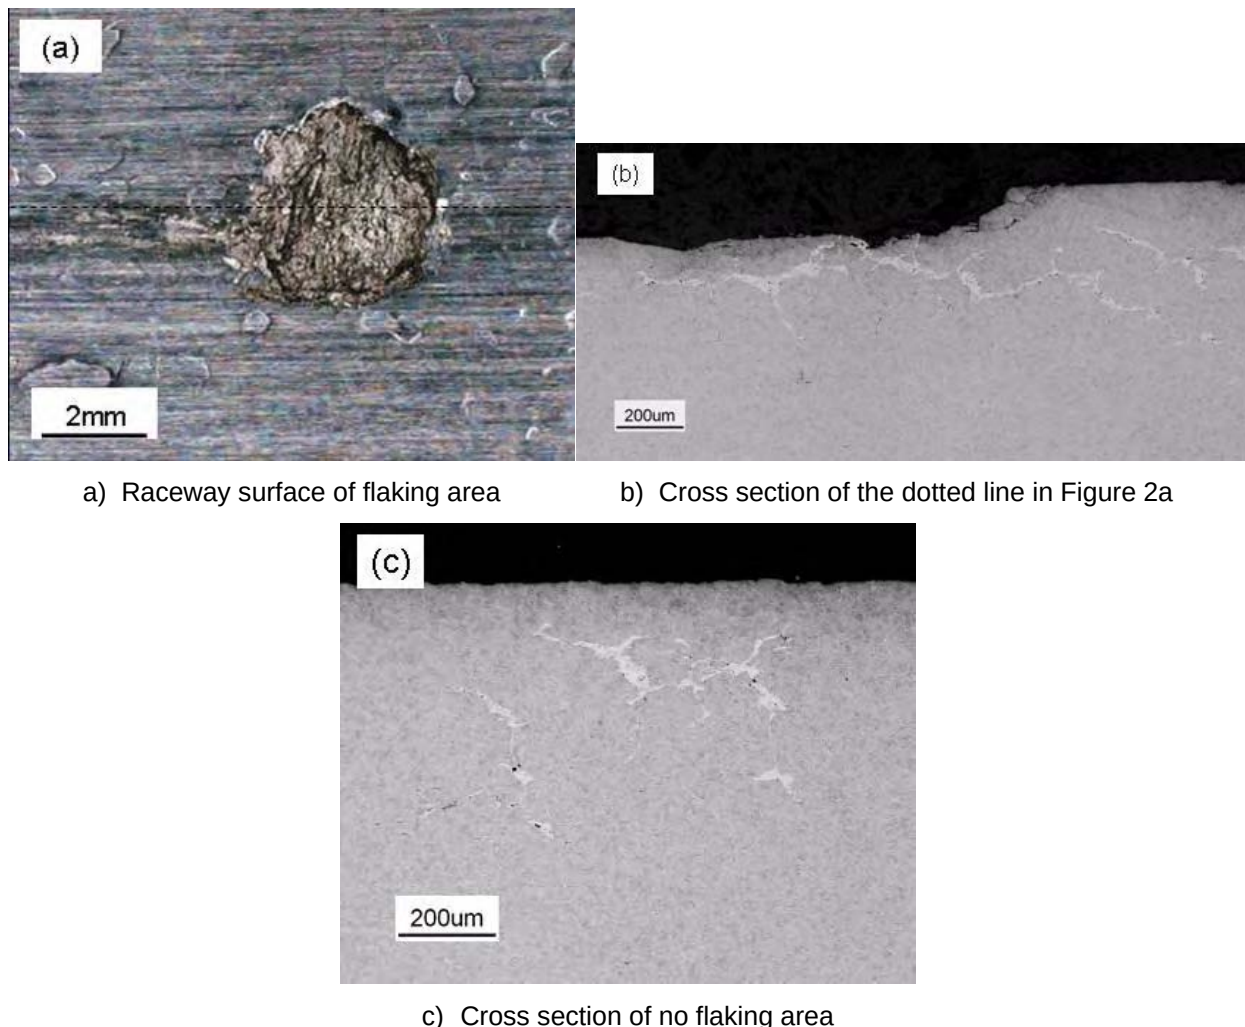
Figure 2 shows the observation results of a failed cylindrical roller bearing, which were used on the high speed shaft in wind turbine gearboxes. A small flaking was seen in the raceway surface as shown in Figure 2a. Figure 2b shows the cross section of the flaking area at the dotted line in Figure 2a. A microstructural change called white structure was observed at the flaking. Flaking morphology of failed bearings in wind turbine gearbox and automotive electrical accessories seem to be very similar as shown in Figure 1 and Figure 2b although bearing types and size are quite different. Namely, small size ball bearings are used for automotive electrical accessory and large size roller bearings are used for wind turbine gearboxes. Figure 2c shows the cross section of an area without flaking in the same bearing as shown in Figures 2a and 2b. White structure was observed even in this area, which is most likely to be the prior stage to flaking. Therefore it is presumed that this type of flaking in wind turbine gearboxes is initiated at the white structure.

**Figure 2. The raceway and the cross section of a failed bearing with white structure.**
