# The Mechanism of Failure With and Without Titanium Nitride Coating in Roller Tests

by: Jože Vižintin, University Ljubljana

American Gear Manufacturers Association

## TECHNICAL PAPER

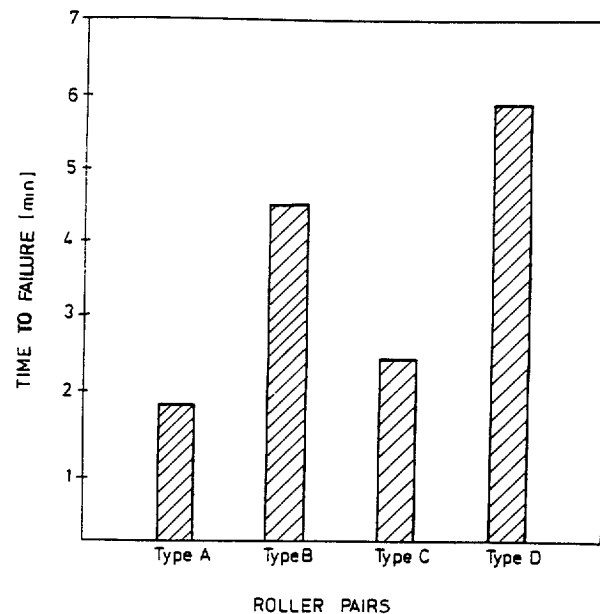
Figure 5 Time to failure of unlubricated roller pairs

Figure 5 shows the running time until failure occurred. The test was carried out twice for each roller pair, and the mean value out of two measured values is shown. The life of the coatings of the roller pairs Type B and D was longer than that of roller pairs Type A and C.

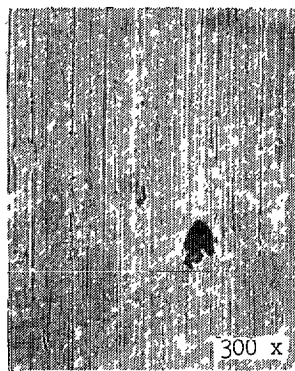
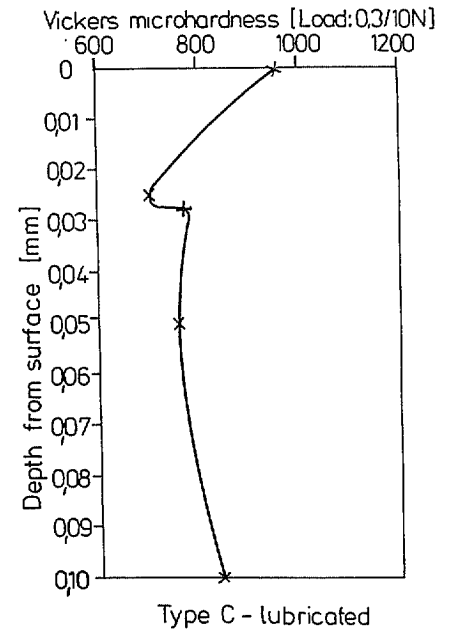
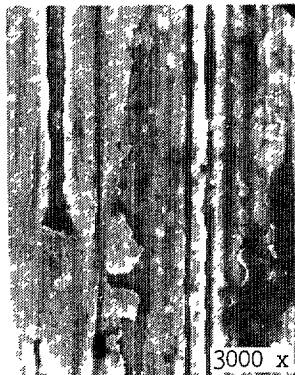
Figure 6 Micrographs and sub-surface hardness of the wear track type A. C no coating

Figures 6 A B show a micrograph of the wear track of the rollers Type A and C after a  $1.2 \cdot 10^6$  m.

wear length. The surface layer of the roller Type C was slightly more sheared in the direction of frictional force. Along the contact surface and in the vicinity of the surface there are distinct modifications of microstructure induced by shear stresses and temperature. This can be confirmed by the fact that the hardness is considerably higher than that in the subsurfaces. Figure 6 B shows the change in Vickers microhardness with depths measured along the line A - A, probably caused by work-hardening due to the action of compressive stress, frictional force and cooling with lubricating oil. Figure 7 A shows a micrograph of the wear track of the roller Type B after failure at about  $1.2 \cdot 10^6$  m. An undulation was observed in the circumferential direction of the roller and the TiN surface layer was fatigue-damaged in the direction of the frictional force. Figure 7 B shows a micrograph of the section plane cut in axial direction of the roller and the distribution of Vickers microhardness measured along the line A-A. From this micrograph it can be seen that the metal in the vicinity below the TiN layer was distinctly deformed. The hardness in the vicinity of the boundary of the TiN layer was the same as that before the tests. The TiN layer had a larger elasticity modulus than the base material, and that the compressive, shear and thermal stresses cause a much larger deformation in the base material in the vicinity of the TiN layer than that in the TiN layer. On the other hand the surface temperature was lower than that used for heat treatment.

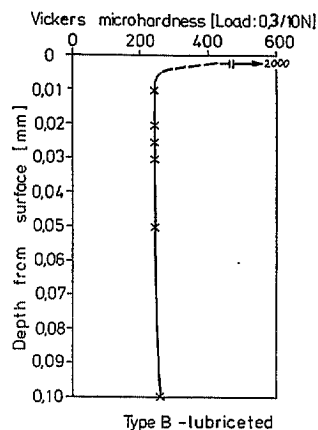
Figure 7 Microphotograph of failed portion of roller type B. with TiN coating

The degree of surface fatigue damage of the TiN layer of the roller Type B was more substantial than that of the roller Type D

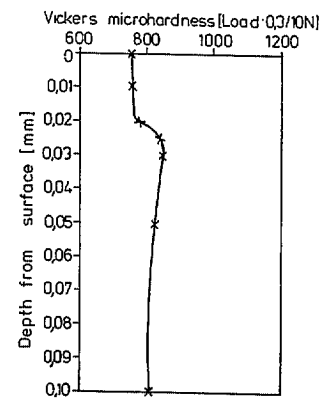
Figure 8 Microphotograph of failed portion of unlubricated roller type A no coating

Figure 8A shows a micrograph of the wear track of the roller Type A after failure unlubricated. An undulation was observed in the circumferential direction of the roller, and the surface layer was sheared in the direction of the frictional force. Figure 8B shows a micrograph of the sectional plane cut in the axial direction of the roller and the distribution of Vickers microhardness. Along the surface there are no signs of deformation. There was an approx. 1  $\mu\text{m}$  thick layer of austenite. This confirms that the temperature was above the AC3 point which, according to the catalog, is 875°C. The austenite layer could not be separated from the wear track with a hammer impact. Therefore, the austenite layer was regarded as a structure affected by the actions of frictional force and frictional heat.

An undulation was observed in the circumferential direction of the roller Type C, and the surface layer of the roller was sheared in the direction of the frictional force. Along the tested surface there is an approx 1  $\mu\text{m}$  thick layer of austenite. This layer was produced in the same way as that on roller pairs type A.

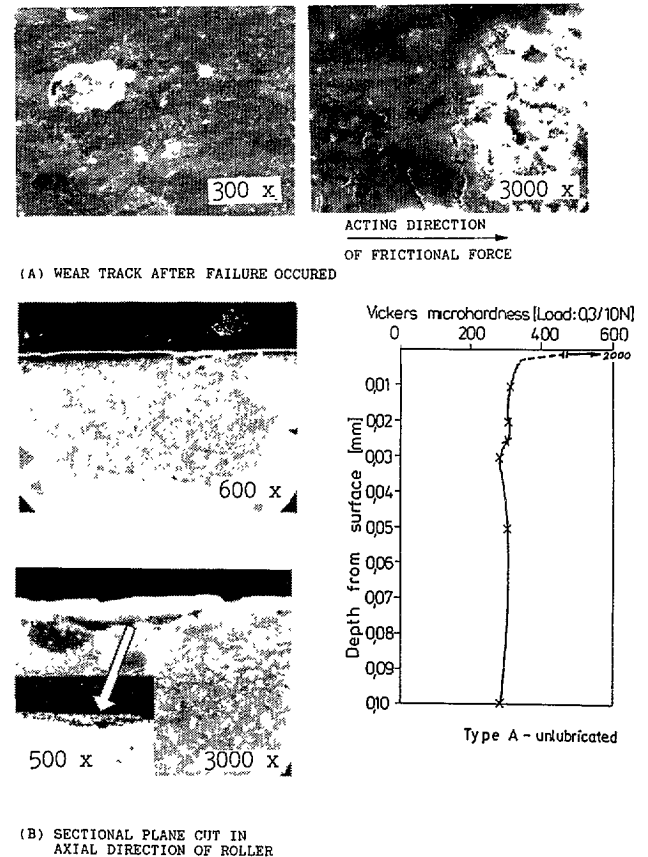
Figure 9 Micrograph of failure portion of the roller Type B with TiN coating

Figure 9, A,B shows a micrograph of the wear track and the sectional plane cut in the axial direction of the roller Type B after failure. Comparing the roller Type D with the roller Type B, the degree of surface fatigue damage by failure was higher than that found on the rollers pairs type D. Figure 9 B shows the distribution of Vickers microhardness which is the same as that before the tests. The mechanism of the failure of TiN-layer was slightly different appearance than that of the lubricated. The elastic deformation of the base material was larger than elastic deformation of the TiN-layer and larger than that of the heat-treated base material of the roller in the lubricated conditions
