# The Effect of Material Defects on Gear Performance - A Case Study

by: R.J. Drago, Mechanical Power Transmission Systems  
Consultants and A.F. Filax, University of Chile

# **The Effect of Material Defects on Gear Performance**

## **— A Case Study —**

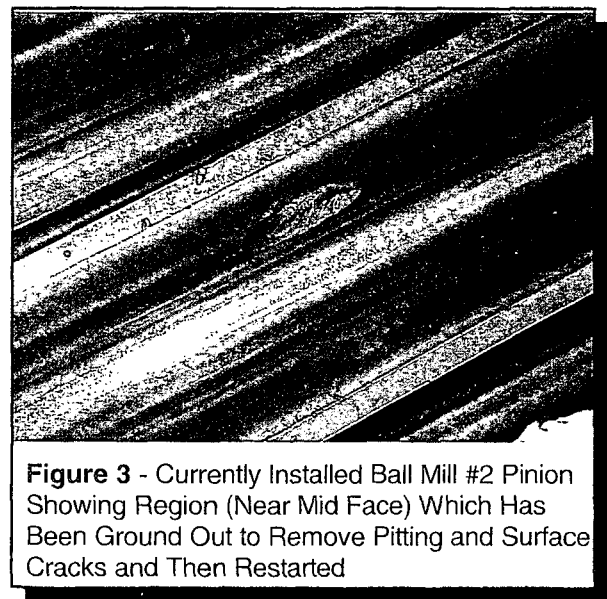
The failed pinion was replaced and the mill restarted. During a visual inspection conducted in early 1999, the new, replacement pinion was found to be exhibiting pitting very similar in both extent and location as the original pinion. This pitting was hand dressed out and was found to have not progressed significantly during a visual inspection which was conducted during April 1999, as Figure 3 shows.

**Figure 3 - Currently Installed Ball Mill #2 Pinion Showing Region (Near Mid Face) Which Has Been Ground Out to Remove Pitting and Surface Cracks and Then Restarted**

During an inspection in April 1999 we did not observe any cracks on this pinion (we were unable to dye check it) but it was reported to have some cracks in the pitted region which were discovered during a previous dye check inspection. The cracks were ground out and the pinion was returned to service. At the time of our inspection, it appeared that only minor progression of the pitting was occurring.
