**AC POWER INTERACTIONS WITH PIPELINES –  
The “Usual Suspect,” The Ugly Geology, and, Finally, The Weird:  
Faulty AC Power Conditioning Capacitors Interacting with Well-Coated Pipeline**

Cal Chapman, P. E.  
Chapman Engineering, Inc.  
PO Box 1305, Boerne, Texas 78006

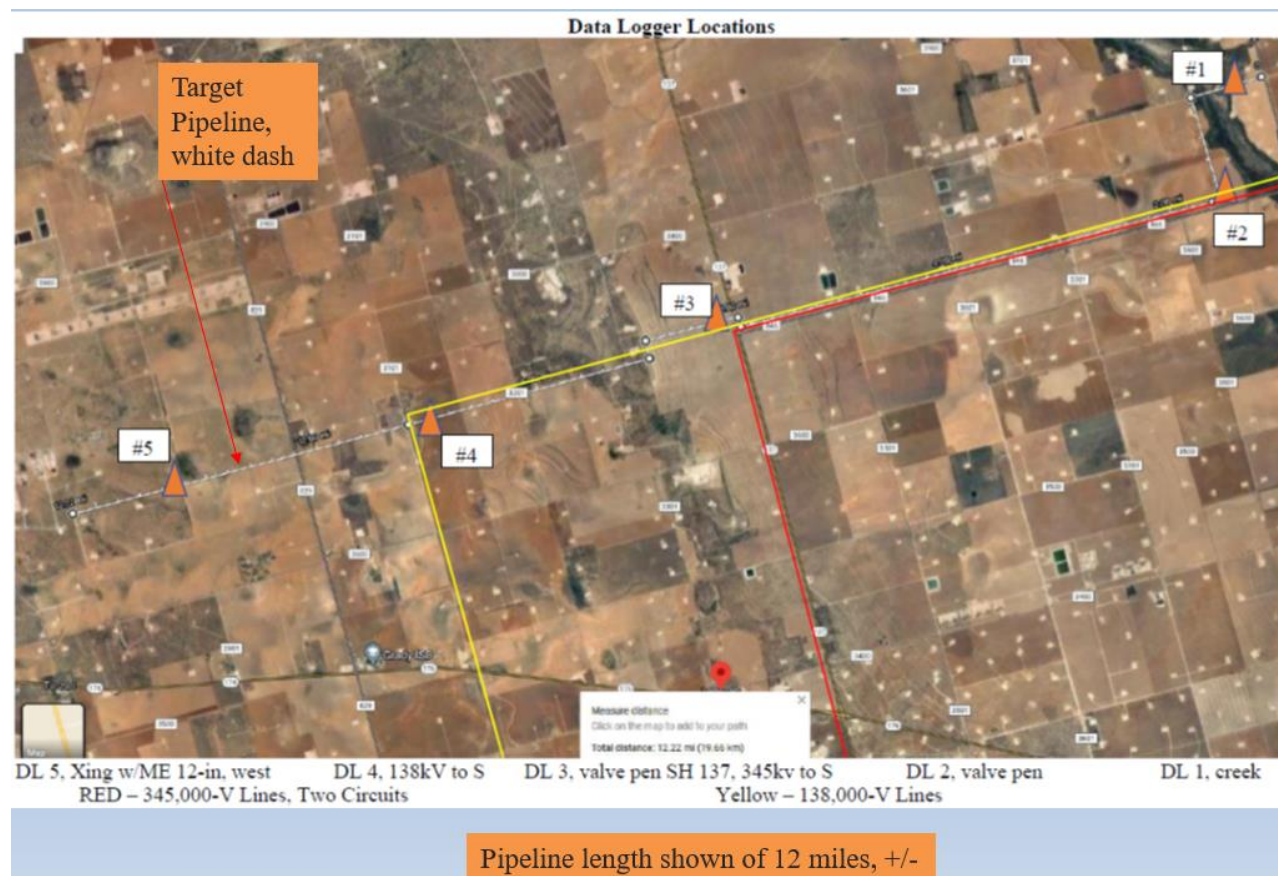
**Figure 1: Map and AC Power Line Layout for 10-inch Pipeline, Case 1**

At west end of 345-kV alignment, the power lines (red line in map above, Figure 1) come up from south, then turn east to come into dead parallel with the 10-inch Crude Line. DL #3 was positioned there (follow arrow from legend “Series3” to gray-colored data set). This 345-kV high line interconnects the El Paso, Texas market with the Dallas-Fort Worth market, and must have widely varying loads on it. These loads do not show the usual weekday early morning and evening residential peak loads, but rather have some erratic (by “clock” and “calendar” evaluations) highs and lows for induced AC voltages.

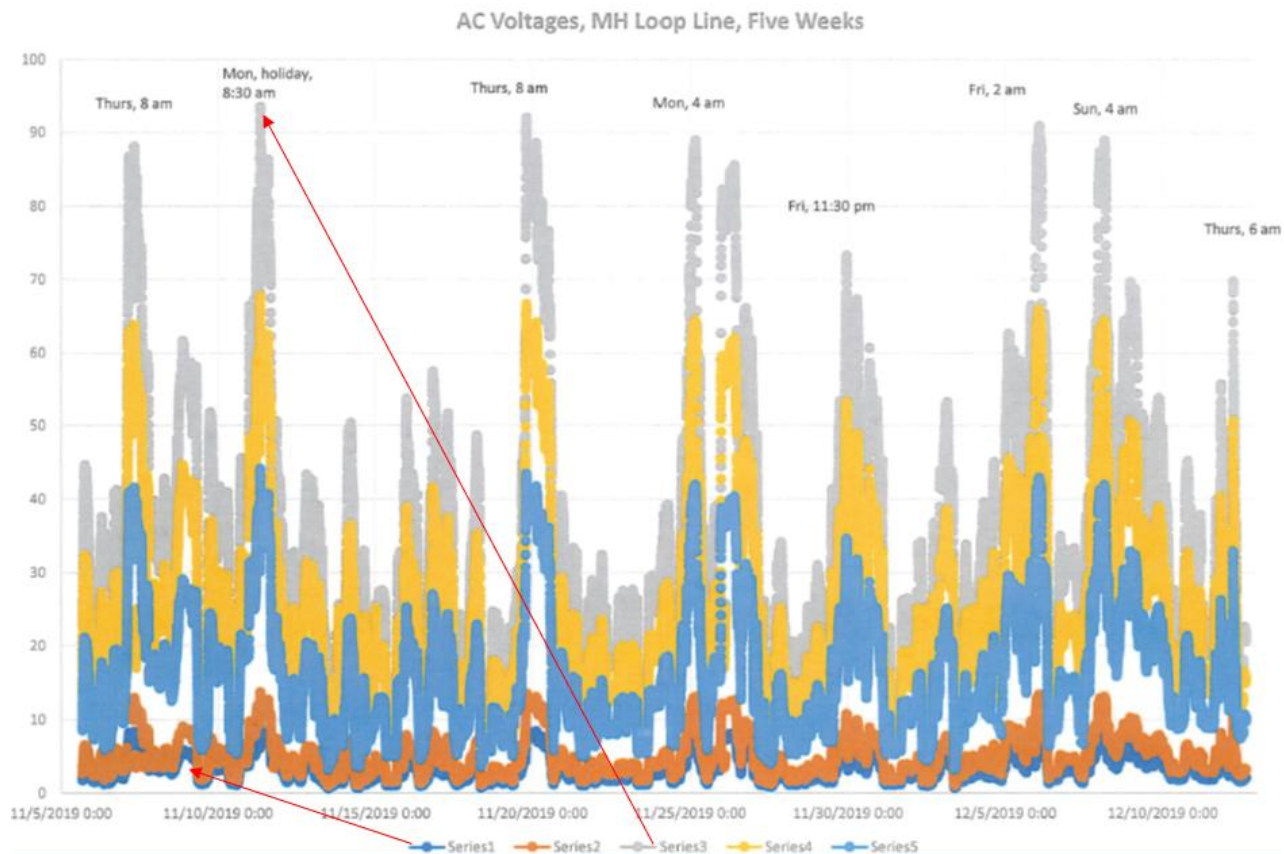
**Figure 2: Graph of AC Voltages Measured at Five Data Logger Locations, Case 1**

The east end of this 345-kV alignment, with Data Logger (DL) #1 (darker blue at bottom of graph, and “Series1” in legend) has salty soils in drainage area with the intermittent creek called Sulphur Spring Draw, and much lower AC voltages measured, structure to soil. This is likely an AC current discharge area, with very low soil resistivity found (at 2.0 ohm-meters), and wet ground on a frequent basis in the Draw topography. DL #2 in brown-orange color also had relatively low AC voltages, and lay not more than a quarter mile (400 meters) west of the same Sulphur Spring Draw discharge area.

The 138-kV power line is probably carrying a large regional load. DL #4, of goldenrod color, showed second-highest voltages on average. Its variations, though, track the 345-kV line load changes to a great degree. As a further observation, induction from both power lines onto the pipeline was/is very significant a few miles further west of the 345-kV turnout away from pipeline. Power on the 345-kV HVAC line might easily be five to 20 times larger a load, on average, compared to the power on the 138-kV line. No information was obtained from the regional power distribution entity, and that is an ongoing research need.
