## Stray Current Induced Localized Corrosion of Stainless-Steel Plates in A Tainter Gate System

Hongbo Ding, Jared Pannell, Dirk van Oostendorp  
Corpro  
7000A Hollister Road  
Houston, TX, 77040  
USA

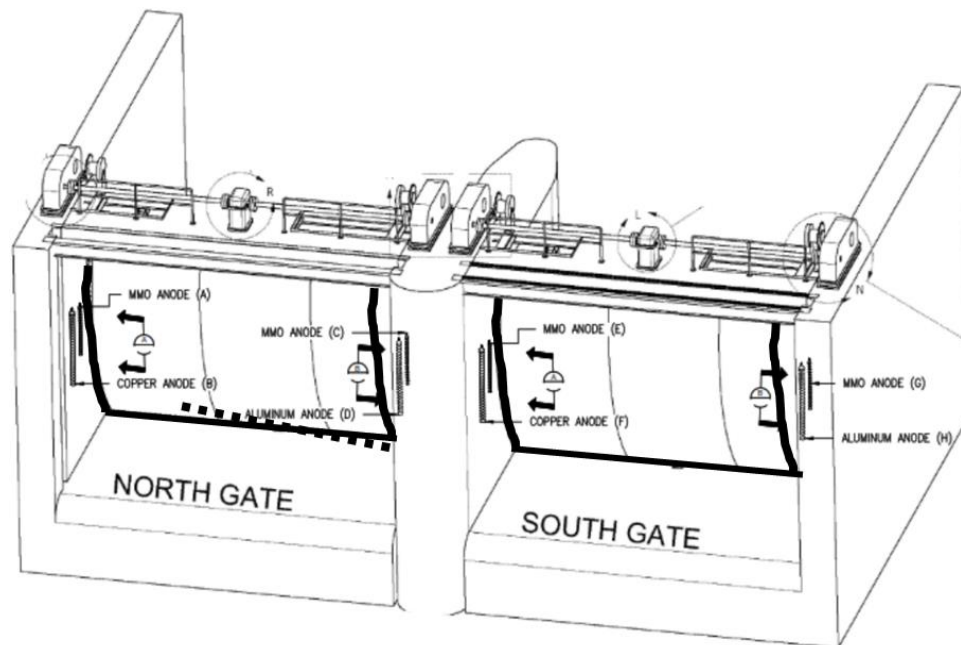
**Figure 2: Diagram for the ICCP Anode Locations for the Gates and the Location of Major Corrosion**

There are two gates adjacent to each other, i.e., the South Gate (right in the image) and the North Gate (left in the image), or Gate 1 and Gate 2 respectively. The Tainter gates were installed in 2012. Magnesium anodes were originally installed, known as a galvanic anode cathodic protection (GACP), system for the subject gates. The GACP was replaced with an impressed current cathodic protection (ICCP) system in 2014. Localized corrosion was observed in 2018 on the bottom plate that is not part of the ICCP system. The location of the ICCP anodes are shown in the drawing as dashed line below (Figure 2). The corrosion is observed on the bottom plates that are not protected by the ICCP system.

The solid line in the diagram illustrate the location of the EP plates. For clarity, the dashed line is illustrated as separate line to identify the corrosion location on the stainless steel plate.

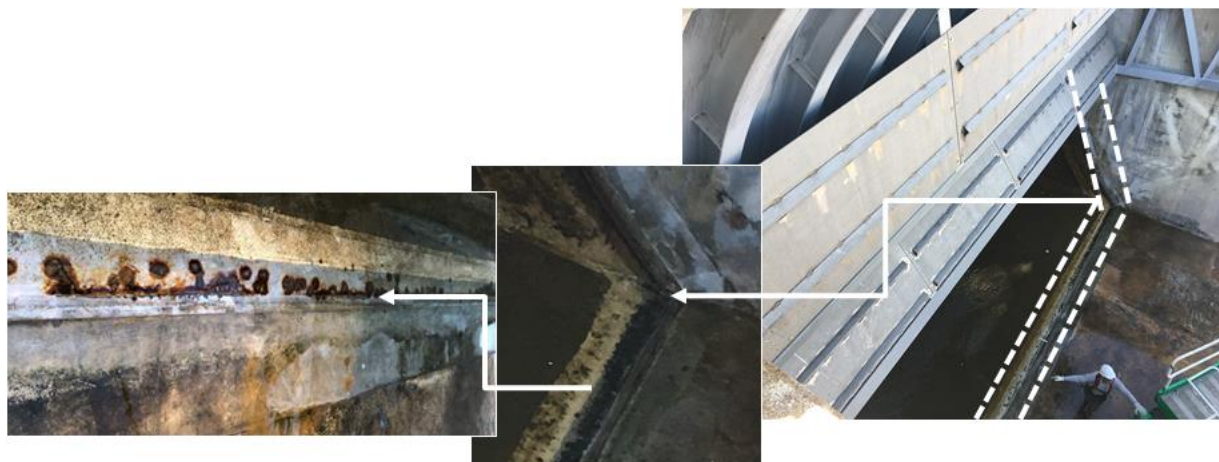
**Figure 3: Corrosion Morphology and Location for the Stainless Steel Embedment Plate**

The corrosion is observed on the stainless steel embedment plate. The EP is embedded in concrete walls and floor. Corrosion of the SS304 EP was focused on areas where a crevice is formed by the contact of the EP with the rubber seal on the opposite side of the Tainter gate. The main body of the Tainter gate is made of low alloy steel that is separated from the EP. The low alloy steel gates are protected against corrosion using organic coatings and a localized ICCP system.

There are also stainless steel plates on the edges of the gate to hold the rubber seal. The gate plates (GP) are intended to be electrically isolated by isolation bolts and the rubber seal. However, some of the isolation bolts were found to be defective, causing some of the GP being electrically shorted to the gate. It was found that location of the localized corrosion on the EP is exactly opposite to the location of the GP that are shorted to the low alloy steel gate.
