## **Metallurgical Analysis of Hydrotested 20-Inch Natural Gas Pipeline**

Sudhakar Mahajanam, Efrain Garcia and Ken Riggs

Stress Engineering Services, Inc.  
13800 Westfair East Drive  
Houston, TX 77041

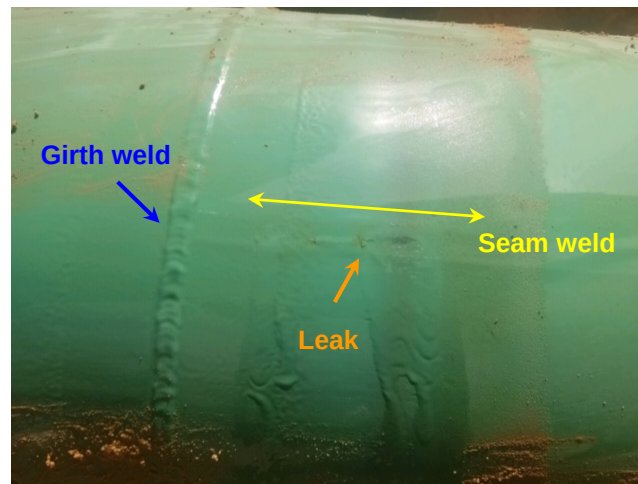
pipeline fabrication. This work will add to metallurgy side of hydrotesting operations, and emphasize the role played by hydrotesting in assessing the integrity of a pipeline prior to installation. We evaluated a long seam weld defect that was detected during hydrostatic testing of a repaired 20" natural gas pipeline at a client site. The electric resistance welded (ERW) pipeline was reported to be API 5L X65 PSL2 steel with a nominal wall thickness of 0.375". This pipeline was new, likely manufactured in 2018 and installed in 2019. Dye penetrant testing, x-ray radiography and phased array UT inspection all indicated that the defect was a lack of fusion (LOF) at the seam weld, located about 3" from the girth weld. Figure 1 shows a picture indicating the location of the defect.

Figure 1. Photograph taken in the field showing the location of the defect.

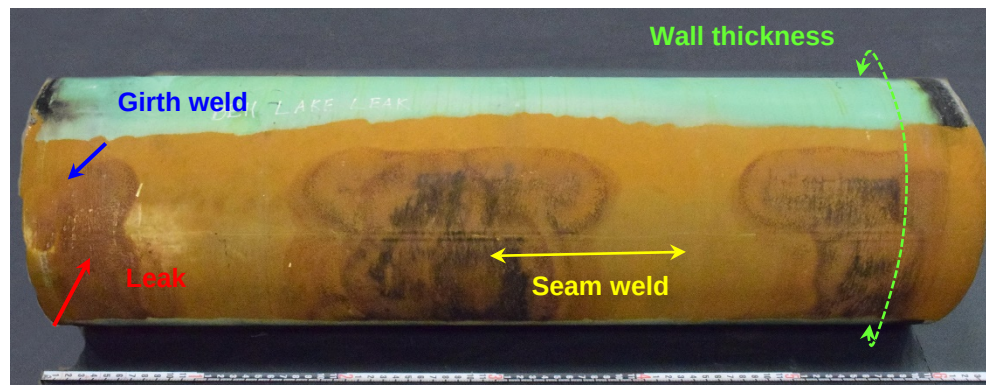
Figure 2. As-received photo of the leaked pipeline section sent to SES. Numbered scale divisions are feet.

The leak was located 3-3½" from the girth weld. The pipeline showed no deformation across the length. The outside diameter (OD) was at the leak 20.06". Wall thickness measurements were taken around the circumference on the other end of the leaked region (green dotted line in Figure 2). The OD at this location was 20.03". The average wall thickness (8 readings) in this region was 0.379".

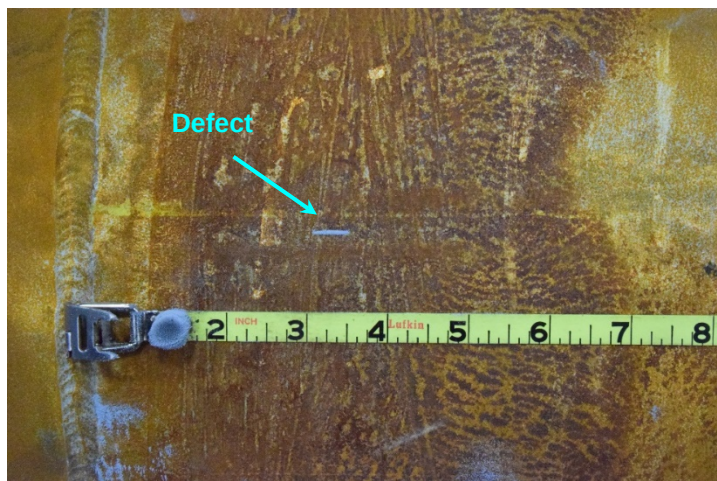
Figure 3 shows a picture of the defect following MPI testing. The region containing the defect was sectioned off for metallography and scanning electron microscopy (SEM). The section containing the

**Figure 3. Photograph taken following MPI testing. Numbered scale divisions are inches.**

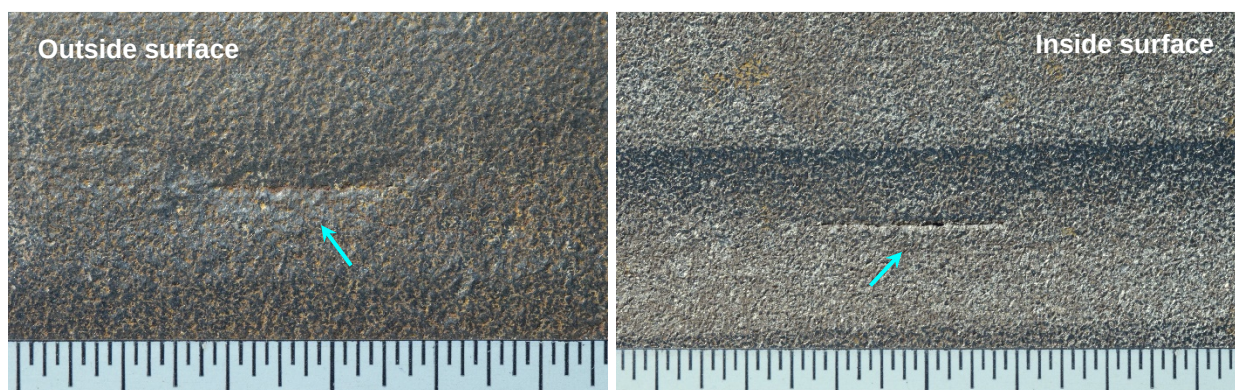
defect was cleaned and wire brushed on the outside and inside surfaces. Figure 4 shows a picture of the defect. The defect measured 0.28 inch on the outside surface and ~0.5 inch on the inside surface.

**Figure 4. Close-up photographs of outside and inside surfaces containing the defect (marked by arrows). Scale divisions are  $\frac{1}{32}$  inch.**

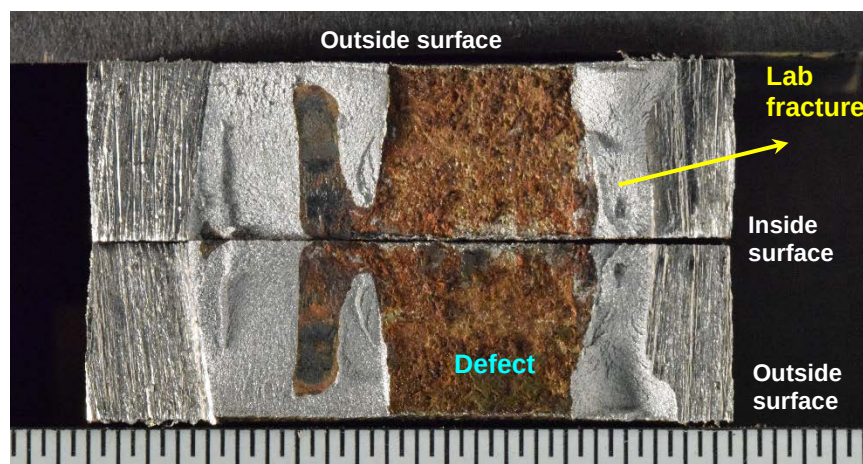
The defect area was then broken open in order to expose the defect surfaces. The two matching surfaces obtained are shown in Figure 5. One of these matching pieces was cleaned in Alconox to remove the brown corrosion product. A photo of the section after the cleaning process is shown in Figure 6.

**Figure 5. Photograph of matching surfaces following lab fracture. Scale divisions are  $\frac{1}{32}$  inch.**
