# Case Study of AC-Induced Corrosion on Buried Pipeline: Field Test and Mitigation Design

Yi Liang, Yanxia Du, Xun yuan, Le Chen

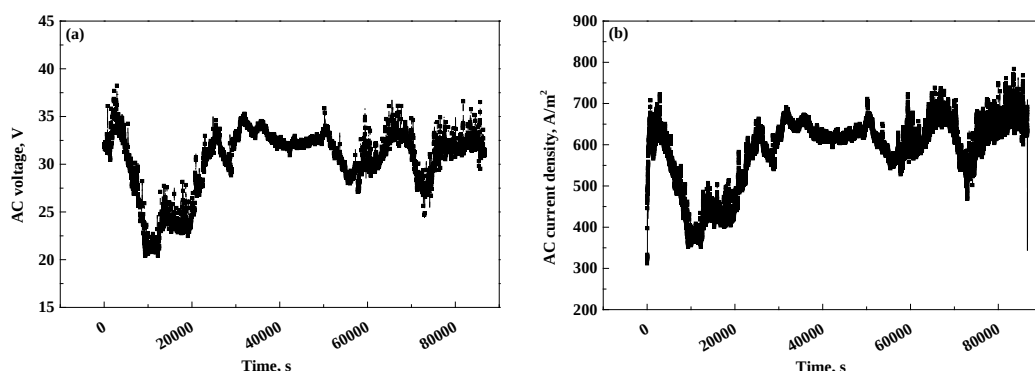
The AC voltages and current densities were monitored for 24 h and the results measured at 2# test post were shown in Figure 2. AC voltage and current density of the pipeline had the same trend during the monitoring. It seemed that AC voltage and current density would reach a steady value and the results were presented in Figure 3. It could be seen that AC voltage exceeded 4 V at all test points and exceeded 15 V at 6 test points. The AC current density of pipeline exceeded 100 A/m<sup>2</sup> at all test sites and exceeded 300 A/m<sup>2</sup> at 5 test sites. Moreover, the maximum AC voltage reached 44.3 V and the maximum AC current density was 1248 A/m<sup>2</sup>. From the results above, some  $U_{ac}$  peaks exceeded the maximum allowable AC touch voltage of 15 V according to NACE SP 0177<sup>12</sup> and some  $J_{ac}$  peaks exceeded the maximum allowable AC current density

according to NACE SP21414-2018<sup>11</sup>. It could be concluded that the buried pipeline suffered from serious AC interference.

**Figure 2: Detection results of AC voltage and AC current density at 2# test post: (a) AC voltage; (b) AC current density**

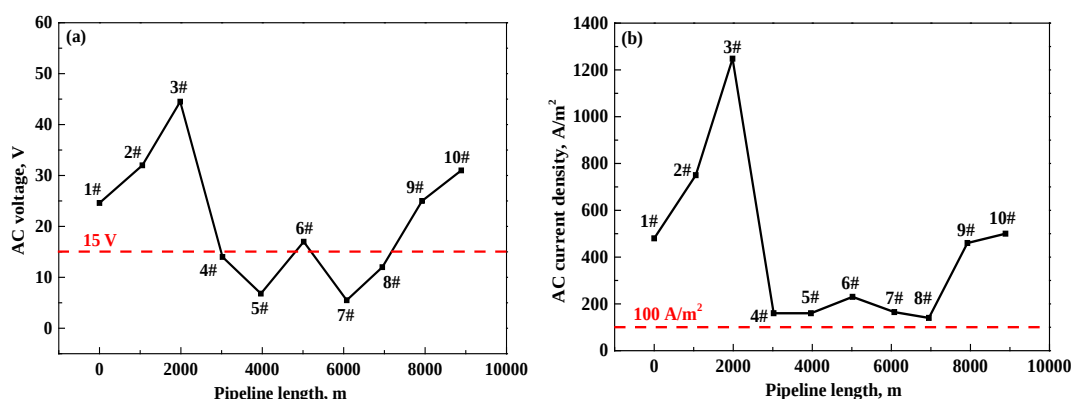
**Figure 3: Detection results of AC voltage and AC current density at all test posts: (a) AC voltage; (b) AC current density**
