**Paper No.**  
**16434**

## **Inspection and Mitigation of Corrosion for Pipe Cable Systems**

Frank Rea, PCS  
Consulex Corrosion Professionals  
960 North Cocoa Boulevard  
Cocoa, FL 32922  
USA

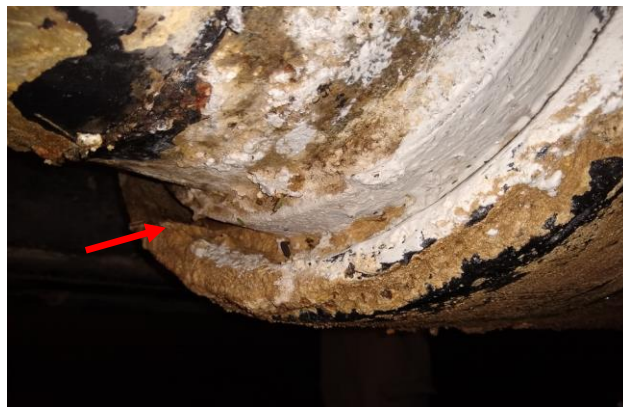
From a corrosion perspective, the exteriors of the pipe cables are in good condition. Visual examination did not reveal any pack rust or metal section loss. Spot surface rust was evident (See Photograph Nos. 4-6), but determination of surface area percentage affected was not possible due to the presence of cement on significant surface area of the pipe cables. The original coating system (black finish) is very brittle and probing with a knife revealed very little adhesion to the substrate. On the pipe cables that ran the full length of the chamber, the average DFT of the original system without white maintenance paint was 18.2 mils (462  $\mu\text{m}$ ) and the average DFT of the original system with white maintenance paint was 22.2 mils (559  $\mu\text{m}$ ). On the capped pipe the average DFT was measured as 73.2 mils (1859  $\mu\text{m}$ ). Spot maintenance painting with a silicone coating (white) was present on approximately 40% of pipe cable surfaces.

Photograph No. 4 – Location #1,  
Spot Rust on Pipe Cable

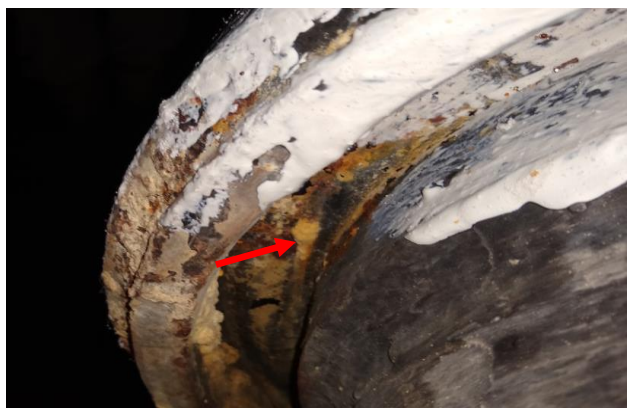
Photograph No. 5 – Location #1,  
Spot Rust on Pipe Cable

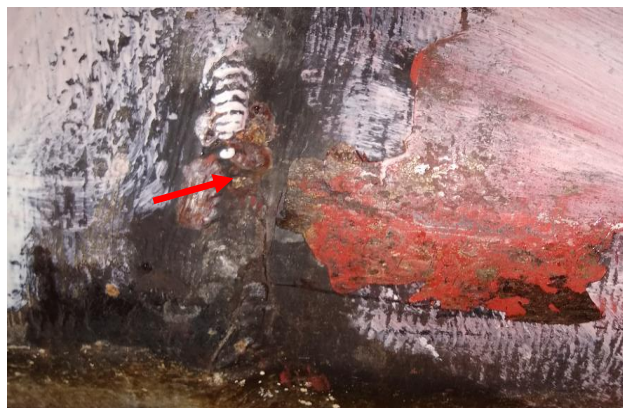
Photograph No. 6 – Location #1,  
Spot Rust on Pipe Cable
