**Paper No.**  
**16501**

## **Evaluation of a 60-year old Iron Pipeline in a Corrosive Environment and Flow Test of a 97-year old Cement-mortar Lined Iron Pipeline**

L. G. Horn  
Ductile Iron Pipe Research Association  
P.O. Box 190306  
Birmingham, AL 35219

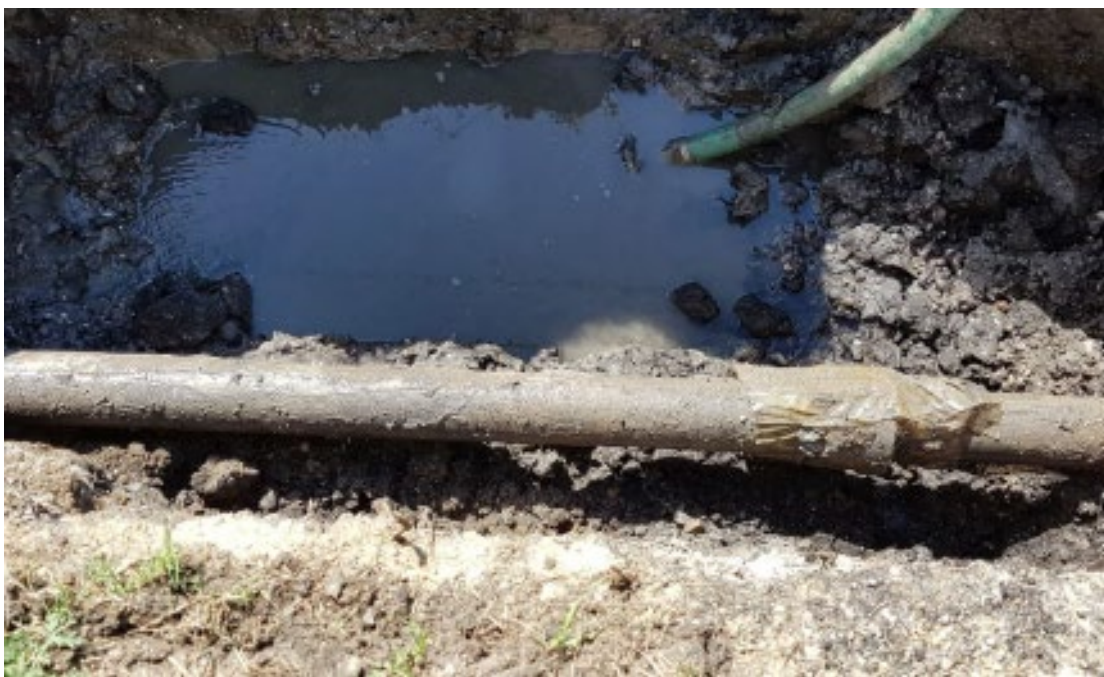
These results indicate an extremely aggressive soil environment and provide an excellent indication of the limits of the protection provided by polyethylene encasement. In Figure 2, the soil has been removed from around the pipe at the first excavation location. The outside of the pipe has not been cleaned at this point. Note the pump line used to keep the water in the excavation at a manageable level.

**Figure 2: The exposed pipe prior to removal of the polyethylene film. Regular pumping controlled the inflow of groundwater from the surrounding soils.**

The polyethylene was a clear low-density polyethylene film that was applied to the pipe as a sheet that was tightly wrapped around the pipe barrel, with another sheet used to encase the joint. The only noted damage to the film resulted from contact with the shovel used to remove the soil from directly around the pipe.

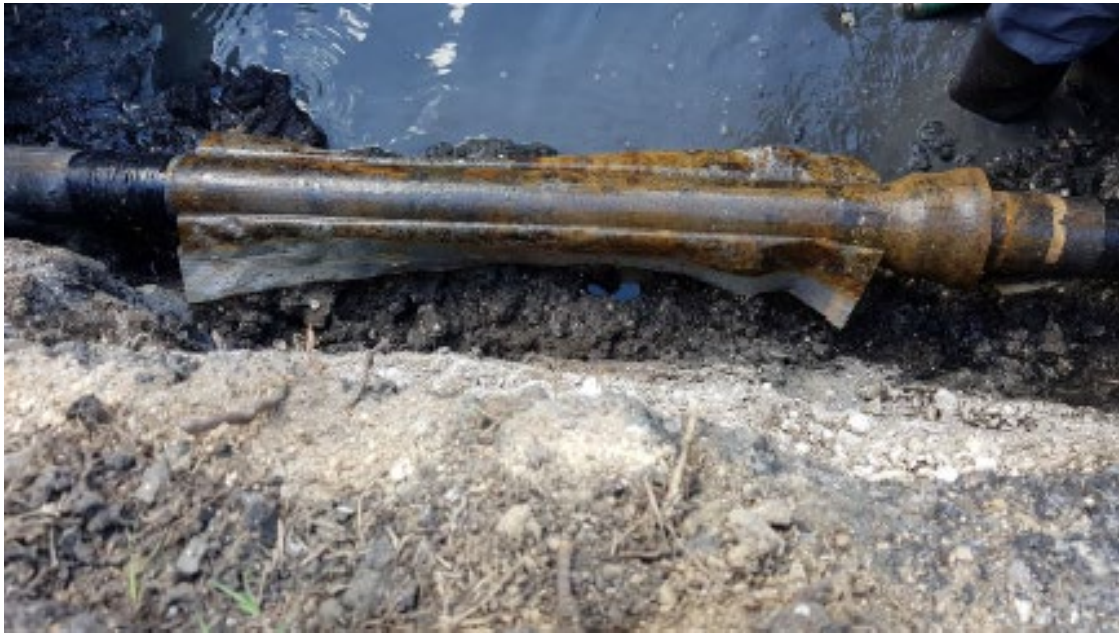
Prior to removal of the film from the pipe, the ends of the exposed pipe were provided with several wraps of tape to keep the film in place and to provide adequate overlap when the pipe is encased in new film prior to backfilling. The film was then removed from the section of the pipe to be investigated and was packaged for shipment to a laboratory where the tensile strength of the material in both the machine and transverse directions and the material thickness were measured. The exposed pipe presented evidence of oxidation of the pipe surface (Figure 3). Once the film was removed, the surface of the

**Figure 3: The film was removed from the pipe prior to shipment to laboratory for physical testing. Oxidation is visible on the surface of the pipe prior to cleaning.**

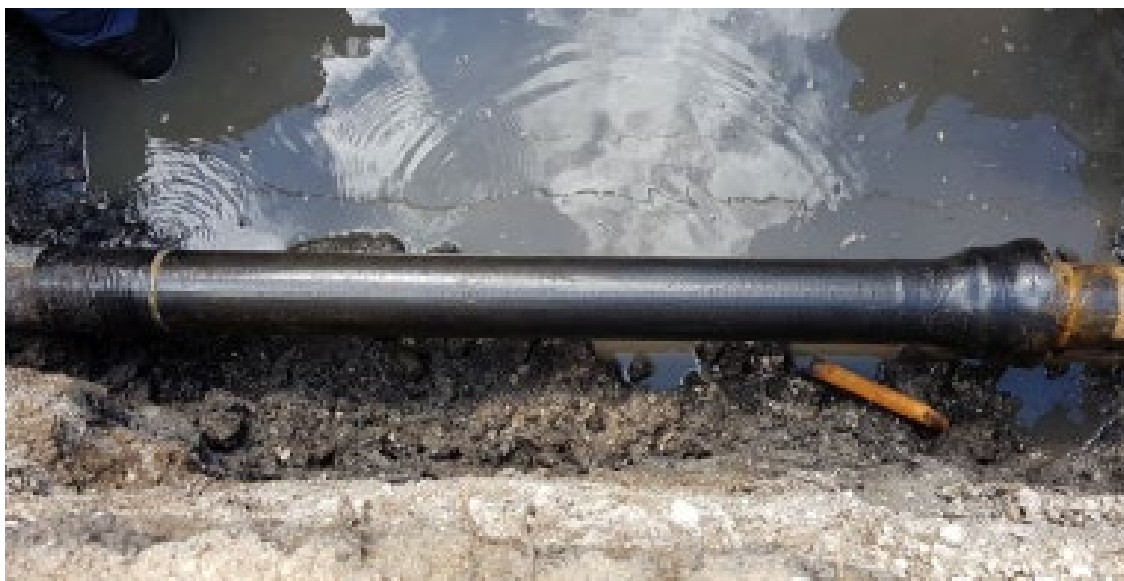
exposed pipe was thoroughly cleaned using a wire brush and water. This effort resulted in removal of the oxidation, which proved to be superficial (Figure 4).

After cleaning of the pipe, the surface was sounded using a welder's hammer to determine if there were any locations where graphitic corrosion had occurred. There was no pitting found on the surface of the pipe.

**Figure 4: The surface of the exposed pipe has been cleaned using a wire brush and water. The oxidation was removed and found to be superficial.**
