## **An Operator's Experience with AC Induced Corrosion**

Kyle Platt  
Marathon Pipe Line  
539 S Main Street  
Findlay, OH, 45840  
USA

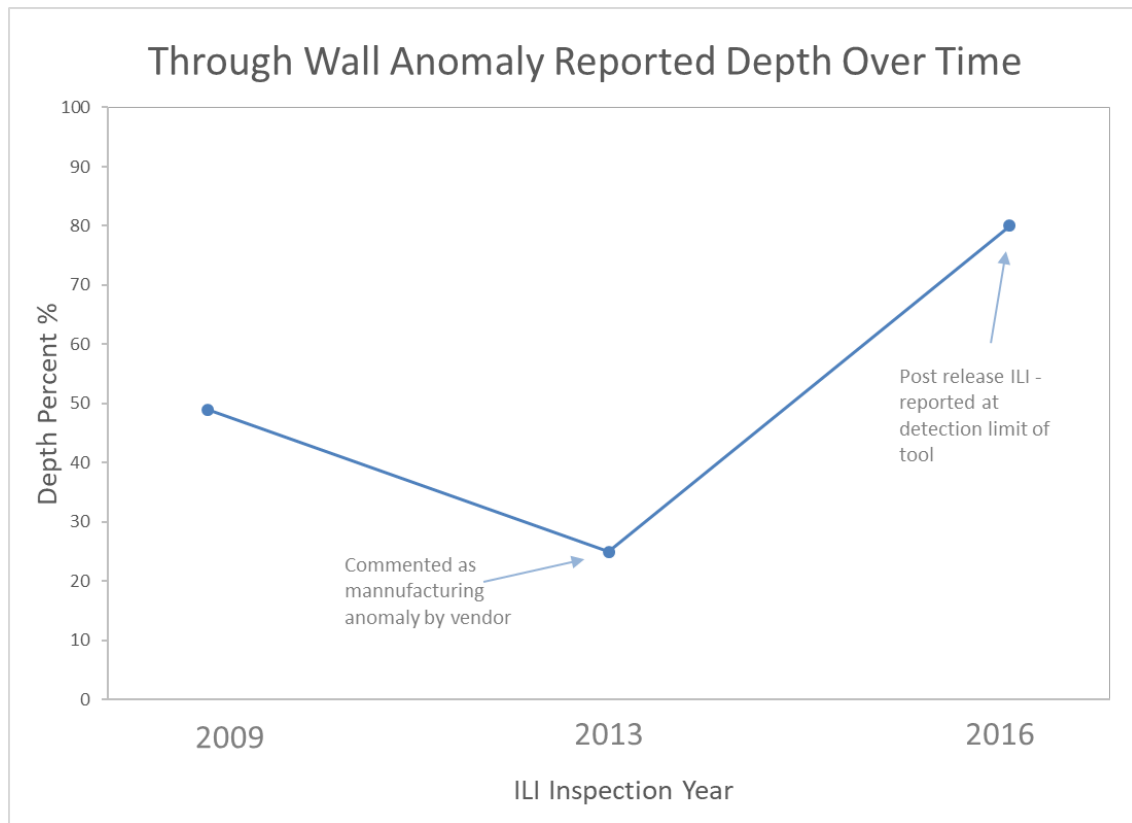
**Figure 1: Through wall anomaly reported depths over successive ILI assessments**

The previous two in-line inspection (ILI) assessments consisted of a caliper and magnetic flux leakage (MFL) tool in 2009, and a caliper, GPS, and ultrasonic wall measurement (UTWM) in 2013. The through wall anomaly was reported as a 49% metal loss feature in 2009 and as a 25% manufacturing indication in 2013. The same ILI vendor was used in both runs. A summary of the ILI results can be seen below in Figure 1 and an image of the through wall anomaly in Figure 2.

The 2013 ILI assessment further hindered the identification of ongoing AC induced corrosion. The pipeline of interest transports HVLs which can create issues for ultrasonic ILI tools in accurately sizing and detecting metal loss features. The eventual through wall anomaly was classified as a 25% manufacturing indication and was not considered an integrity concern.

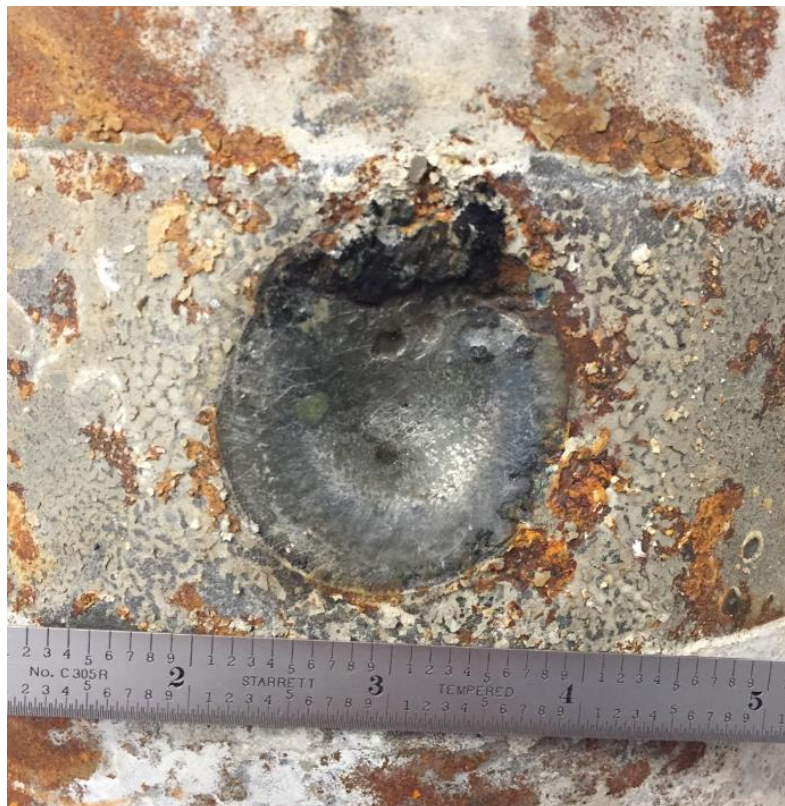
**Figure 2: Through wall anomaly**

During the summer of 2016 an in-service leak was discovered on a pipeline carrying highly volatile liquids (HVLs) outside of Houston, Texas. The pipeline of interest is an 8 inch (200 mm), 0.358 inch (9.1 mm) wall thickness, grade X52 line that shares a right-of-way (ROW) with several other pipelines and multiple 345 kV powerlines. Many of the pipelines within the ROW are electrically continuous through various connections and bonds. The pipeline was constructed in 1979 and is coated in vintage fusion-bonded epoxy (FBE).

According to NACE SP21424-2018<sup>1</sup>, DC current densities need to be considered when evaluating a pipeline for susceptibility to AC induced corrosion. In this case, the CP polarized potentials were measured around -1.2 V vs. CSE near the release site. The pipeline of interest shares a ROW with several other pipelines and is electrically continuous with many of them. Maintaining polarized potentials more electropositive than -1.2 vs. CSE is difficult due to influence from foreign CP systems. At the time of the release, no coupons were installed to measure the DC current density experienced by the pipeline. However, considering the elevated CP polarized potentials and coating disbondment discovered during excavation, the DC current densities were likely elevated on much of the system.

Prior to the release, detection of AC interference was completed by analysis of annual survey AC voltage readings. AC voltage readings collected at a test station approximately 1,000 feet from the release site were 3.74 V<sub>AC</sub> in February of 2015 and 2.70 V<sub>AC</sub> in February of 2016. AC interference was not considered a threat in this area based on the relatively low amount of induced AC voltage measured during annual survey.

The impact of low soil resistivity was not considered when analyzing the annual survey AC voltage data. The soil resistivity near the release site was measured between 700 to 900 ohm-cm. Using 800 ohm-cm soil resistivity and the AC voltages recorded, the theoretical AC current density on a 1 cm<sup>2</sup> coating holiday calculates to 106 A/m<sup>2</sup> in 2015 and 76 A/m<sup>2</sup> in 2016. It has also been demonstrated on this pipeline that the AC voltages fluctuate daily and seasonally based on powerline loads, further impacting the AC current densities experienced.
