## **Stress-Assisted Corrosion of a Superheater Tube: The Role of Thermal Fatigue Cracking and Crevice Corrosion in the Failure Mechanism**

Ewa Labuda  
Sheppard T. Powell Associates LLC  
Baltimore, MD  
USA

This paper discusses the results of a failure examination of superheater tubes from a boiler. The superheater tubes failed along steamside fissures associated with external surface welds attaching finger bars to adjacent tubes. The morphologies of the fissures were consistent with stress-assisted corrosion (SAC). In addition, cracks typical of thermal fatigue were present on some ID surfaces and at the tips of some fissures. The elemental compositions of corrosion products within the wide SAC fissures, determined using Scanning Electron Microscopy (SEM)/Energy Dispersive X-ray Spectroscopy (EDXS), support the possibility that crevice conditions led to accelerated corrosion during cool down periods, resulting in pit-like areas along the fissures. Failed and unfailed superheater tubes were examined using standard metallographic techniques. The results were used to develop a theory of the role of thermal fatigue cracking and crevice corrosion in SAC fissure initiation on the st

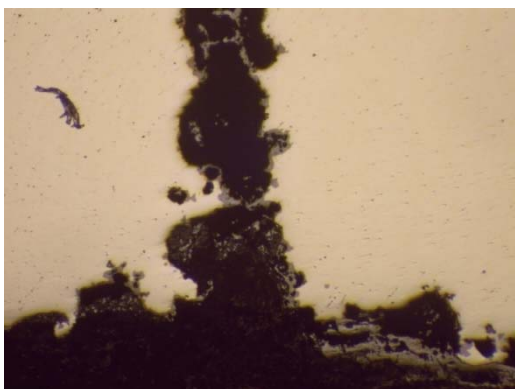
**Figure 1: Typical SAC Fissure: ID Surface<sup>(1)</sup>**

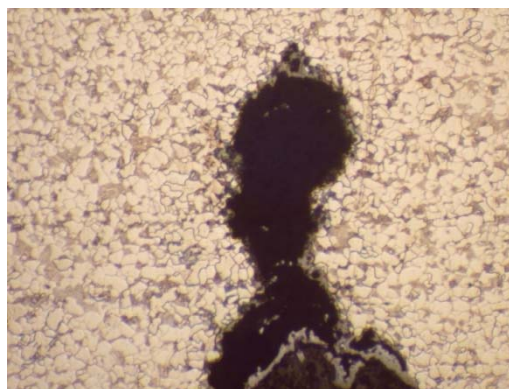
**Figure 2: Typical SAC Fissure: Blunt Tipped<sup>(1)</sup>**

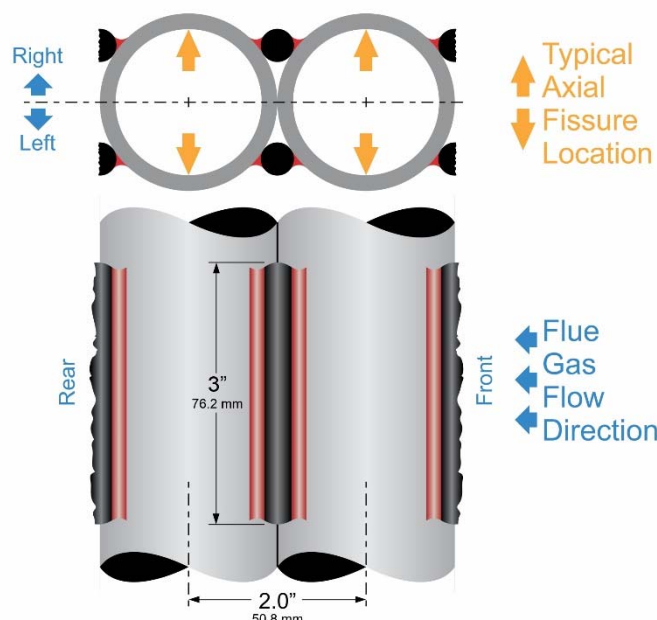
It will be shown that the finger bar attachment welds played a critical role in the stress-assisted corrosion that produced the axial steamside fissures found midway between the finger bars on the side of a superheater tube in contact with the flue gases passing alongside a superheater platen (Left and/or Right Sides in Figure 4). Therefore, all examined tubes were split longitudinally to separate the left and right sides as shown in Figure 4.

**Figure 4: Schematic Representation of Finger Bar Welds in this Recovery Boiler**
