**Paper No.**  
**16553**

## **Stress Corrosion Cracking of a Stainless Steel Vacuum Tower Bottom Line**

Xavier Roumeau  
Total  
Total Antwerp Platform  
Antwerp  
Belgium

Matthieu Devallée  
Total  
Total Port Arthur Refinery  
Port Arthur / Texas  
USA

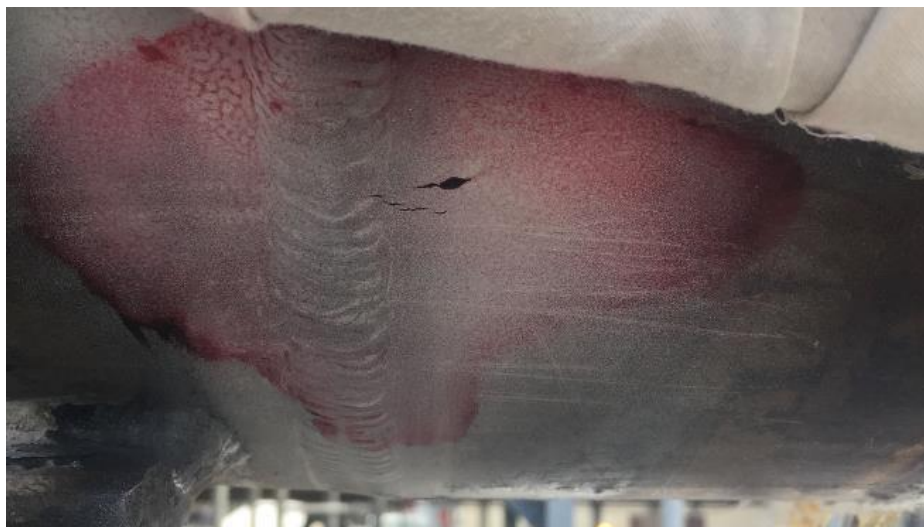
The visual inspection localized the leak near a circumferential weld between a 12" piping and an elbow. The crack was adjacent to the steam tracing tubing. A Penetrant Testing (PT) was done on the Outside Diameter (OD) in order to identify the exact location of the leak. Multiple crack like indications were found. The cracks were oriented longitudinally on the piping side of the weld and were relatively close to the bottom of the horizontal run of piping. It was not possible to determine if the cracks were originated from the ID or the OD. The inspection department did not recommend installing an engineered clamp or a welded leak enclosure because of the presence of cracks.

**Figure 2: Cracking highlighted by PT (cracking occurred next to the steam tracing tubing)**

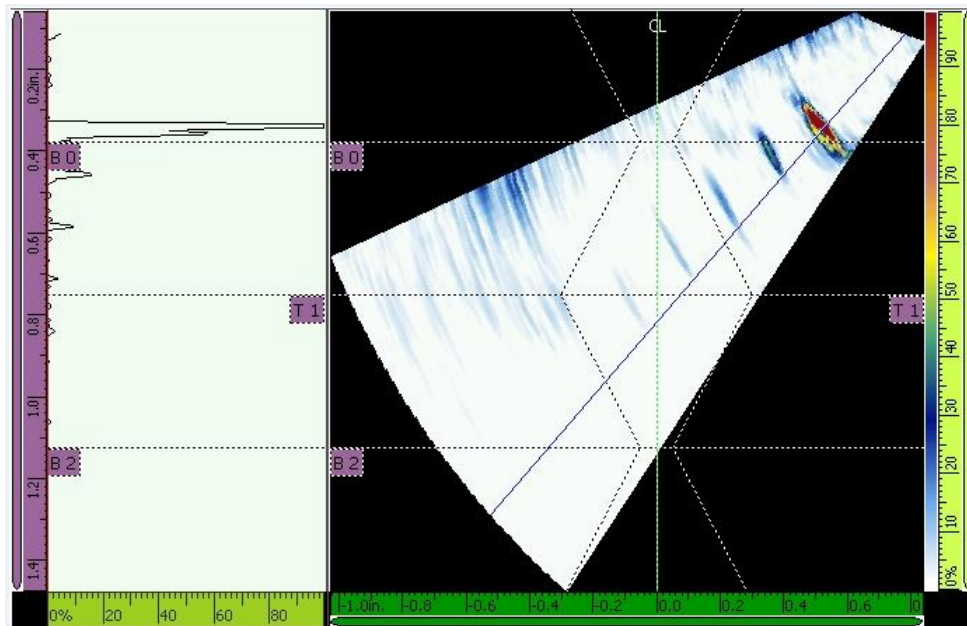
A full volumetric inspection with advanced (Non-Destructive Testing) NDT was performed on the weld seam and expanded to several adjacent piping welds to determine if it was an isolated event or more widespread. The inspection NDT used were "UT shear wave" and "Phased Array" (figure 3). The first results showed additional cracking indications on adjacent welds, therefore, a much more extensive inspection campaign was carried out on all the concerned piping circuit.

**Figure 3: Phased Array scan showing an indication**
