**Paper No.**  
**16566**

## **Excavation, Removal and Evaluation of Coupons Exposed to AC Interference While Connected to an Operating Product Transmission Pipeline**

**Philip Simon, P.E**

**John McCaffery**

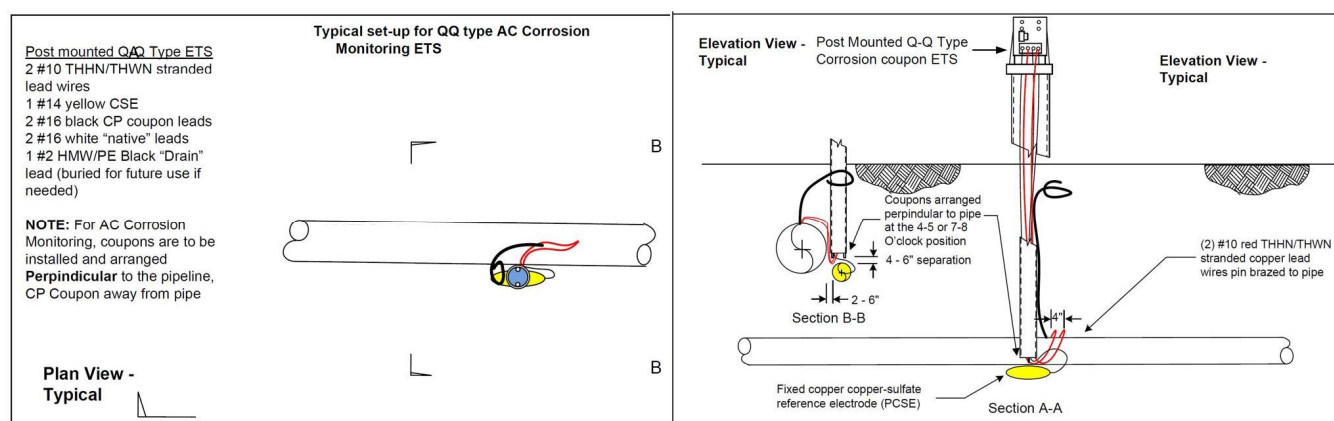
**Figure 1: Typical Coupon Test Station Installation Detail**

This investigation included the excavation and analysis of six (6) coupon test stations. These locations were selected based on the AC interference historical records and accessibility. These test stations were installed as shown in Figure 1. This standard assembly includes two ½ inch (1.27 cm) diameter x 1 inch (2.54 cm) long carbon steel coupons (one for bonding to the pipeline i CP coupon and one not connected i Native Coupon). The CP coupon is connected through a switch in the test station head circuit board to allow instant-off potentials (DC) and the direct measurement of current (AC and DC). The coupons were installed in the spring of 2014 and the CP coupons connected to the pipeline that fall. The RMU data collection began in the fall of 2015.

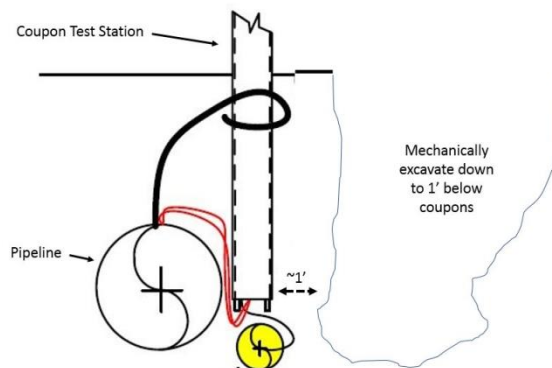
**Figure 2: Coupon Excavation Procedure**

The coupon excavation and removal procedure was performed in a manner that allowed the soil near the coupons to be observed intact and separated from the surrounding backfill. This was done so that any soil characteristic changes from the current collecting on or discharging from the CP coupon could be documented. It also assured any deposits on the coupons or adjacent corrosion products could be preserved and collected. The soil was first removed with a backhoe down to the level of the bottom coupon tube to within 12 inches (300 mm) from the side of the coupon tube. The coupons were then exposed by manually, carefully removing the soil to expose the coupons. Any difference in appearance between the soil at the coupons was documented and photographed. Care was taken to keep this soil separate from the surrounding backfill when the soil samples were collected. Figure 2 is a drawing showing this excavation procedure.

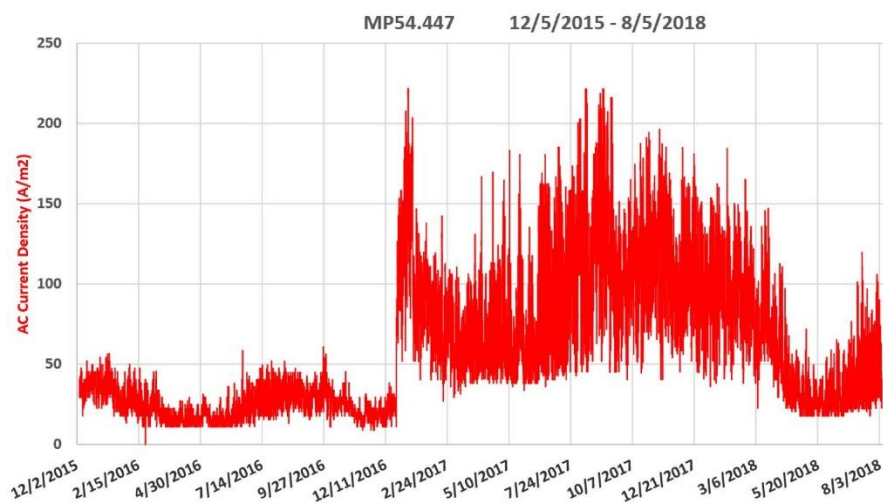
**Figure 3: Recorded Coupon AC Current Density at MP 54.447**

A remote monitoring system was installed and activated at this location in December, 2015. This system recorded the AC volts and CP coupon AC current density at 1-hour intervals. Annual inspections in 2015, 2016 and 2017 included direct measurement of this interference data. The annual survey data indicated much lower levels of AC interference (maximum of 53.82 A/m<sup>2</sup>) and average of 25.59 A/m<sup>2</sup>) than the RMU data shown in Figure 3. There was a significant increase in AC interference in late December 2016. The effect of mitigation installed in April 2018 can also be seen.

There was no continuously recorded AC current density data between the time the CP coupon was connected and the RMU activated. The interference levels recorded prior to the large increase in December 2016 was used to estimate the levels during this time. The interference level in the 50 days between the last RMU data and date of removal was estimated based on the last several months of recorded data. This was used to calculate the estimated life time AC interference exposure. The time the coupon was exposed to over 100 A/m<sup>2</sup>, between 100 and 50 A/m<sup>2</sup>, between 50 and 30 A/m<sup>2</sup> and below A/m<sup>2</sup> was calculated (Table 1). The recorded RMU data did not include the CP coupon DC

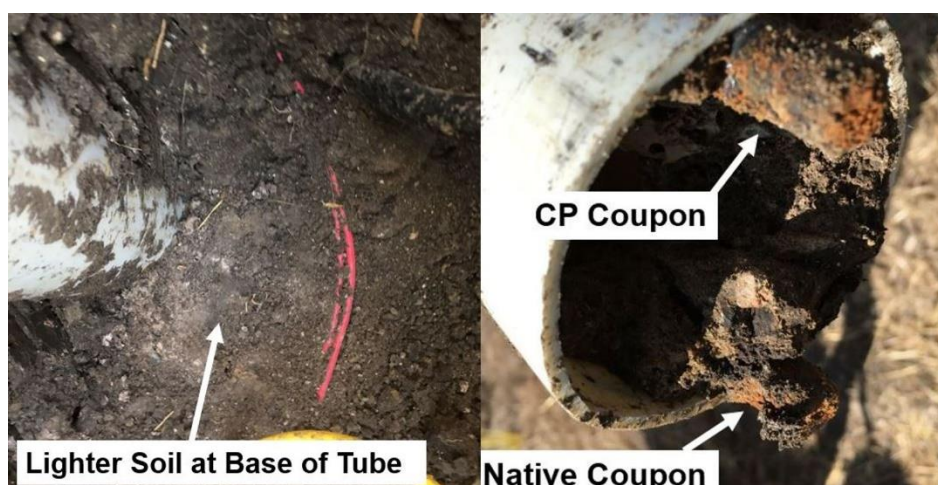
**Figure 4: Condition of Soil and Coupons at MP 54.447 Immediately After Excavation**

Figure 4 includes photographs of the soil at the bottom of the coupon test station tube as it was being excavated and the coupons immediately after removal. The soil in a 5 inch (125 mm) diameter ball around the base of the coupon test station was of a noticeably lighter color than the surrounding backfill. Soil box field testing at the excavation indicated the backfill had a resistivity of 2,300 ohm-cm and a pH of 7.5. The lighter color soil at the coupon level was 850 ohm-cm and a pH of 10-11. The CP coupon did not have the typical calcareous build up characteristic of highly polarized steel or a large, black mound of corrosion product typically found in cases of AC corrosion. The CP coupon did have a thin, hard black film on the surface. Both coupons showed signs of corrosion product (red color) leaching into the adjacent soil. Samples of the soil at the coupons and the backfill approximately 12 inches (300 mm) above the coupons were collected for laboratory analysis. The laboratory analysis results are shown on Table 4.

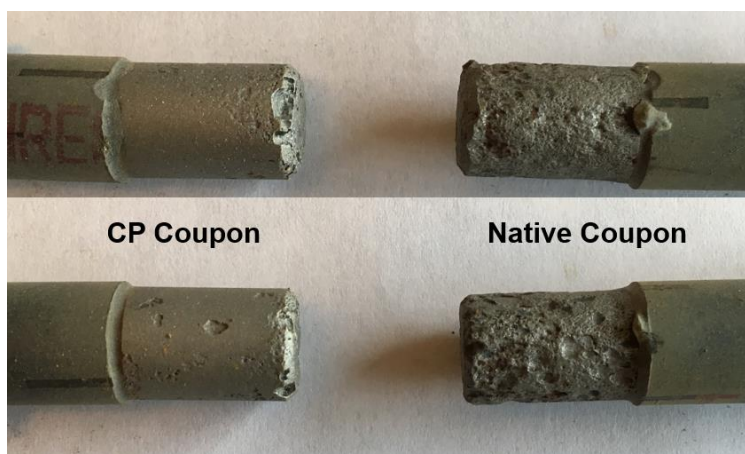
**Figure 5: Photographs of MP 54.447 Coupons After Cleaning****Table 3: Coupon Diameter and Pit Depths Measured on MP 54.447 Coupons**

The coupons were cleaned (media blasted) and the apparent corrosion damage was observed. The CP coupon had limited pitting on the sides with a deep pit on the end edge. This deep pit had the morphology typically seen with AC assisted corrosion damage. The native coupon had general corrosion damage over the entire surface. The observed corrosion is consistent with unprotected freely corroding steel for the native coupon and AC assisted corrosion of cathodically protected steel on the CP coupon. Figure 5 includes photographs of the coupons after cleaning. The depth of the pits was measured with a dial indicator gauge and the diameter with a digital caliper. The results of the measurements are summarized in Table 3.

The native coupon showed a significant amount of general corrosion. General corrosion would be expected on the native coupon, as it is not subject to cathodic protection. The maximum pit depth of

the native coupon of 43 mils (0.043 inches -1.1 mm) equates to a corrosion rate of approximately 9.7 mils per year (mpy)(0.25 mm/yr), typical of freely corroding carbon steel in this soil environment and in the absence of CP.

The maximum depth of corrosion on the CP coupon was 70 mils (0.0708 inches-1.8 mm). It was installed 187 days prior to being connected to the pipeline and receiving cathodic protection and subject to AC interference. If the native coupon corrosion rate of 9.7 mpy is applied to the CP coupon prior to bonding, then approximately 5 mils (0.13 mm) of corrosion damage occurred before being subject to AC interference (assuming adequate CP after it was bonded). If the 65 mils (1.7 mm) of AC corrosion damage only occurred during the 6.15 months the AC current density was above 100 A/m<sup>2</sup>, the average indicated AC corrosion rate would have been 127 mils/year (3.2 mm/yr). If the damage occurred during the entire time the AC current density was above 50 A/m<sup>2</sup> (15.32 months), the average indicated AC corrosion rate would have been 51 mils/year (1.3 mm/yr).

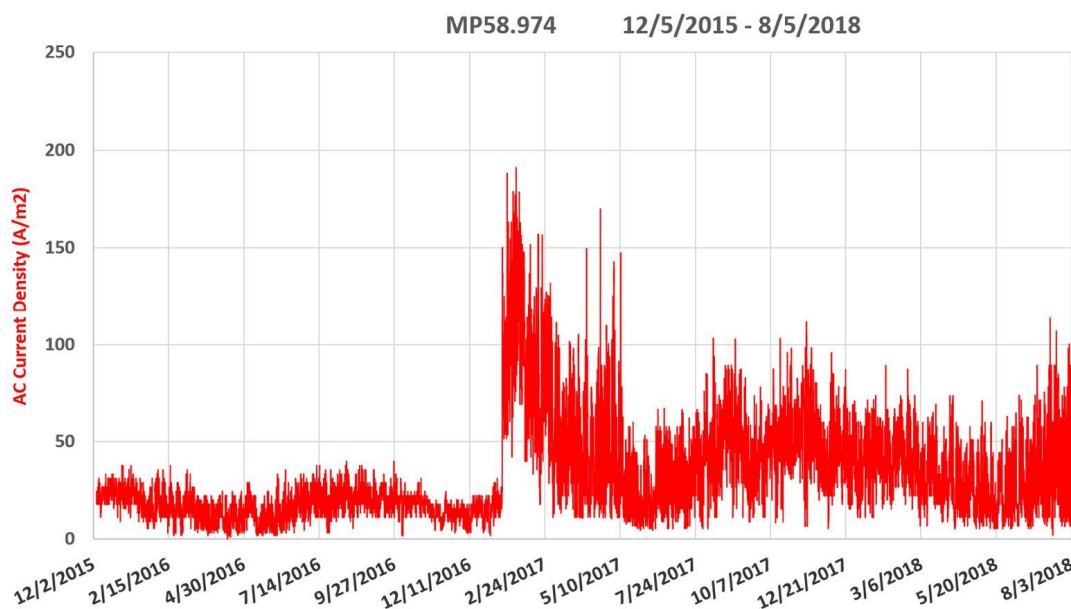
**Figure 6: Recorded Coupon AC Current Density at MP 58.974**

A remote monitoring system was installed and activated at this location on December 4, 2015. Annual inspections included direct measurement of this interference data. The annual survey data indicated much lower levels of AC interference (maximum of 40.9 A/m<sup>2</sup> and average of 25.83 A/m<sup>2</sup>) than the RMU data shown in figure 6. There was a significant increase in AC interference on January 12<sup>th</sup>, 2017. The effect of mitigation installed in May 2017 can also be seen. The calculated estimated lifetime exposure to the various levels of AC interference for the coupon at MP 58.974 is shown in Table 4. Just prior to excavation the DC current density was 2.3 A/m<sup>2</sup>, polarized potential was ÷ 1,280 mV and AC current density 85 A/m<sup>2</sup>. The native coupon resistance to the pipe was 61 ohms and the CP coupon 25 ohms.
