## **Case Study – Suspected SAC in Recovery Boiler Screen Tubes Revealed a Manufacturing Defect**

Catherine A. Noble, P.E.  
Acuren, Inspection, Inc.  
1815 S. Highway 183, Suite 100  
Leander, Texas 78641  
USA

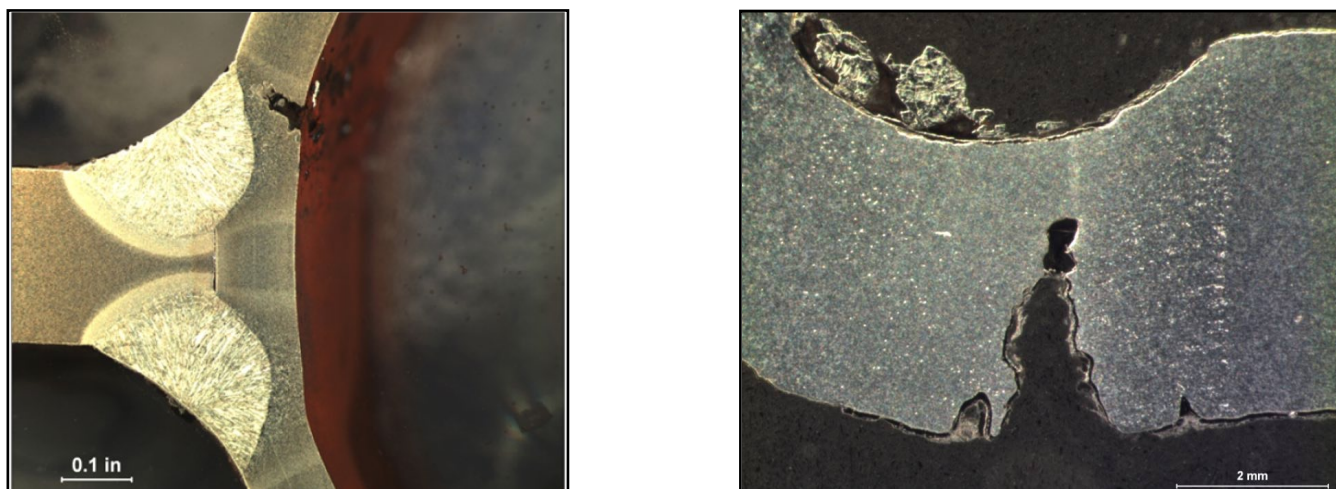
Cracking is typically bulbous, necklaced, longitudinal, and straight through the tube wall. There are often multiple, deep pits present on the internal surface as well that are characteristic initiation points for CF or SAC. Figure 1 shows some pictures of typical SAC damage in boiler tubes. If CF or SAC is present in a tube, it is likely to be present in other similar tubes. Determination of CF or SAC warrants additional inspection to assess the extent of damage and determine if larger scale tube replacements are necessary.

**Figure 1: Typical SAC in boiler tubes.**

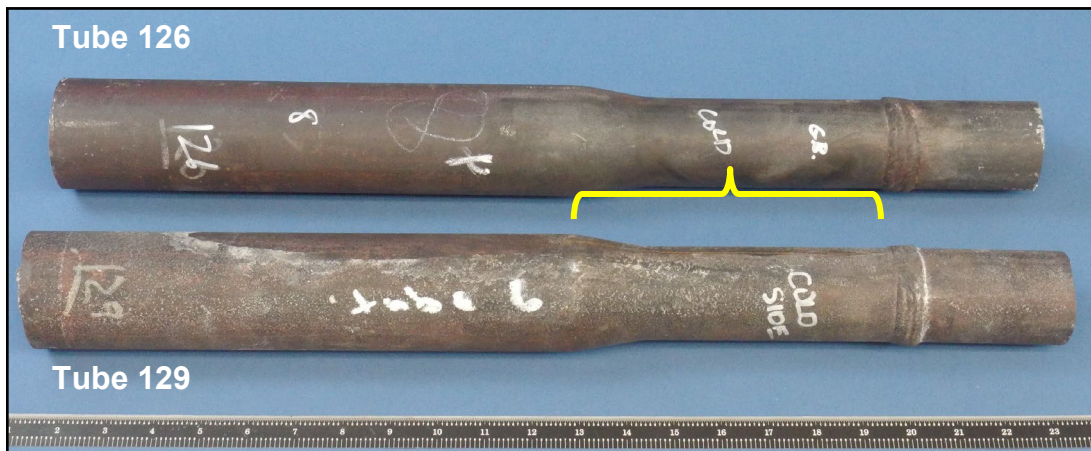
After one of the mill's spring outages, two rear wall screen tubes were received from the boiler for analysis (Figure 2). One tube contained a visible longitudinal crack in the swaged section on the cold side (Tube 129), and the other tube contained a crack-like indication in the same area when X-rayed (Tube 126). A metallurgical examination was performed on the tubes to determine the failure mechanism(s).

**Figure 2: Screen tubes received for analysis. Bracket indicates crack location.**

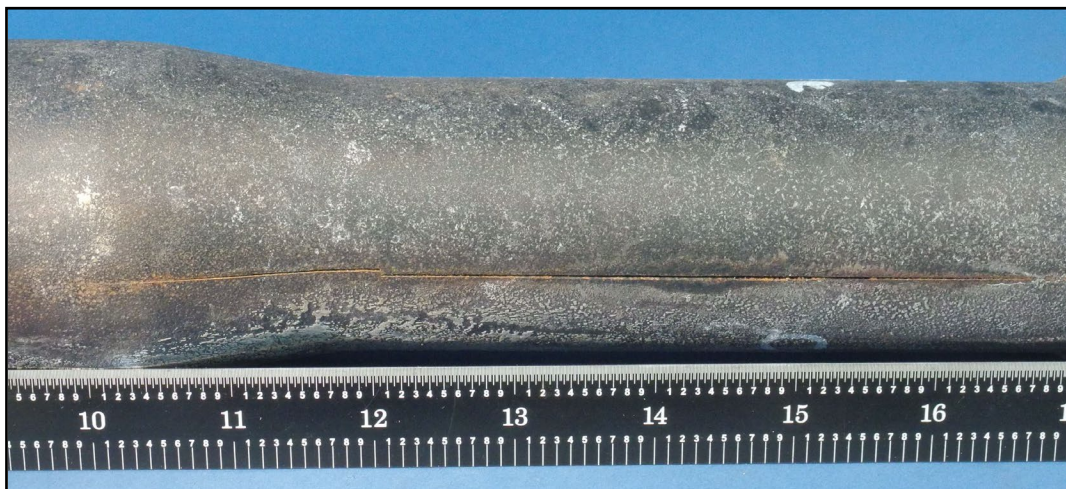
The crack was straight, non-branching, through-wall over most of its length, and extended from the butt weld at the small diameter end to the swaged transition on the larger diameter end of the tube (Figure 3). No cracking was observed in the swaged area of Tube 126, and the only anomaly observed was a discolored area on the hot side of the swaged area (Figure 4). Tube 126 was split open and cleaned, revealing a defect in the internal tube surface. No internal or external corrosion was noted.

**Figure 3: Closer view of the crack in Tube 129.**

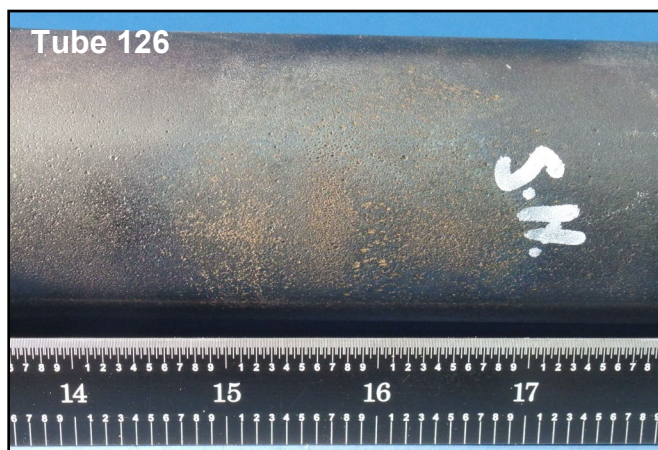
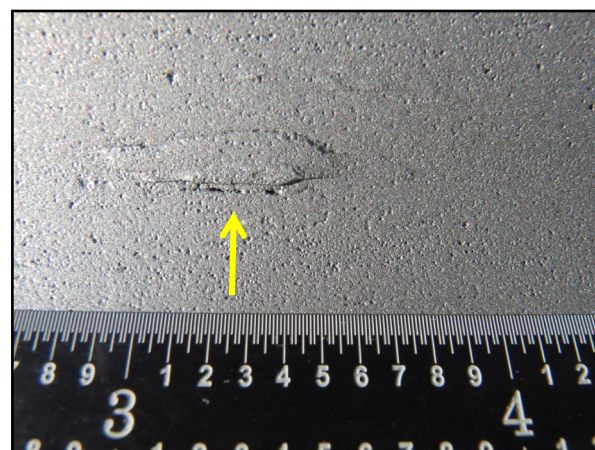
**Figure 4: Swaged Area of Tube 126 where an X-ray indication was noted (left – external surface, right – internal cleaned surface).**
