**Paper No.**  
**16649**

## **CORROSION FAILURE ANALYSIS OF CORRUGATED N10276 AND STAINLESS STEEL FLEX HOSES**

**Suresh Divi and Sri Krishna Chimbli**  
Stress Engineering Services, Inc.  
13800 Westfair East Drive  
Houston, Texas, USA

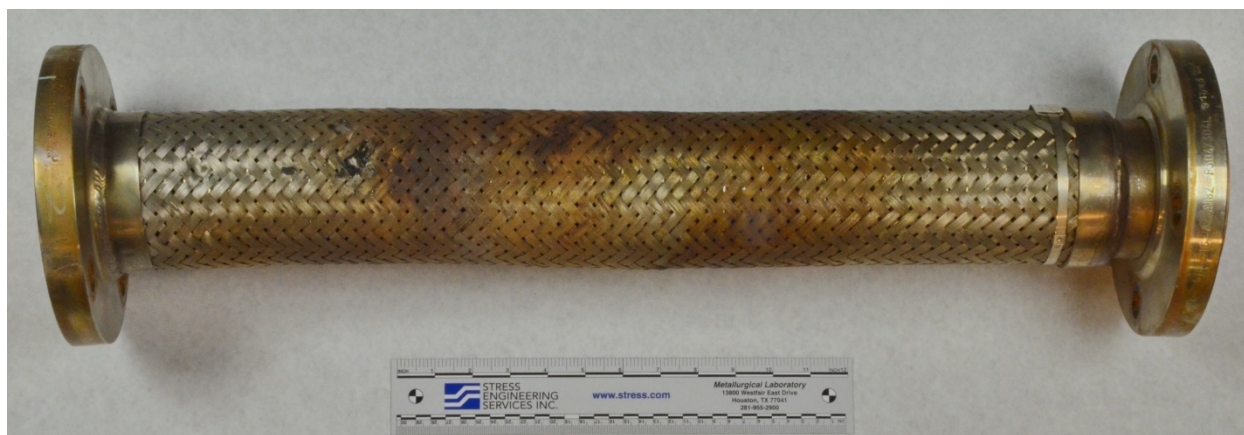
A leak developed in a 3-inch (76-mm) diameter SS flex hose following an unspecified length of service supplying fuel gas to an HRSG. The failed flex hose is shown in Figure 1. Discoloration of the outer braided jacket was evident and indicated either the location of the leak or external contamination of the hose. Identification markings on one of the flanges indicated NPS 3, 150-pound, ASME SA-182, Type 304/304L SS.

**Figure 1: Leaking fuel gas 304L flex hose as received for analysis. Numbered scale divisions are inches/cm.**

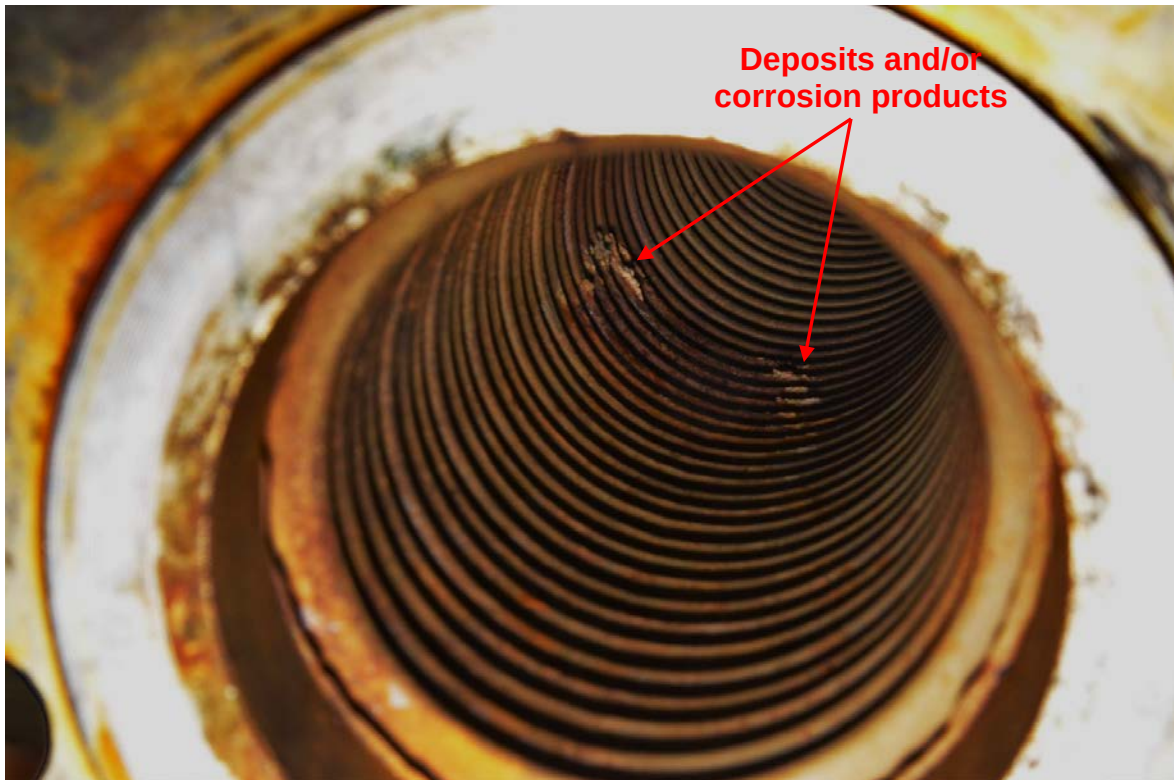
Figure 2 shows the inside surface of the corrugated inner tube of the hose as viewed through one of the flanges. A region of deposits and/or corrosion products was observed.

**Figure 2: Inside surface of the corrugated 304L flex hose inner tube. Deposits and/or corrosion products were observed.**

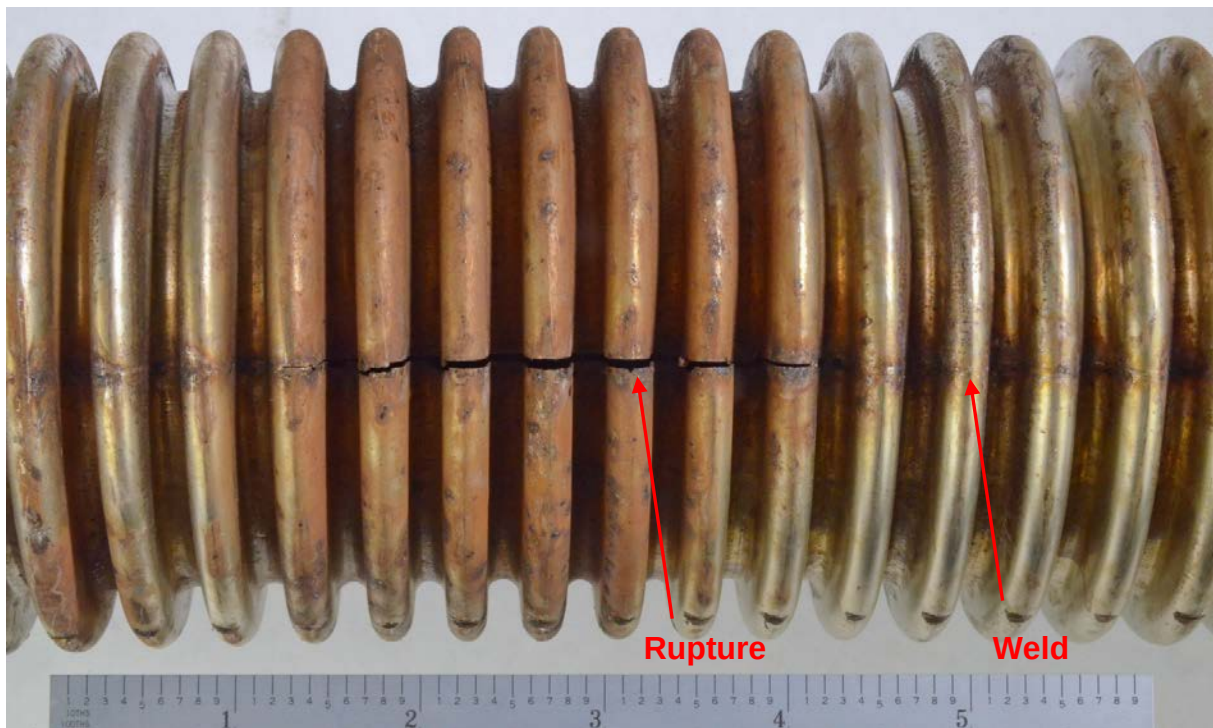
A portion of the braided external jacket was removed from the hose by sectioning, which exposed the leak site. The leak was determined to be the result of a rupture that followed the longitudinal weld of the corrugated inner tube of the hose (Figure 3).

**Figure 3: External surface of the corrugated 304L inner tube after removal of the braided outer jacket. Rupture followed the longitudinal weld of the corrugated tube. Major numbered scale divisions are inches.**

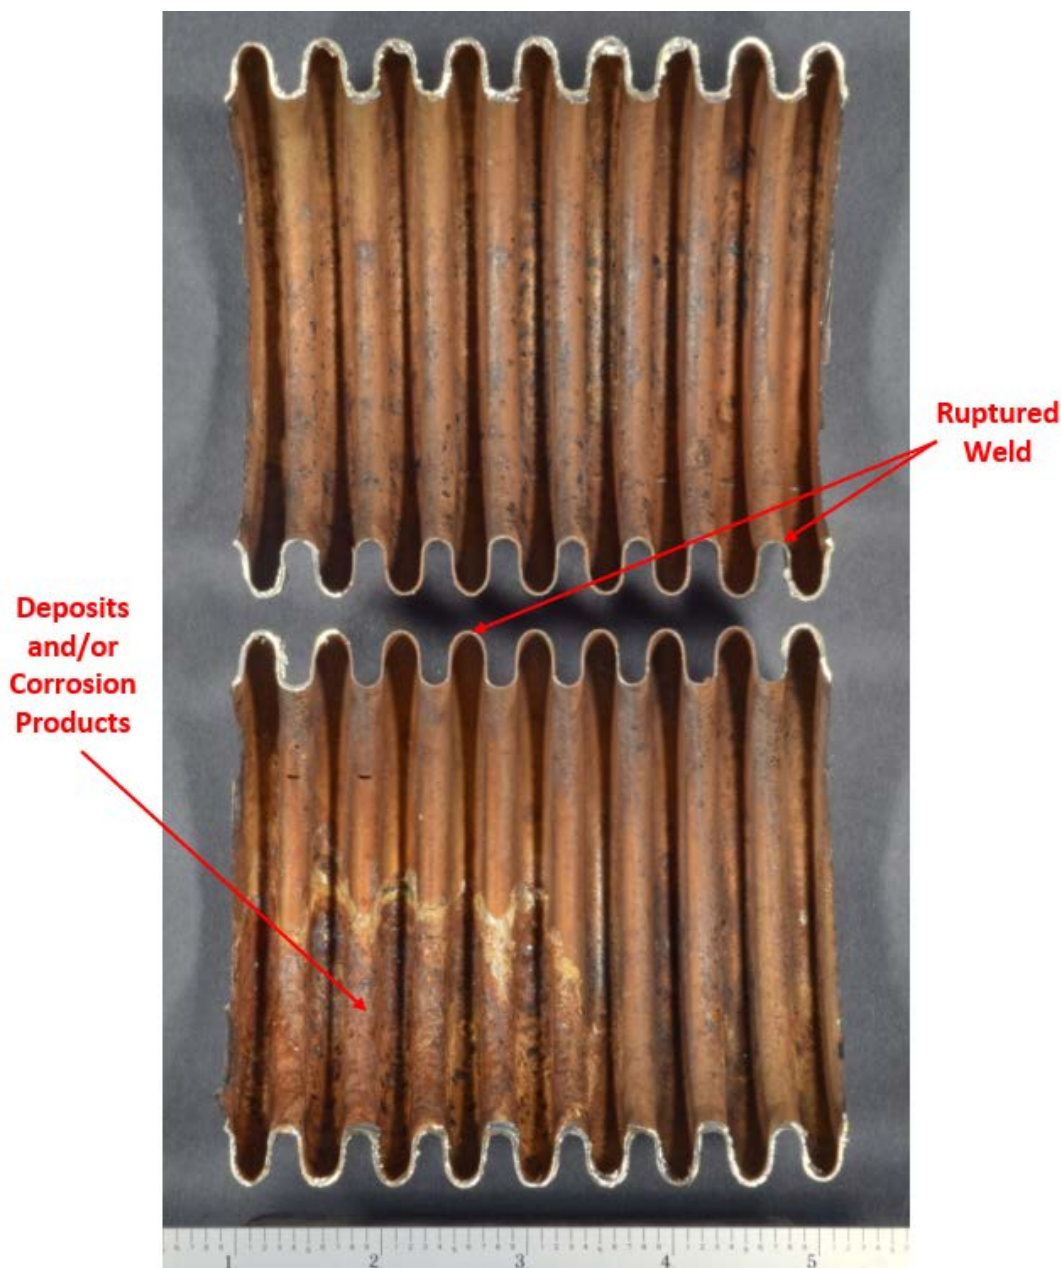
The inner tube was further sectioned to expose the fracture surfaces of the rupture, as well as the internal surface of the tube. Figure 4 shows the mating surfaces of the rupture and the region of heaviest deposits and/or corrosion products on the inside surface of the corrugated tube.

**Figure 4: Inside surface of the corrugated 304L inner tube at leak site. The ruptured longitudinal weld is brown compared to the shiny metallic appearance of sectioned corrugations. Major numbered scale divisions are inches.**
