**Paper No.**  
**16672**

## **Corrosion Failure Analysis and Corrosion Prevention Practice Of Water Injection Pipeline In Middle East Carbonate Oilfield**

Zhengrong Ye, Xiang Zhou, Weidong Jiang, Zhichao Qiu, Xiaodong Cui, Guohao Chen  
PetroChina Research Institute of Petroleum Exploration and Development  
Beijing 100083  
P. R. China

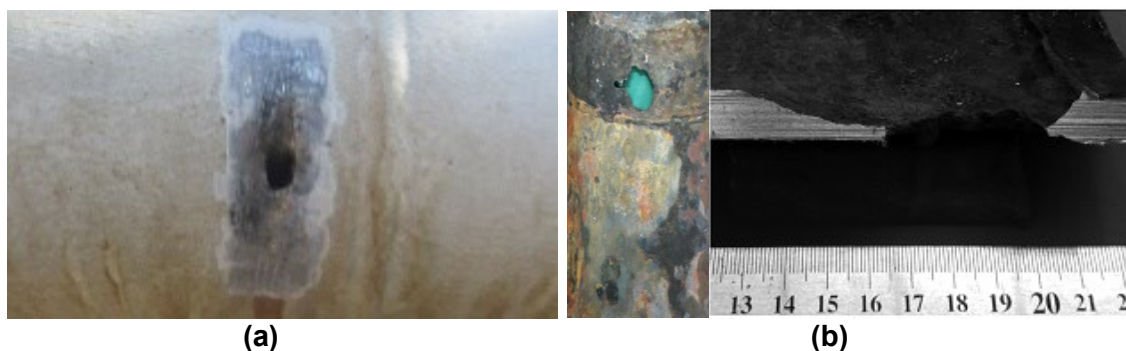
Take the case of a water injection pipeline. It was put into service in August 2014. In October 2017, Corrosion perforation occurred and the perforation position was located at 6 o'clock and near the weld of the pipeline. Also, the internal wall was covered by the unequally distributed corrosion product or scale. The diameter of the pipeline was 152.4mm and the wall thickness was 9.53mm, the perforation rate was about 3.01mm/y. The material was API 5L X52N, and the service temperature was 40°C, the flow rate was 0.2m/s. And the longest stopping time before perforation was 30 days, the flow rate was 0m/s. The total sulfur content of the injected water exceeded the standard and reached 80mg/L. The dissolved oxygen content ranged from 0.05 to 0.10 mg/L. The injection salinity reached  $13.5 \times 10^4$ mg/L, which was a high-salinity water quality, and the chloride ion content reached  $8.2 \times 10^4$ mg/L.

**Figure 1: Appearance of corrosion perforation failed pipeline (a) Outer surface, (b) Internal surface**
