Paper No.  
16680

## Microbiologically Influenced Corrosion in a Gas Storage Well

Noelle Easter C. Co, Ryan D. Milligan, Ming Gao,  
Rudolf H. Hausler, Ravi M. Krishnamurthy  
Blade Energy Partners  
16285 Park Ten PI Suite 600  
Houston, TX, 77084  
USA

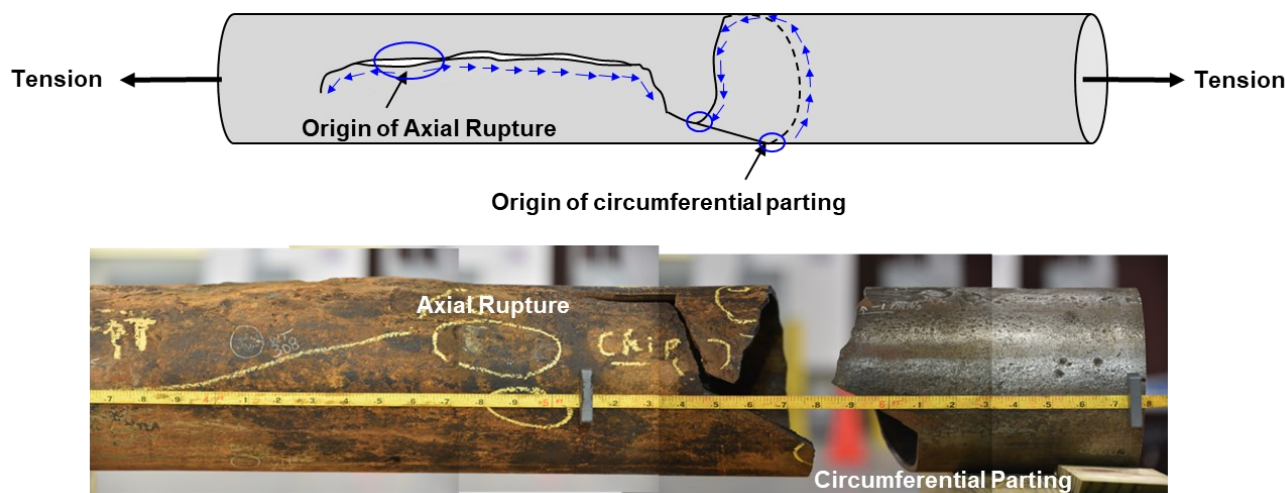
A root cause analysis for the failure was initiated during the final weeks of the blowout<sup>1</sup>. Prior to the extraction of the tubing and the casing, the failure was identified to be a circumferential parting of the 178 mm (7 in.) production casing using wireline deployed casing inspection logs and downhole camera. The failure location was confirmed at a depth of 272 m (892 ft). After removal of the wellhead, the entire length of 73 mm (2 7/8 in.) tubing, and the upper and lower portions of the parted production casing were then extracted for investigation. A total of 312 m (1025 ft) of production casing was recovered. Visual examination of the lower portion of the parted production casing showed that in addition to the circumferential parting, a 52 cm (1.72 ft) long axial rupture had initiated from the 85% wall loss corroded area (9.4 cm x 23.5 cm) on the outer diameter (OD) of the casing. The analysis showed that during the axial rupture, plastic bulging occurred first, along with slow ductile tearing due to internal pressure. When the axial flaw reached the critical size, tearing instability occurred, followed by rapid crack propagation in the axial direction. The axial crack changed direction and finally arrested due to dynamic

energy consumption. As a consequence of the axial rupture, high-pressure gas was released that dramatically decreased the temperature of the adjacent casing. This extremely cold temperature resulted in a brittle failure of the casing circumferentially (see Figure 2).

**Figure 2: Axial Rupture and Circumferential Parting of 178 mm (7 in.) Casing**

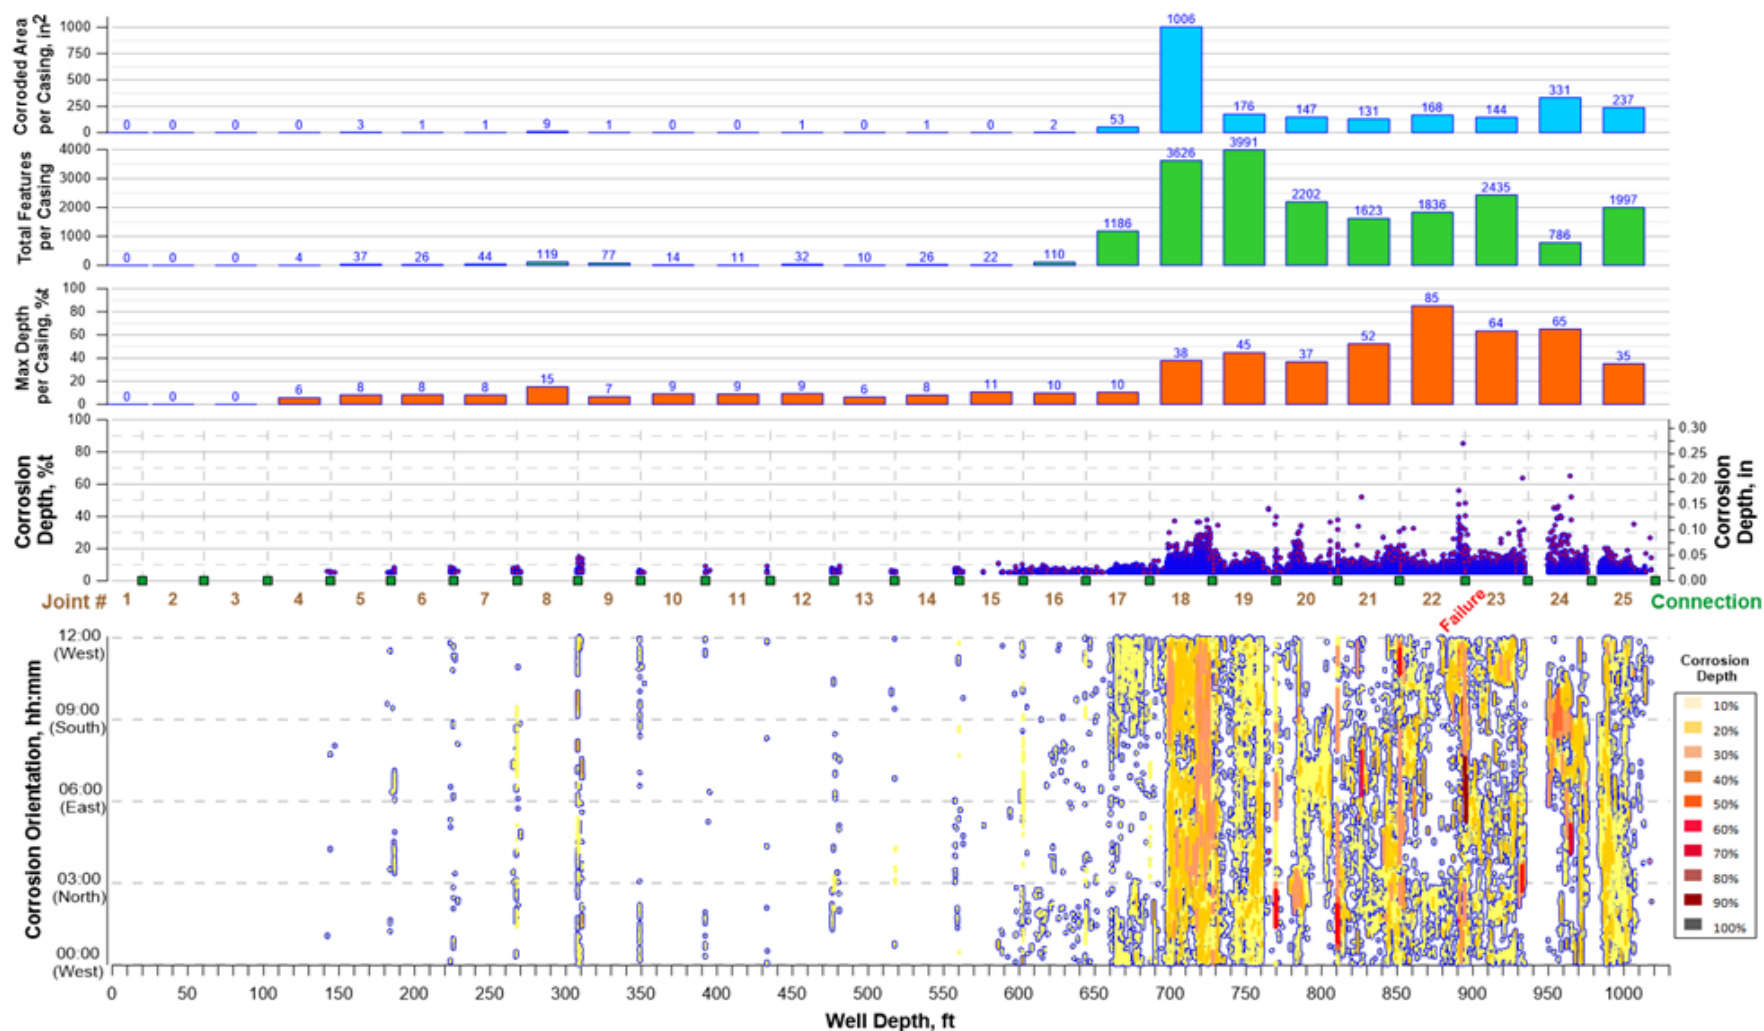
Figure 3 shows the corrosion distribution as a function of depth and circumferential orientation for the casing in the well from joints 1 to 25 (0 to 1025 ft depth) based on the laser scan data. The color map includes information about corrosion depth, the maximum depth, the total feature, and the total corroded area per casing. These parameters are taken as indicators of corrosion severity. The color map in Figure 3 has a distinct zone of severe corrosion, beginning at 213 m (700 ft). High-resolution vertilog (HRVRT) inspection of the inner diameter of 298 mm (11 3/4 in.) surface casing also revealed the presence of corrosion starting at this depth. The 213 m (700 ft) depth corresponds to the level of fluid inside the 298 mm (11 3/4 in.) x 178 mm (7 in.) annulus. A spike in the maximum corrosion depth (dark red region in the color map) was observed at joint 22 near connection 23. This spike was identified as the corrosion associated with the axial rupture.

Figure 3: Corrosion distribution based on laser scan data
