**Paper No.**  
**16742**

## **Mitigation of Flange Face Corrosion during Plant Construction**

Takahiro Tsuda, Nozomi Satake, Manabu Itoki  
JGC Corporation  
2-3-1, Minato Mirai  
Nishi-ku, Yokohama 220-6001  
Japan

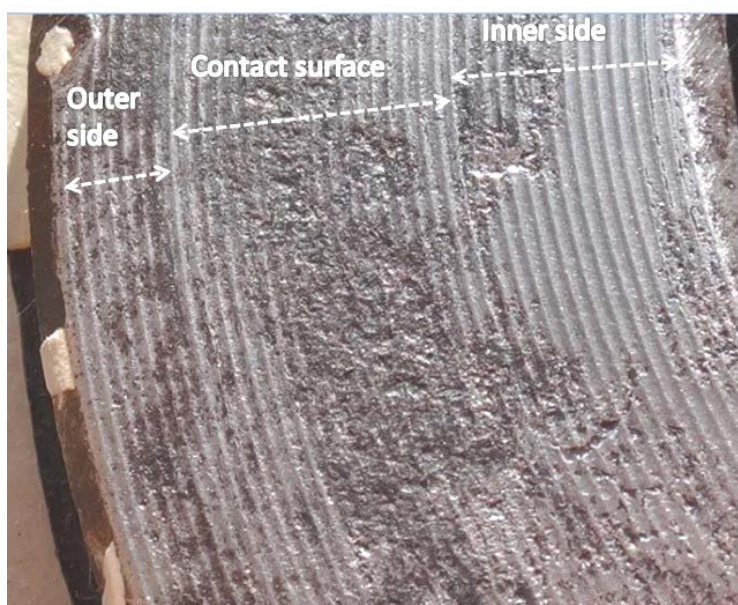
**Figure 1: Photo of Flange Face Corrosion**

The plant was partially constructed in module fabrication yards, far from the plant site, and the modules were transported to the plant site by sea. Despite the flanges having been tightened at the module fabrication yards, severe corrosion of the flange faces, including the gasket contact surfaces, was found at the plant site (Figure 1).

Root-cause analysis indicated that there is a greater chance of water ingress in tightened flanges in modular construction than in stick-built construction. Also, the period from flange tightening in the module yard to start-up of the plant is much longer than in stick-built construction. They, combined with the fact that both, the module fabrication yards and the plant site, were in tropical regions, resulted in the severe corrosion observed.

In order to mitigate or prevent corrosion of flange faces in such projects, countermeasures should be taken, and considering the huge number of flanges, those measures should be simple and practical to apply. In this study, two such measures were tested on tightened flanges: one was a rust preventive coating applied by an aerosol spray and the other was a special spiral-wound gasket (SWG).<sup>2</sup>

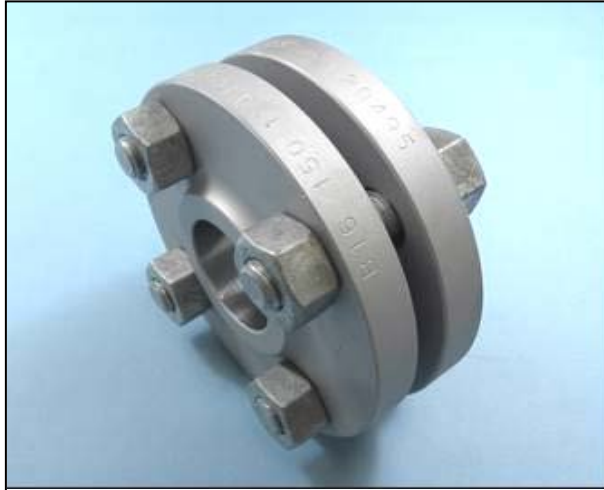
**Figure 2a: Appearance of Tightened Flange**

The flange faces were cleaned with ethanol and, then, wetted with saltwater (3 wt% NaCl solution), which was applied using a brush. The gasket used was a normal SWG (316L SS inner ring, carbon steel outer ring, 316L SS hoop, and expanded graphite filler), which was also wetted by immersion in the same saltwater. After the flange faces and the gasket had been wetted, the flange bolting was immediately tightened to a torque of 50 Nm (Figure 2a).

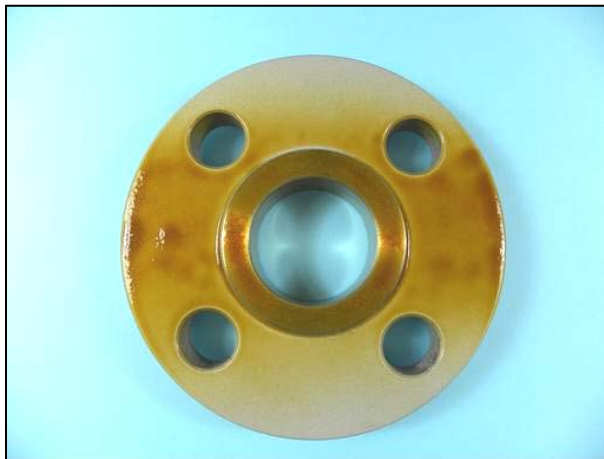
**Figure 2b: Appearance of Flange Face with Rust Preventive Coating**

The flange was prepared in the same manner as in the control case, except that a rust preventive coating (waxy film) was applied by aerosol spray to the flange faces (Figure 2b) to a wet film thickness (WFT) of approximately 200  $\mu\text{m}$ , corresponding to a dry film thickness (DFT) of 100  $\mu\text{m}$ . The coated flange faces were wetted with saltwater 10 minutes after applying the coating, even though the coating had not yet completely dried, since during construction, the flanges would be tightened before the coating had dried.
