## **Prediction of Top of Line Corrosion Risk due to Damages in External Pipeline Insulation**

### **ABSTRACT**

This paper presents the methodology adopted to evaluate the effect of external insulation damage on TLC within carbon steel flowlines. A field development, consisting of subsea wells in 830 m water depth, transports wet gas via two 20" diameter production flowlines. The wet gas contains about 1.5 to 2 mol% CO<sub>2</sub>. The pipeline system is largely carbon steel with only short lengths made of CRA piping. Lean MEG mixed with corrosion inhibitor is injected at the wellheads for hydrate inhibition. A subsea remotely operated vehicle inspection of the deep water 20" spools revealed insulation damage and bulging. These damages could act as cold spots and lead to enhanced water condensation and TLC on the internal wall of the flowlines. In order to assess the severity of the impact of the damages, a thermal Finite Element Analysis step was undertaken to determine the condensation rates on the inside of the lines. The corresponding TLC rates were then calculated using mechanistic corrosion prediction software considering multiple production conditions. The corrosion assess

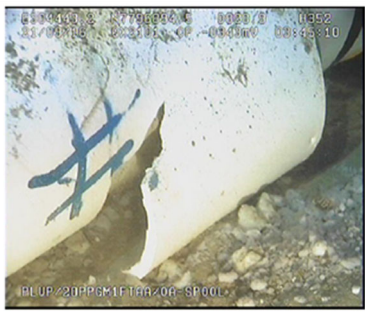
**Table 3**  
**Detailed description of anomaly case 3**

Case 3: 90° insulation damage (Table 3)

- Insulation disbondment between 3 and 6 o'clock.
- Seawater could be present as a film directly around the pipe in a stagnant state as that full adhesion of the remaining insulation cannot be guaranteed.

| | <p>Summary:</p> <ul style="list-style-type: none"><li>• Insulation was found to be damaged/dislodged on eastern side, 350mm wide x approx. 250 mm long. End not seen at 6 O'clock position.</li><li>• Heat diffraction was obvious at upper edges of perforation/tear.</li><li>• Small section of spool sighted within the dislodged insulation appeared to have paint coating intact.</li><li>• The damage only evident on the eastern face.</li></ul> |

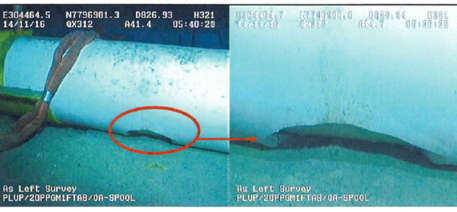
**Table 4**  
**Detailed description of anomaly case 4**

Case 4: 30° insulation damage (Table 4)

- Insulation disbondment between 5 and 6 o'clock.
- Seawater could be present as a film directly around the pipe in a stagnant state as we full adhesion of the remaining insulation cannot be guaranteed.

| | <p>Summary:</p> <ul style="list-style-type: none"> <li>• The insulation was found dislodged on the eastern side, approximately 200 mm long and 100mm wide.</li> <li>• Heat diffraction for the damage was noted.</li> <li>• Small section of spool sighted within the dislodged insulation appeared to have paint coating intact.</li> <li>• The insulation damage was only evident on the eastern side.</li> </ul> |
