## AC Corrosion at Other Frequencies Part A: Field Investigation and Mitigation

### ABSTRACT

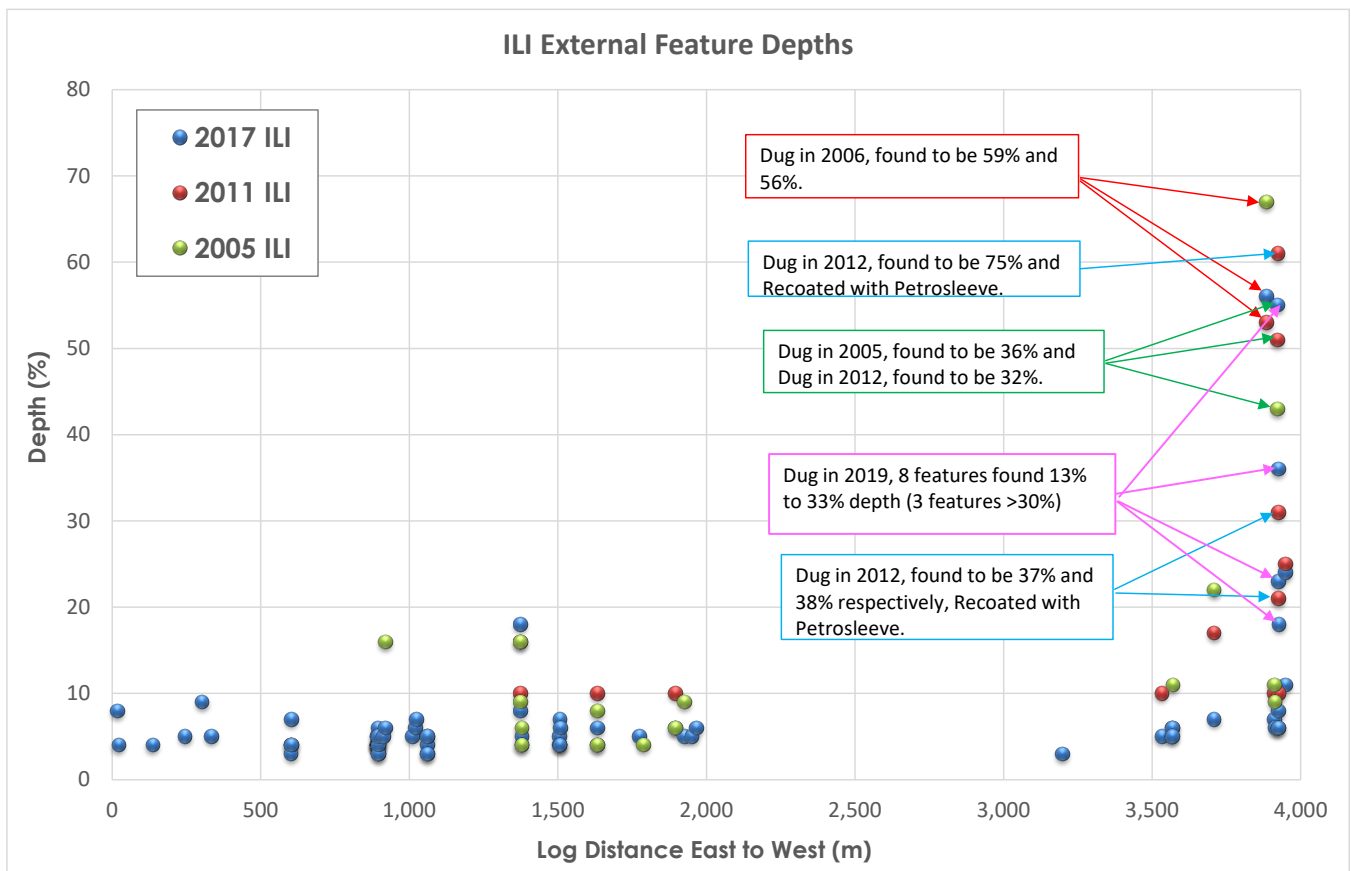
Figure 2: Distribution of External Metal Loss (ML) Features vs. Odometer Distance

A 2017 ILI reported a total of 70 external metal loss anomalies. As shown in Figure 2, the majority of these, including the deepest one at 56% wall thickness, are in proximity to the LPG manifold at the west end of the pipeline (near TP1 and TP2 at odometer distance 3,950 m). The results from previous ILI inspections and inspection digs and repairs are also shown and indicate that corrosion in this area has been an ongoing problem since shortly after pipeline installation. Maximum corrosion rates based on the latest ILI runs are estimated to be between 0.22 and 0.44 mm/yr.
