## **Validation of the Dry Gas Internal Corrosion Direct Assessment Methodology using In-Line Inspection**

James Warner  
Consumers Energy  
530 West Willow Street  
Lansing, Michigan, 48906  
USA

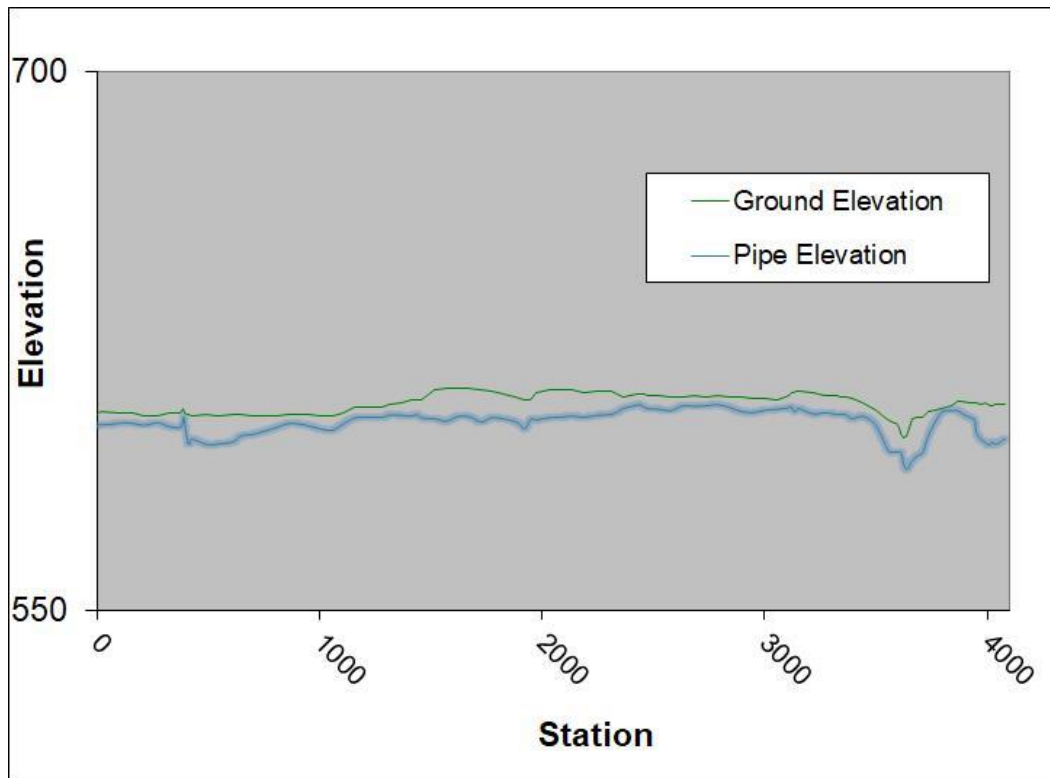
Figure 2a: Pipe 1002g Elevation Profile

The first branch in the line downstream of Red Run CG is created by an in-line tee with the feeder line (line 1002g) perpendicular to the branch line (line 1002f), due to this type of branch connection, flow modeling was performed on both branches of the tee, lines 1002f East and 1002f West. Flow modeling showed a flow velocity of 13.5 ft/sec (4.11 m/s) and a critical angle of 1.23 degrees for line 1002f East. For line 1002f West flow modeling showed a flow velocity of 16.3 ft/sec (4.96 m/s) and a critical angle of 1.84 degrees for line 1002f West prior to the second branch, line 1002. After the second branch, which was constructed using a top tee which would not permit liquids to take the branch, flow modeling showed a flow velocity of 12.6 ft/sec (3.84 m/s) and a critical angle of 1.04 degrees for line 1002f West.
