## **Reassessment of CP Effectiveness in a Multifaceted Electrolyte**

### **ABSTRACT**

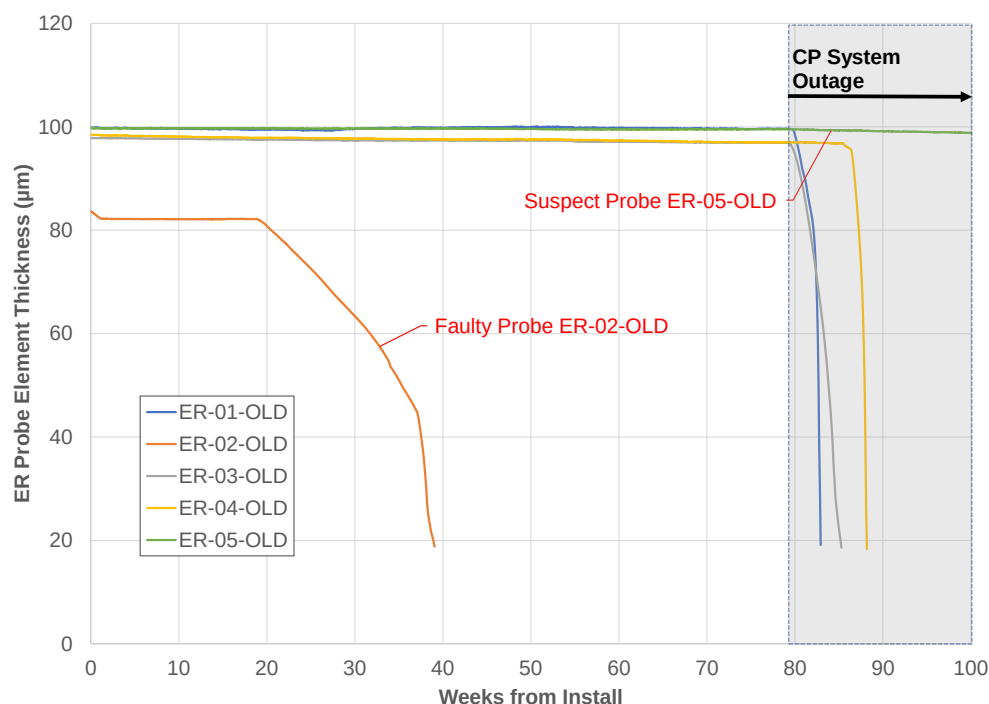
**Figure 1: Summary of 100 µm ER Probe Data**

Continued monitoring of the 100  $\mu\text{m}$  probes produced intriguing data, which is summarized in Figure 1. Four of the ER probes in Figure 1 depict insignificant corrosion with the CP system fully operational. One of the probes (ER-02-OLD) failed during a period of time with the application of CP. The data was erratic and inconsistent, and was attributed to faulty equipment.

During a CP system outage, Figure 1 depicts when three of the remaining original ER probes exhibited high corrosion rates, and eventually failed (i.e. ER-01-OLD, ER-03-OLD, ER-04-OLD). In all cases, there was an incubation period before the corrosion began to accelerate, which varied from two to five days for probes ER-03-OLD and ER-01-OLD, to 50 days for probe ER-04-OLD. Once initiated, an average CR between 0.7 and 1.4 mm per year was observed, resulting in the failure of all three probes within 27 to 62 days of the CP system outage. No corrosion occurred on probe ER-05-OLD during the outage, and the measured CP current density remained close to zero with the CP system both On and Off, indicating that the probe may not be fully continuous with the structure.

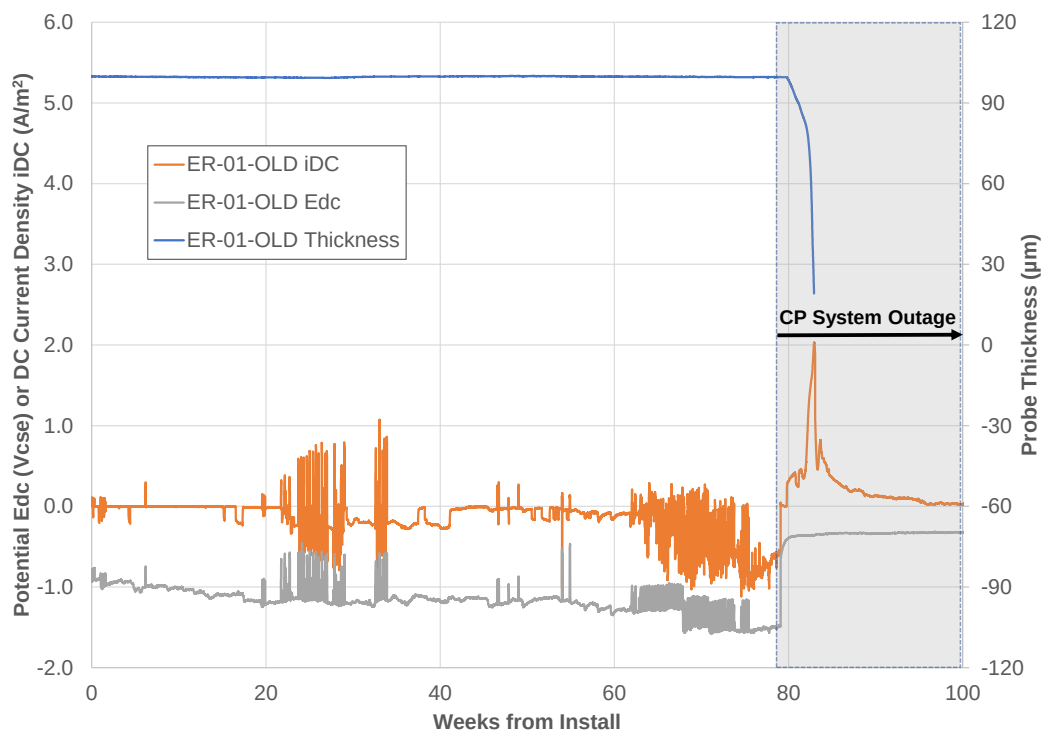
**Figure 2: Summary of ER-01-OLD Probe Data (Location 01)**

As shown in Figure 2 for ER-01-OLD, the start of corrosion was accompanied by a significant shift in current density (iDC) in the positive direction (indicating current discharge), with current densities as high as 2 A/m<sup>2</sup> recorded on Probe ER-01-OLD.

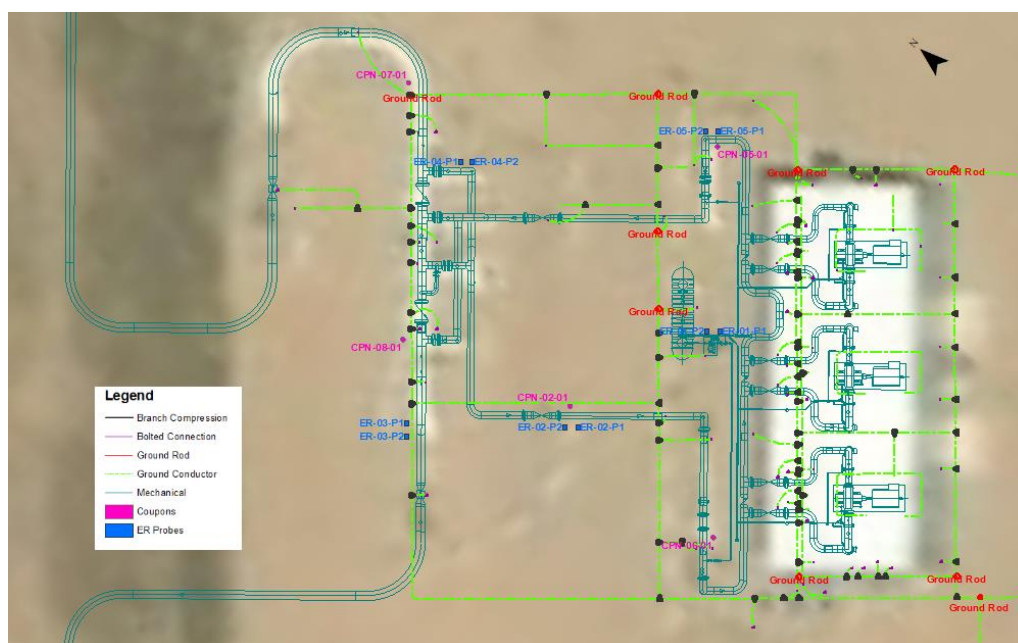
**Figure 3: Revised Corrosion Monitoring System Spatial Overview**

Given the multiple datasets required for analysis (e.g. corrosion rates, coupon-to-electrolyte potentials, coupon currents, soil composition) a Geographic Information System (GIS) environment was utilized for comparison and analysis of data with spatial and attribute qualities represented in a digital format.<sup>4</sup> Figure 3 provides an overview of particular feature classes, commonly referred to as a layers, that developed an important visual used to understand the reported attribute data in proximity to other buried electrically continuous metallic infrastructure (steel piles, coated piping, copper ground rods).
