**Paper No.**  
**16875**

## **Evaluation of Corrosion of Copper Drinking Water Pipes Exposed to Sulfurous Well Water and Ozone Treatment**

Kimberly Steiner  
Wiss, Janney, Elstner Associates, Inc.  
330 Pfingsten Road  
Northbrook, Illinois 60062  
USA

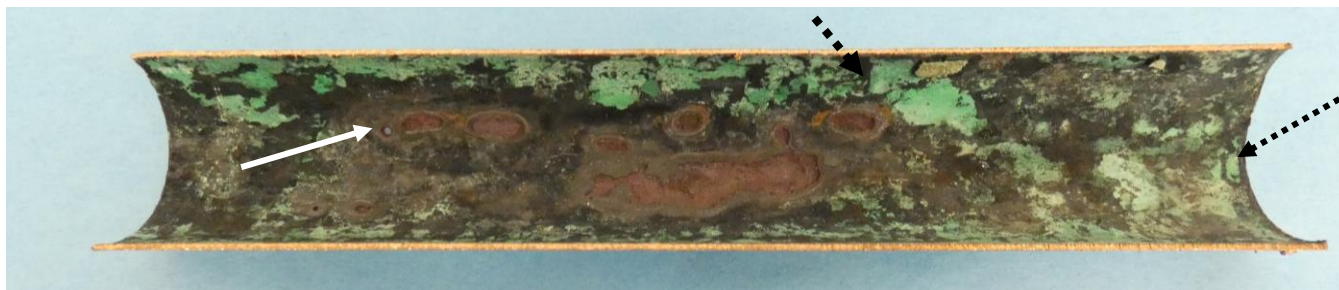
Sample 1 was received approximately nine years after occupancy of the home. Leakage occurred due to pinhole corrosion originating on the inside surface of the pipe. Multiple layers of corrosion products were apparent on the pipe, with reddish corrosion products inside the pits, and a layer of bright green and blackish corrosion products on top. A loosely adhered layer of blackish corrosion products with pale green on top was also present on top of the other corrosion products, but mostly debonded when the pipe sample was cut lengthwise. Wide and deep pits were apparent on the pipe interior, along with one pinhole, as seen in Figure 1. The pits were lined with reddish corrosion products, while the blackish and green corrosion products appeared to sit on top or to the side of the pits. Examination of a polished cross-section of the pipe indicated that red and green corrosion products were present in the pits, and the red, black and green corrosion products sat on the surface of both the pits and the unpitted pipe (Figure 2). The corrosion products thickness was measured at up to 1000 microns.

**Figure 1: Interior surface of Sample 1, after sectioning lengthwise. The pinhole is indicated with a solid arrow. Remnants of the corrosion products are indicated with dashed arrows.**

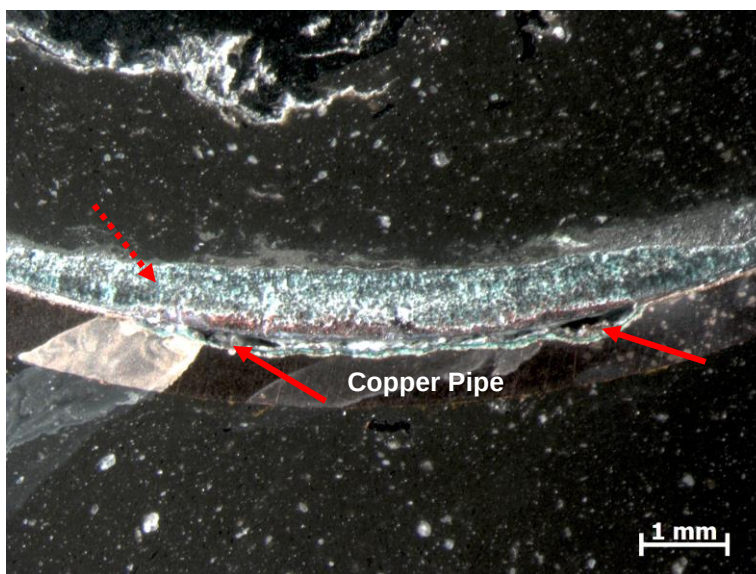
**Figure 2: Micrograph of a polished cross-section of Sample 1, taken away from the pinhole. In this location, the thickness of the corrosion products is greater than 1000 microns. Note how the reddish corrosion product sits on and inside the pits (arrows), and the blackish and green corrosion products remain on the surface (dashed arrow).**
