## **Long Life Chloride Affected Concrete Structures – Some Corrosion Mechanistic Considerations**

### **ABSTRACT**

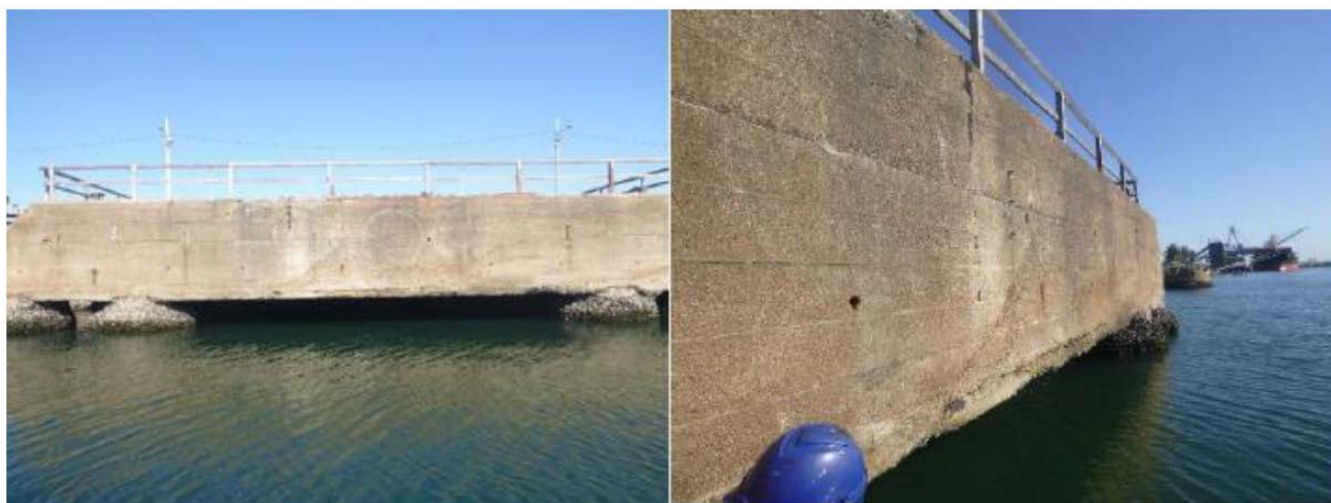
Limited investigation was undertaken on a reinforced concrete marine berth structure constructed circa 1908, located on the east coast of Australia. Superficially the structure appeared visually in sound condition (Figure 1) with no major signs of reinforcement corrosion induced deterioration such as rust staining, cracking, delamination or spalling. Sampling and chloride content determinations identified very high chloride ion concentrations at the depth of reinforcement of ~0.39% by weight of concrete (~2.73% by weight cement).<sup>1</sup>

**Figure 1: 100+ berth structure (now fishing jetty).**

The age of the structure, and its high chloride content, suggest that it should be showing signs of considerable deterioration, particularly reinforcement corrosion.<sup>1</sup> Further investigations, as part of undergraduate or post-graduate engineering student research projects, are proposed in the future to diagnose reinforcement corrosion state and concrete composition.

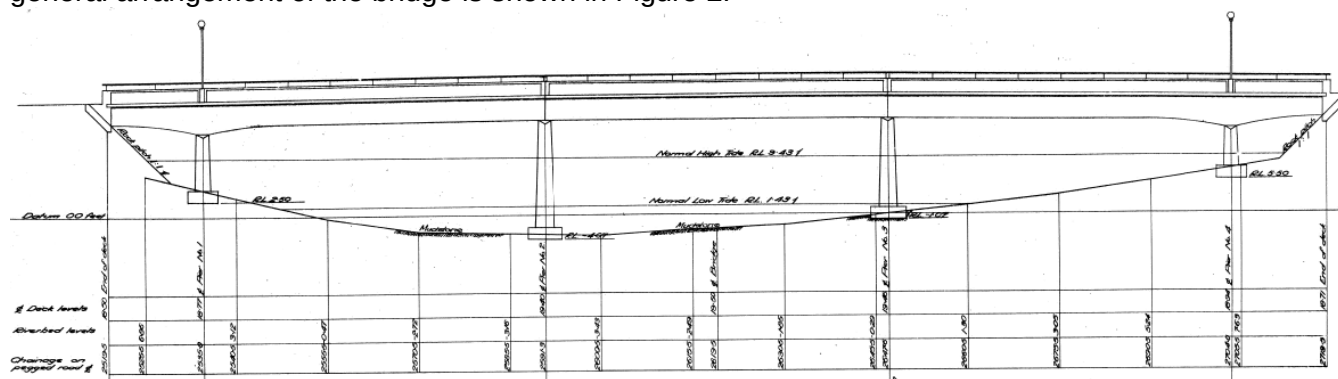
**Figure 2: General arrangement of 65+ coastal road bridge.**

The diagnostic testing results from within the tidal and splash zone pier locations indicate the following:

- Chloride levels at mean reinforcement depth (60-67mm) of ~0.1-0.4% by weight of concrete (~0.7-2.8% by weight of cement).
- Gradients of electrode (half-cell) potentials, together with breakouts to expose reinforcement, did not indicate that pier reinforcement was corroding.

In terms of the absolute values of the electrode (half-cell) potentials, if interpretation were undertaken in accordance with the criteria proposed in ASTM C876<sup>2</sup> then incorrectly the assessment would be that pier reinforcement is corroding.

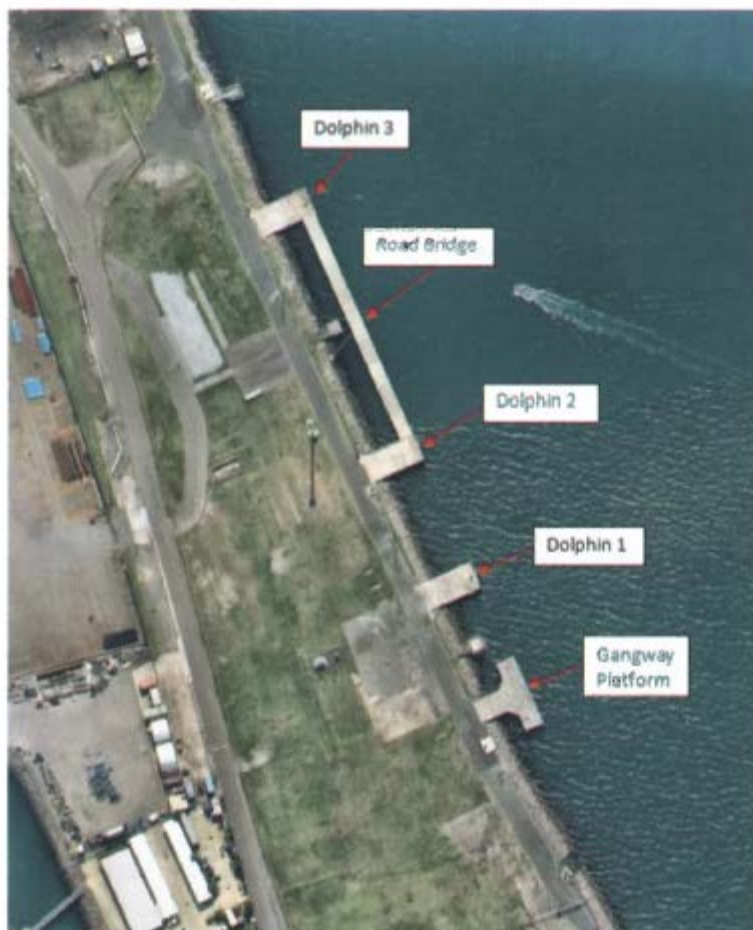
The reinforced concrete marine structure in this instance was constructed in 1977 and is a berth wharf within a Port on the east coast of Australia. The wharf structure generally consists of the components indicated in the aerial photograph provided at Figure 3. Dolphin 1, Dolphin 2 and Dolphin 3, most particularly substructure reinforced concrete encased steel beams and reinforced concrete deck, were the focus of an investigation by Green et al<sup>3</sup>.

**Figure 3: Aerial photograph of 40+ wharf structure, east coast of Australia.**
