## **Slurry Abrasion Failure Of A Carbon Steel Pipe Carrying Bitumen Froth In Oil Sands**

In this paper, the premature failure of a carbon steel pipe carrying bitumen froth (60 to 90°C; 1,040 kg/m<sup>3</sup> density) from oil sands primary extraction is analyzed. The leak developed at approximately 1,000 m downstream the pumps' discharge on an underground sloped section of the pipeline and was due to the thinning of the pipe wall. An extensive investigation was conducted including detailed visual and microscopic examination, mechanical testing, froth and solids abrasivity characterization, and hydraulics analysis. Various laboratory tests were performed to simulate different wear and corrosive-wear conditions in order to replicate and better understand the failure. Results showed that despite slurry erosion to be the expected damage mechanism, the failure was actually caused by a slurry abrasion process. This can create thickness loss rates much more aggressive than those expected by an erosive process under similar conditions. A new wear mechanism is proposed to explain the observed results.

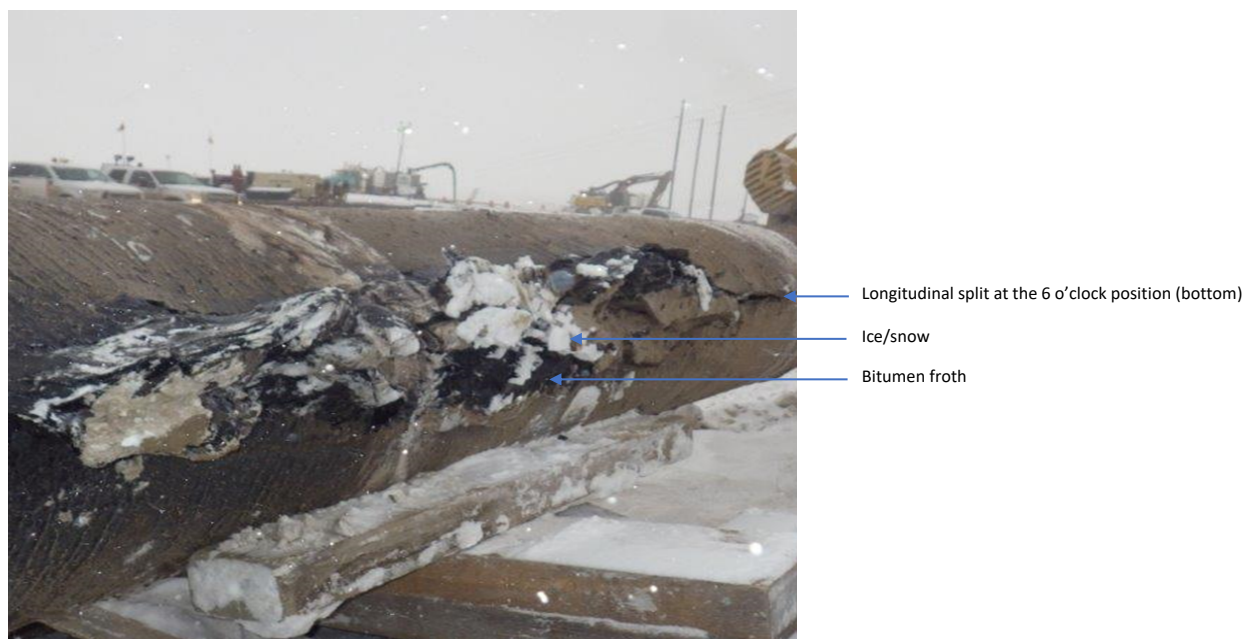
The failure location was in a sloped section between 900 m to 1,100 m from the Steepbank Plant, and exhibited severe wall thickness loss with a split over 12 m long (Figure 2), which resulted in 600 m of pipeline to be replaced due to thinning. In order to understand the thinning mechanism(s) leading to such premature failure, an extensive failure investigation was conducted including detailed visual and microscopic examination, mechanical testing, froth and solids abrasivity characterization, and hydraulics analysis. Various laboratory tests were performed to simulate different wear and corrosive-wear conditions in order to replicate the damage and better understand the failure.

**Figure 2:** Failed spool after removal from the pipeline, showing the split at the 6 o'clock position propagated on a fairly straight manner over 12 m in length.

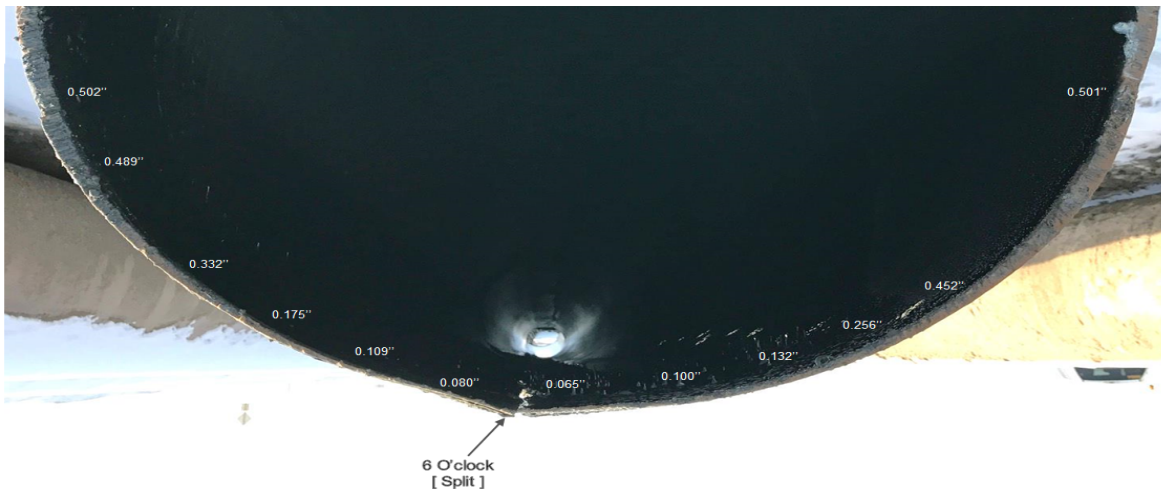
Visual examination of the failed pipeline section revealed that the thinning mechanism was completely developed from the internal surface, with the external fusion bonded epoxy coating still intact with no visible signs of coating damage or external corrosion. The thickness profile was consistent along the length of the failed section of the pipeline, featuring a sharp thickness change from nominal thickness (12.7 mm) towards the bottom of the pipe where it reaches less than 1.5 mm near the split. The thickness loss was mainly confined within the 4 to 8 o'clock position at the bottom of the pipe (Figure 4). There was no evidence of preferential thickness loss at the longitudinal seam and girth welds. The low thickness profile at the bottom of the pipe extended over a section of approximately 600 m beyond which the pipeline thickness recovered to nominal values in all o'clock positions both upstream and downstream of the affected section. This indicated that the phenomenon must have been driven by a change in the hydraulics / flow dynamics that triggered a more aggressive thickness loss rates or a change in the degradation mechanism able to cause significantly more damage than under pure mechanical erosion. It was also evident that with less than 1.5 mm at the bottom of the pipe the final failure event occurred due to ductile overload as the pipe thickness was not enough to withstand the internal pressure.

**Figure 4:** Typical thickness profile throughout the cross section of the failed pipe.

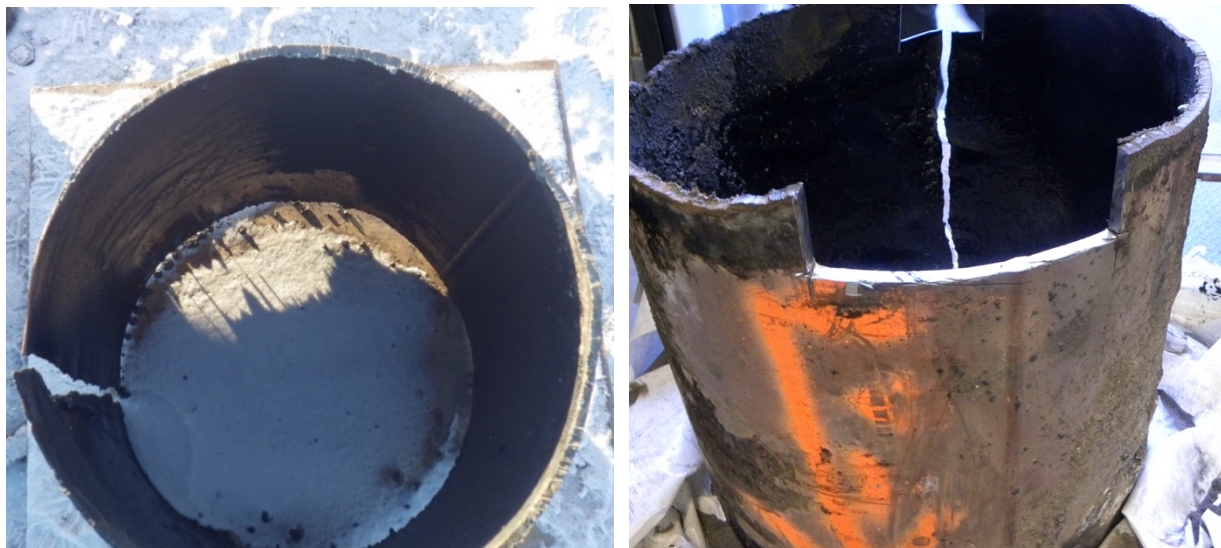
**Figure 5: Pipe section cut out of the failed spool for further analysis.**

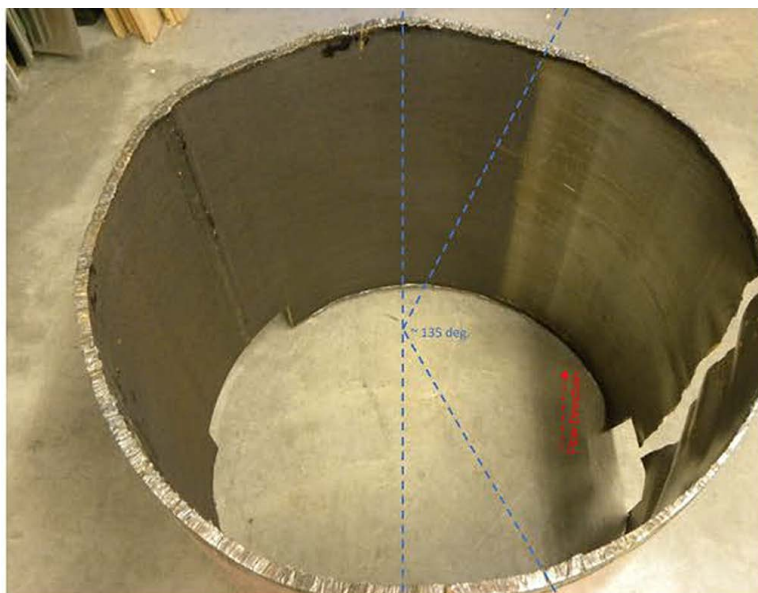
A section of approximately 0.6 m long representative of the failure was selected and cut out from the failed spool for further analysis in the lab (Figure 5). After cleaning of the internal surface to remove the bitumen that was stuck to the surface (Figure 6), it was evident that the final failure was ductile, with clear plastic deformation along the split. It also became evident that there were two distinct zones in the pipe internal surface that were consistent with the areas of nominal thickness and the area with pronounced thickness loss, respectively. The inner surface of the pipe surrounding the rupture line (within an angle of about 135°) was shiny while the rest of the pipe surface was dull with light oxide scale. The pipe wall thickness changed rapidly within this shiny region, from less than 1 mm thick at the rupture to about 12.5 mm at the boundary (shiny/light rust) which was almost the same as the original pipe wall thickness. That is, wear occurred mainly in this 135° sector while the rest was intact.

**Figure 6:** Pipe section cut out for laboratory testing, after cleaning of the bitumen products.

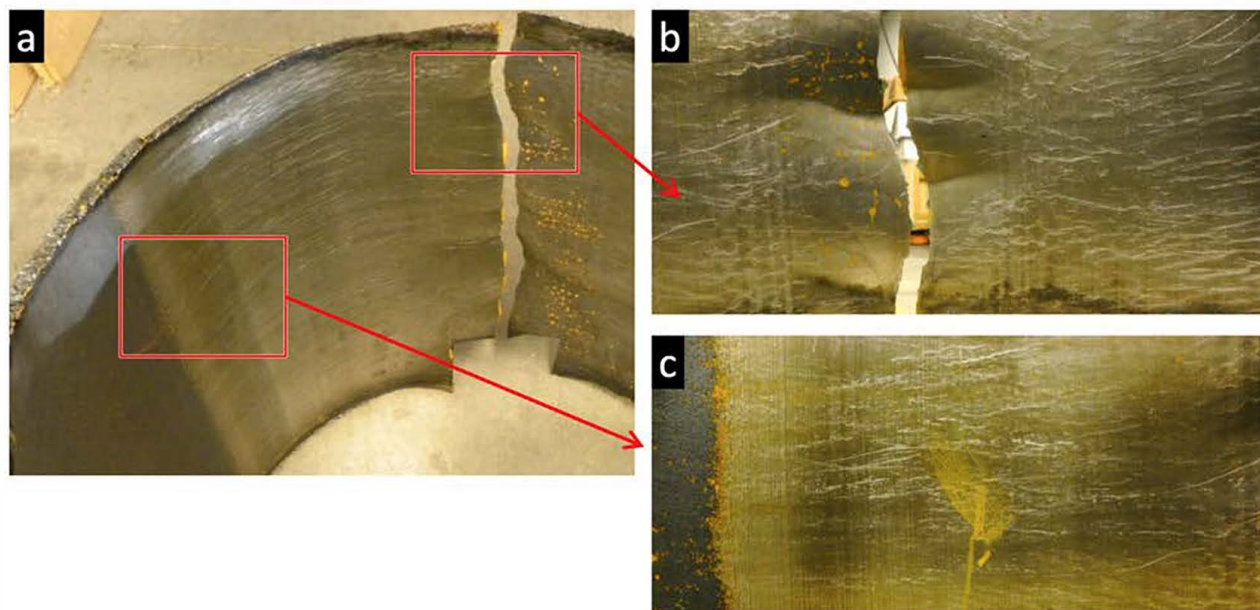
A closer examination of the internal surfaces revealed the presence of clear long scratching/abrasion scars near the boundary between the shiny and light rusty surface, covering approximately a 75 mm wide area (Figure 7). The more severely worn pipe surface (around the rupture) is characterized by sand-beach like wave patterns superimposed by longitudinal scratches. Optical microscopy of these distinct areas of the internal surface can be seen in Figure 8, depicting in more details the scratching lines near the boundary of severe wear (Figure 8(a) & (b)), and wavy wear surface in the more severe wear region, (Figure 8(c)). There appears to be small shallow oxide pits in the surface indicative that even though the damage appears to be wear dominant, corrosive-wear is commonly a factor when dealing with slurries.

**Figure 7:** A closer look at the internal surfaces of the pipe cut out after cleaning.

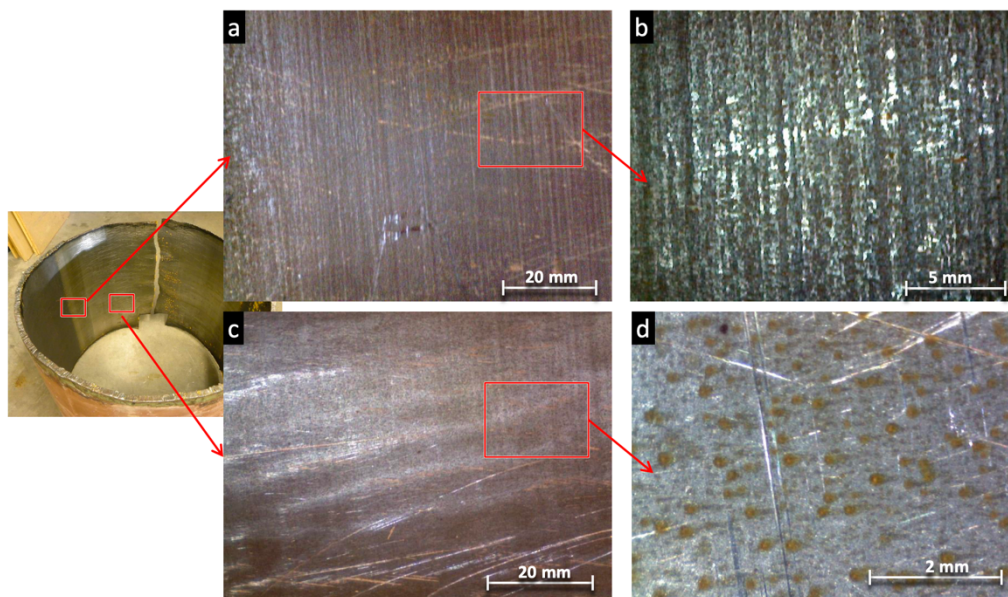
**Figure 8:** Optical micrographs obtained on areas of the internal surface near the transition between the lightly rusty /shiny areas (a and b); and near the rupture (c and d).

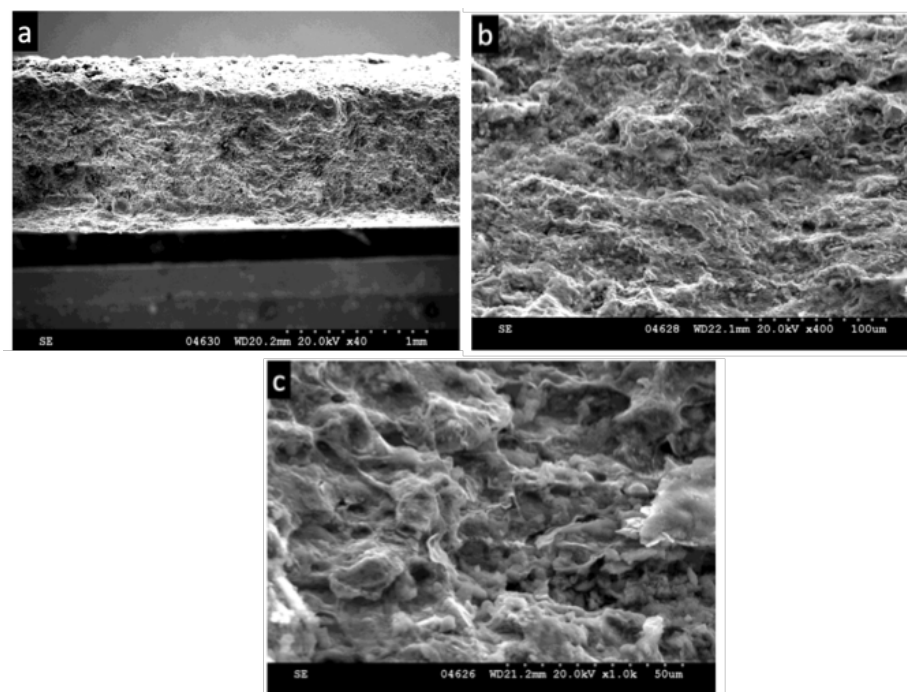
Figure 9 shows the SEM micrographs obtained at the suspected initiation location of the longitudinal split or fracture at the bottom of the pipe, approximately at the 6 o'clock position. The fractographic features confirmed the pipe rupture was clearly ductile, featuring shear lips (Figure 9(a)), plastic deformation ridges (Figure 9(b)), and dimples (Figure 9(c)) [10].

**Figure 9:** SEM micrographs at the split or fracture surface, featuring ductile features.
