## Black Powder Results in NGLF Interruptions

Yahya T. Al-Janabi, Noktan Alyami, Matteo Leoni,  
Anaam Al-ShaikhAli, Eid F. Al-Helal, Taib B. Abang  
Saudi Arabian Oil Company,  
Dhahran 31311, Saudi Arabia

### ABSTRACT

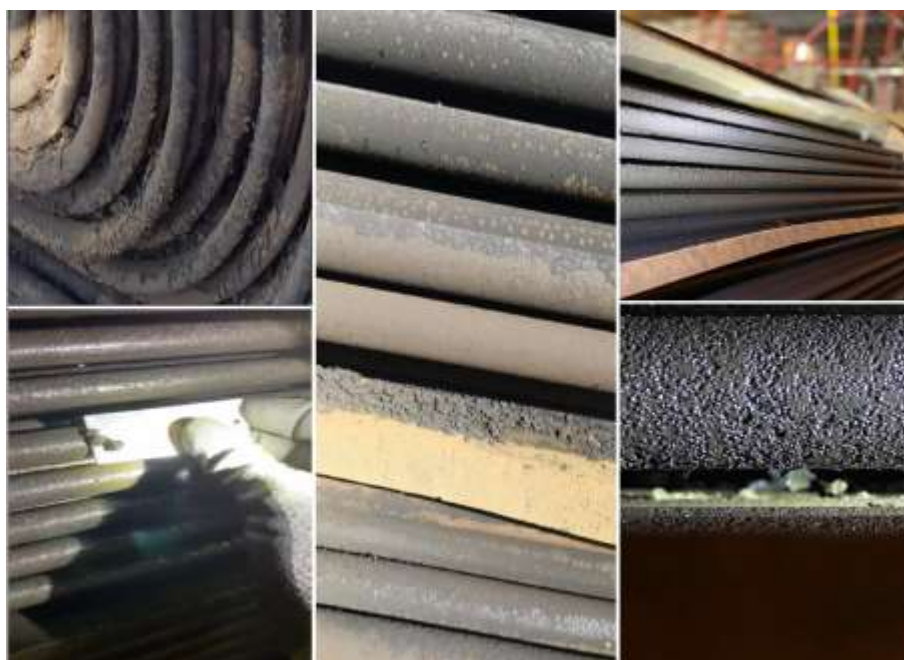
From July 2019, the NGLF plant experienced severe fouling at the de-ethanizer reboilers, as shown in Figure 3. These deposits resulted in reducing the performance of the reboilers, which led to cleaning the reboilers 31 times over a period of 11 months extending from July 2019 until June 2020. A fouled reboiler due to deposits on the reboiler tube bundle, will significantly impact the reboiler performance by reducing the overall heat transfer coefficient and increasing the amount of steam required to meet the desired process temperature. In addition, the presence of solid contaminants resulted in significant impairments to ethane product specifications.

**Figure 3: Solid deposits at reboilers of the NGLF De-ethanizer unit.**

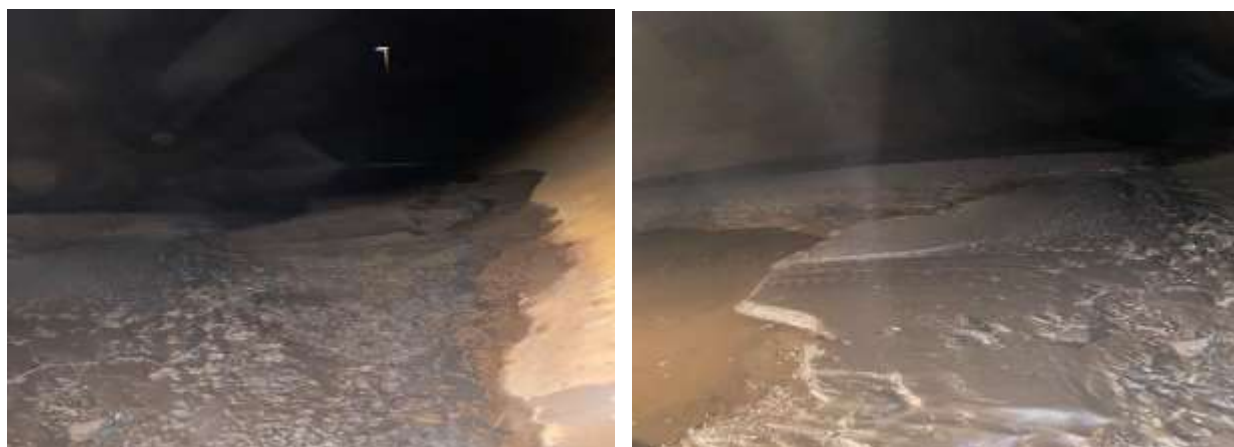
In order to determine the composition and source of solid contaminants, two samples were collected for analysis: 1) from the De-ethanizer reboilers shown in Figure 3, and 2) from the feed working bullet, Figure 5. The first sample was black in color and amorphous in nature. The second sample was collected since cleaning the reboilers 31 times did not improve the situation and the performance of the reboilers continued to decline. Following inspection of the feed working bullets, one bullet was found to be full of sludge, Figure 5, where 1700 drums of sludge were collected. The collected sludge was equivalent to 350 m<sup>3</sup>.

**Figure 5: Picture of sludge sample found in NGLF feed working bullet that was collected in June 2020.**
