**Paper No.**  
**16976**

## **Ductile Iron Wastewater Force Mains Failure Analysis and Service Life Estimation**

**Key words:** microbiologically influenced corrosion, mortar-lined ductile iron, force mains, service life estimation, failure analysis.

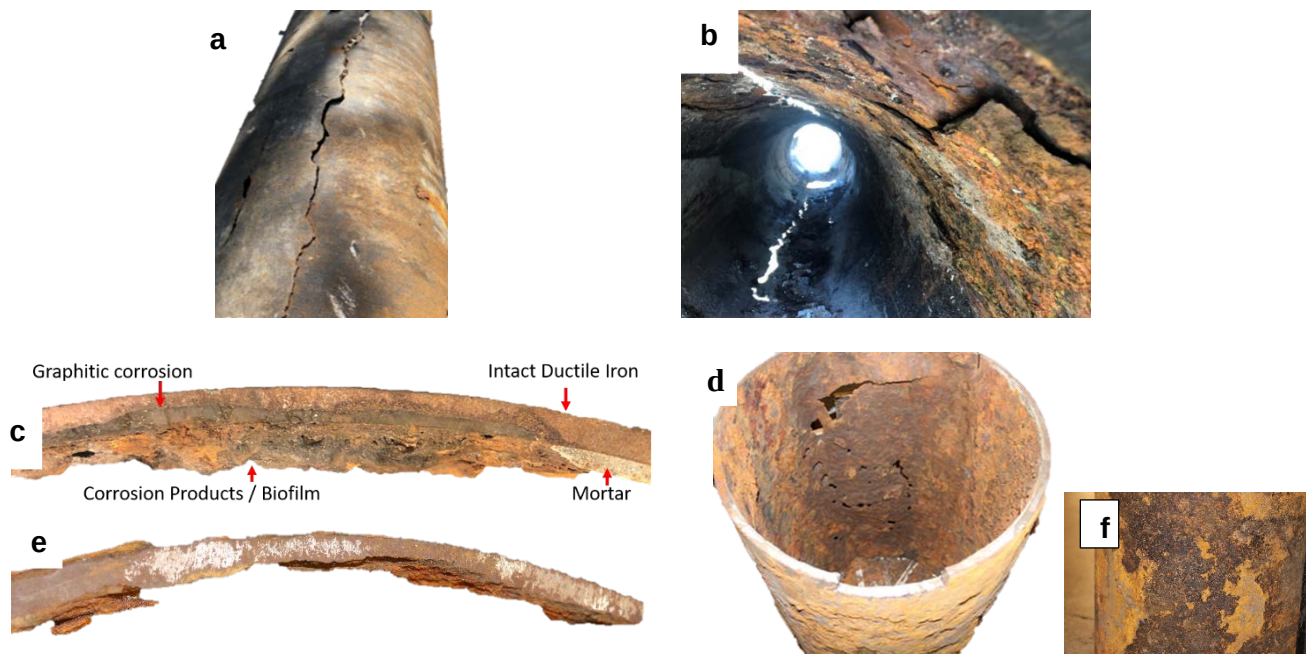
Figure 1 shows images of the two mortar-lined ductile iron pipes retrieved from the field. The two pipes, A and B were both underground pipes that transported wastewater. The larger pipe, MLDIP-A (Figure 1 a,b,c) had an outer diameter of 65 cm, a metal thickness of 1 cm and a mortar lining measuring 0.45 cm in thickness. MLDIP-B (Figure 1 d,e,f) was 45 cm in diameter with a 1 cm thick metal portion and a mortar lining of ~0.3 cm thick. In each pipe, the failure point was at the crown of the pipe and seemed to have initiated internally.

**Figure 1: Optical image of failed mortar-lined ductile iron pipes a) Longitudinal crack in MLDIP-A b) Internal corrosion in MLDIP-A c) Graphitic corrosion in MLDIP-A d) Failure in MLDIP-B e) Cross-section image of a part of MLDIP-B f) Uniform corrosion on external surface of MLDIP-B**

The size of the air pocket was estimated based on the degradation pattern of each pipe. For MLDIP-A, approximately 60% of the pipe's circumference was severely deteriorated as indicated by complete absence of the mortar layer and corrosion of the ductile iron. A longitudinal crack along the crown of the pipe, as shown in Figure 1a, likely suggests that the pipe failed due to the line pressure as a result of the thinned pipe wall. The smallest pipe wall thickness measured along the crack was 1.30 mm. An image of the cross section of the pipe near the failure zone is shown in Figure 1c. On the right end of the image, the ductile iron is completely intact and lined with the original mortar layer designed to protect against corrosion. At the left end of the image, three material layers are present, including a biofilm layer that seems to be mixed with iron corrosion products, a dark corrosion layer, and the original ductile iron. Upon extraction of a small sample for analysis, it became clear that the dark corrosion layer had lost its strength. Since there does not seem to be corrosion underneath the intact mortar layer, visual inspection suggests that the mortar layer deteriorates completely prior to the initiation of the ductile iron corrosion.

In MLDIP-B, severe corrosion can be seen both internally and externally on the pipe surface. While corrosion on the outside surface of MLDIP-B in contact with the soil was mainly uniform as seen from Figure 1f, the internal pipe structure suffered severe corrosion within the failure region. Severe pitting at random spots within the failure region seem to have led to full penetration of the pipe wall. Subsequent collapse around the failure zone can be added to be due from soil pressure as the pipe continued to thin to a point where its strength could no longer hold. This is evidenced from the inward dent of the pipe.

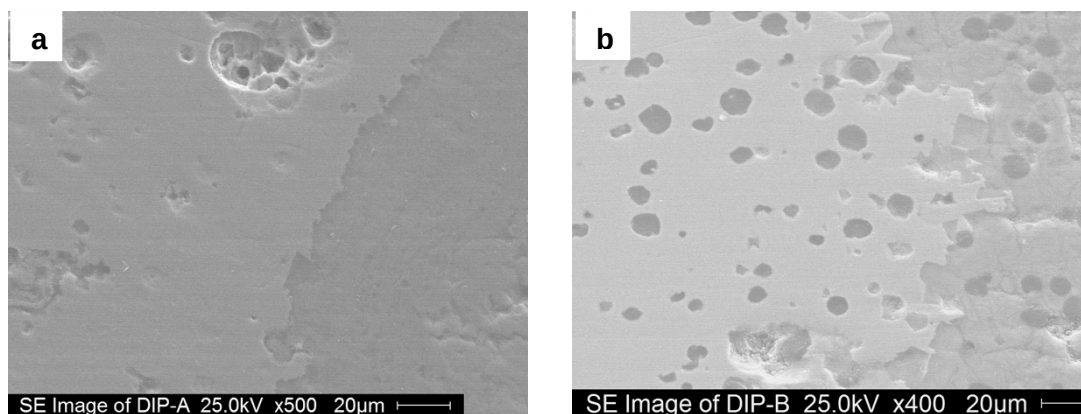
SEM micrographs of the metal samples of MLDIPA and MLDIPB show nodules of graphite distributed in a steel matrix (Figure 2) within the unaffected portion of the metal. Regions affected by the exposure conditions as indicated by darker shades in the micrographs may be used to ascertain the corrosion mechanisms. Interestingly, the darker shaded region of the pipe A sample does not show graphite nodules, while the darker region of the pipe B sample does. This could indicate that the exposure conditions may result in different modes of attack.

**Figure 2: SEM of cross-section of metal taken from failed zone of: a) MLDIPA; b) MLDIP-B**

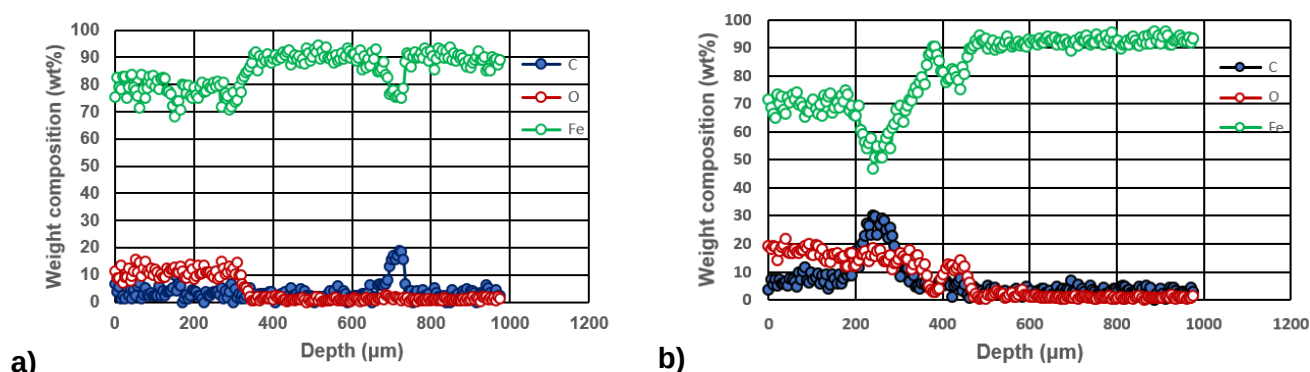
EDS composition analysis was performed throughout the depth of the material to identify how the corroded region differed in composition to that of the unaffected region. The results are shown in Figure 3 which include EDS line scans of the percent weight of iron and carbon as a function of depth with the atomic element as a parameter. A depth of zero reflects the portion of the sample closest to the exposure surface. A high presence of oxygen and a lower amount of iron within this region indicates corrosion taking place. The oxygen concentration decreases away from the exposure surface and the depth of corrosion reaches ~500 µm. The initial decrease in the amount of Fe in the corroding zone of metal components in both pipes can be attributed to the influence of graphitic corrosion which results in selective leaching of Fe (Figures 1c, 3a and 3b). Graphite nodules are more noble than the surrounding ferrite matrix such that galvanic couples form at the nodule matrix interface resulting in preferential corrosion around the nodules which releases them from the matrix.<sup>11</sup>

**Figure 3: EDS line scan of ductile iron samples taken from failure zone of the failed pipes: a) MLDIP-A b) MLDIP-B.**
