## **Present Situation and Countermeasures of Corrosion Protection for Pipeline Crossing by Shield Tunneling**

Su Jin  
Sino-Pipeline International Company Limited  
No. 5 Anding Road, Chaoyang District  
Beijing, 100029  
China

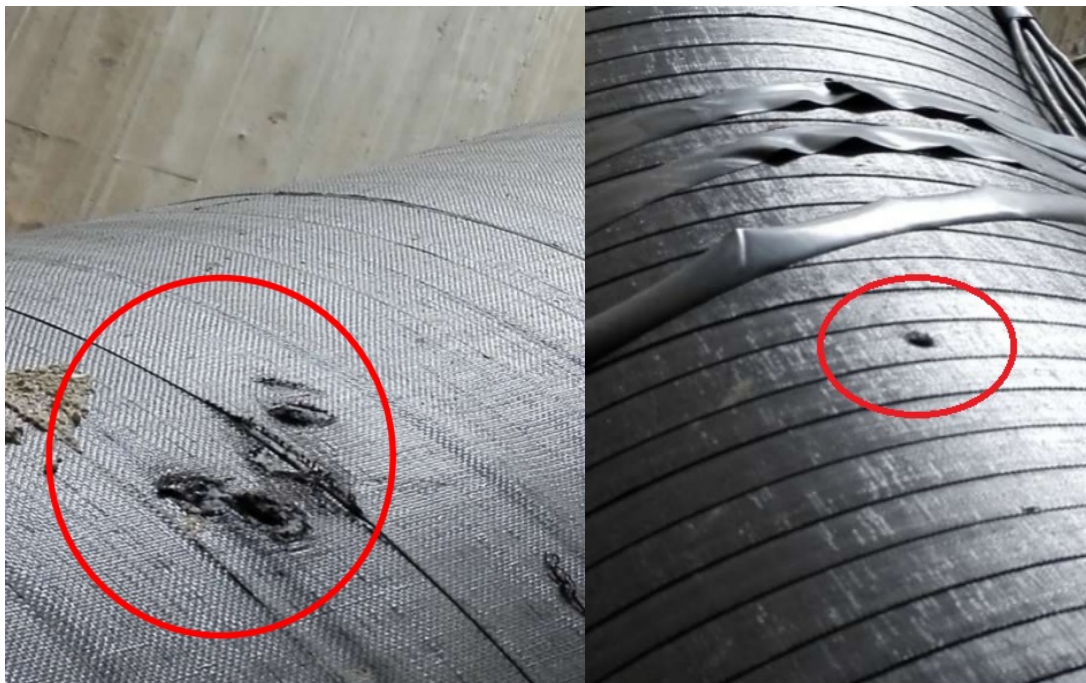
1. Except for the pipeline E, the coating of pipeline main body was 3LPE, which had sound anticorrosion effect in operation.
2. The hot-bending bends were made of double-layer FBE and adding polypropylene tape. It was found through field investigation that the collision damage (maybe occurred while the pipe was being staged and prepared for installation) on the bends was significant, especially the bends in shafts, and some of them were not repaired after damage. As shown in Figure 2.

**Fig. 2 On-site Collision Damage of the hot-bending bends**
