## **Nickel Based Alloy Casting Failure in Potash Production Mill**

A nickel-based alloy knife gate valve exposed to hot potash brine failed in less than two years in service. Failure was realized when the valve was unable to stop the flow. Visual examination of the valve internal body parts revealed heavy scaling and corrosion damage, although the center body part and the two knife gates were intact. Corrosion scale samples were subjected to chemical analysis by X-ray diffraction (XRD) augmented by energy dispersive X-ray spectroscopy (EDS). The XRD technique was unable to identify approximately 85% of the components in the scale due to lack of crystallinity. The crystalline portion of the scale was found to contain a mixture of molybdenum, chromium, nickel and tungsten oxides, and trace amounts of tungsten carbide and nickel sulphate. EDS analysis revealed high concentrations of oxygen, molybdenum and tungsten. Metallographic examination of the corroded surface revealed preferential attack of the inter-dendritic secondary phases in the cast microstructure. The results of the examinations show, the higher carbon content in the cast alloy had consumed a portion of the corrosion re

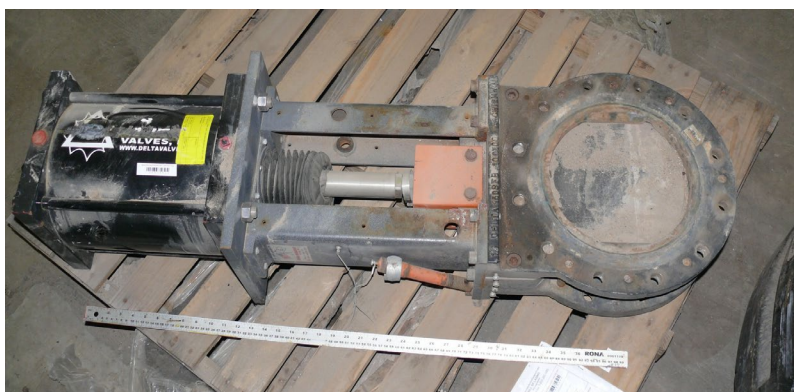
This paper investigates the failure of an NPS 10-inch, Class 150 dual knife gate valve after less than two years in service.<sup>1</sup> The upstream and downstream segments of the valve body was a cast UNS <sup>(1)</sup> N30002 nickel-based alloy,<sup>2</sup> while the gates and center body part were manufactured from UNS N10276 nickel-based alloy wrought plate.<sup>3</sup> This valve was part of a process piping system containing hot saturated KCl and NaCl potash brine which had been operated at 100 °C and 170 kPa with a maximum flow rate of 8500 L/min. It was understood that this piping was also regularly exposed to an acidic descaling chemical containing hydrochloric acid (HCl). Figure 1 shows the failed valve after it was removed from service.

**Figure 1: Knife gate valve**

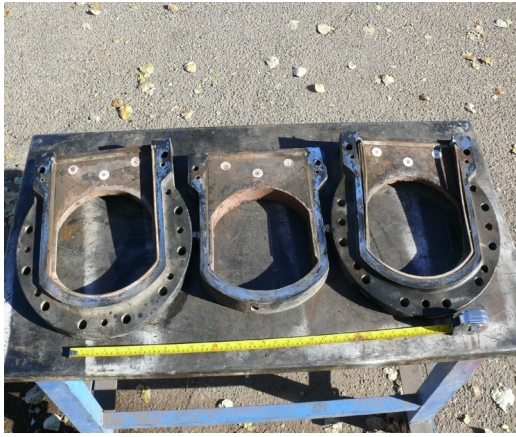
**Figure 2: Disassembled internal parts**

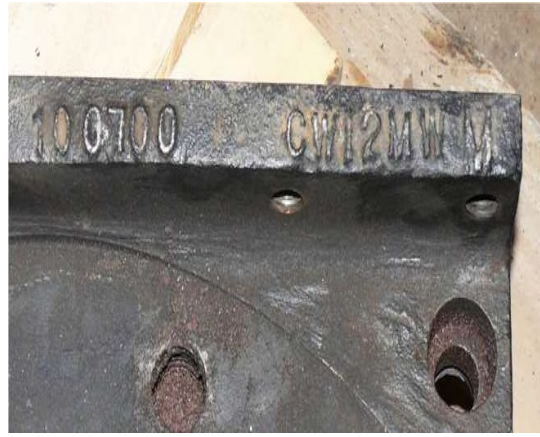
The name plate attached to the valve body specified the valve body material as “HC”. Reference to the valve manufacture’s product literature indicates “HC” meaning the valve body is ASTM A494 <sup>(2)</sup>, material grade CW12MW UNS N30002 nickel-based alloy casting. Visual examination of the internal surface of the upstream valve body revealed heavy scale buildup and evidence of corrosion damage in the bore of the bottom U-shaped region, while the downstream valve body part exhibited less scale buildup and corrosion damage. The center body part and the two knife gates, specified as UNS N10276 nickel-based alloy wrought plate, did not show any evidence of scale buildup or corrosion damage. Figure 2 shows the valve body parts after being dismantled for examination. Figure 3 shows the ASTM casting grade markings that were present on the upstream and downstream body parts. Figure 4 provides a comparison of scale buildup and corrosion damage between the upstream and downstream valve body parts. Figure 5 shows the valve body center part and Figure 6 shows one of the two knife gates.

**Figure 3: ASTM Casting Grade on valve body**

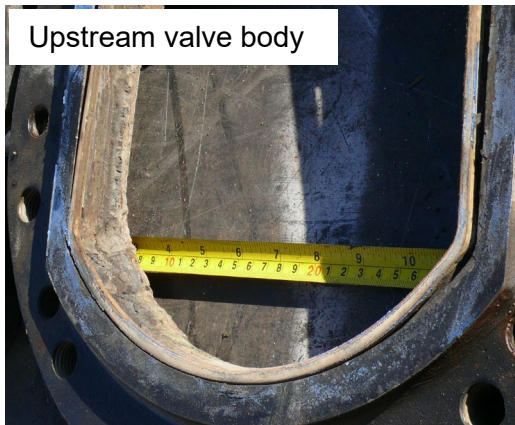
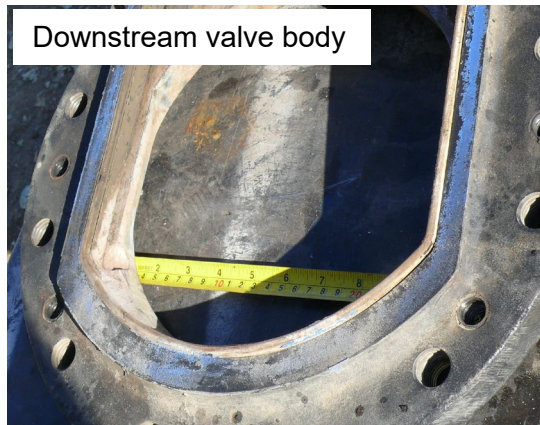
**Figure 4: Upstream and downstream valve body**

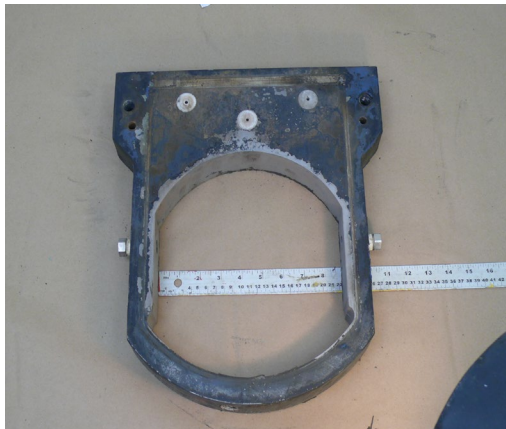
**Figure 5: Center valve body no corrosion**

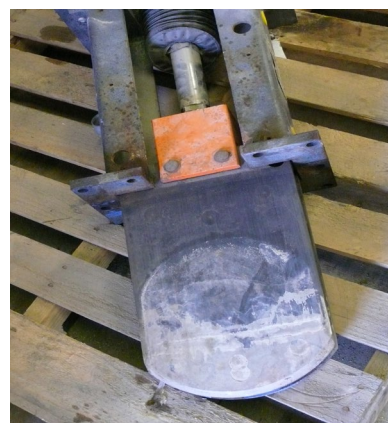
**Figure 6: Knife gate no corrosion**
