## **Failure of 24" Common Crude Piping and Formation of Iron Sulfides Due to the Influence of Sulfate & Iron Reducing Bacteria and Methanogens**

Yousef Khuraibut  
Inspection & Corrosion Team  
Kuwait Oil Company  
Ahmadi, Kuwait

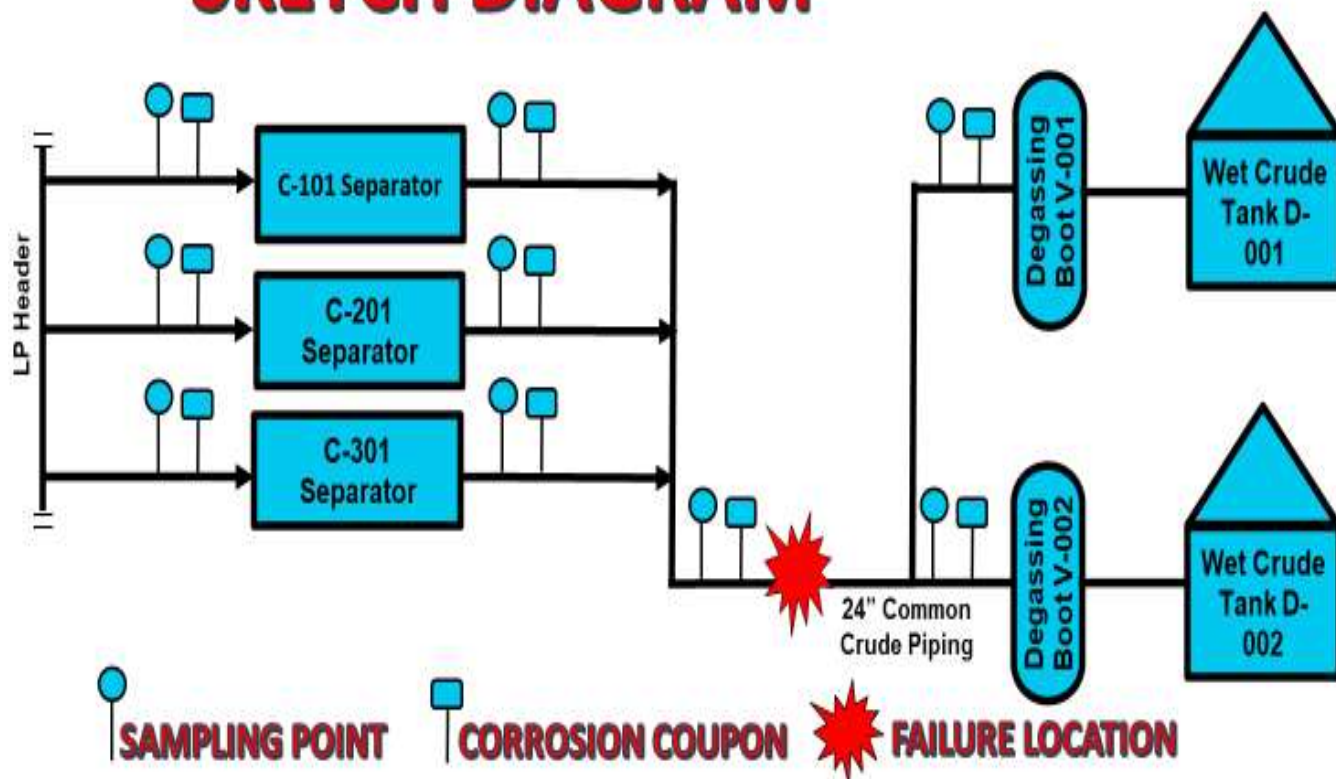
Figure 1: Sketch Diagram for the 24" Crude Stream and Location of Piping Failures

Additional inspections by manual ultrasonic thickness (UT) and long range ultrasonic thickness (LRUT) measurements for the 24" common crude line showed similar deep isolated pits (up to 70% thickness reduction) scattered across the length of the 1100 meter piping (See Figure 1 below). This was extremely concerning since the facility has just been commissioned and in service for 1.5 - 2 years only. Interestingly, no severe general corrosion was observed in all inspected piping. On that basis, the inspection team issued action reports recommending immediate replacement of the spools with most severe localized thickness reduction and pose immediate integrity risk to the facility. The spools with minor and moderate damages were planned for replacement in the upcoming shutdown for the facility, scheduled for December 2020 (88 meters in total for all inspected piping scattered at different spools). Subsequently, an investigation was carried out to determine the root causes and probable reasons for the damages that have occurred.

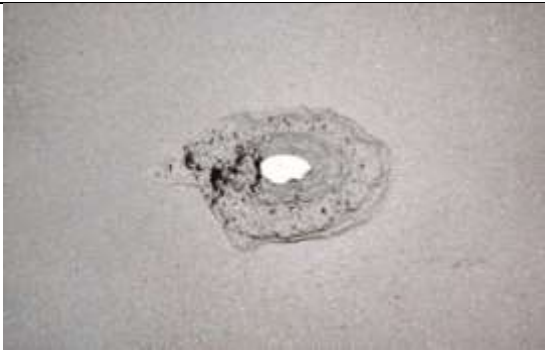
The initial cut spool showed pitting / localized corrosion scattered across the length of the piping with various severities. However, one particular pit that leaked was considerably large in size, approximately 55 mm. This suggests extremely aggressive corrosion taking place at that location. Most of the pits (small or large) had smooth rounded edges with terraced sidewalls and other pockets showed a cluster of mini pits (Figure 2 & 3). Additional damaged spools cut during the shutdown in December 2020 showed similar damage morphologies in all replaced spools as can be seen in Figure 4, 5 & 6 (total length of replaced spools 88 meters).

| <b>Figure 2: Extremely Severe Pitting &amp; Localized Corrosion @ Initially Leaked / Inspected Spools</b> | <b>Figure 3: Smooth Rounded Pits Observed in the Initially Cut Spools</b> |

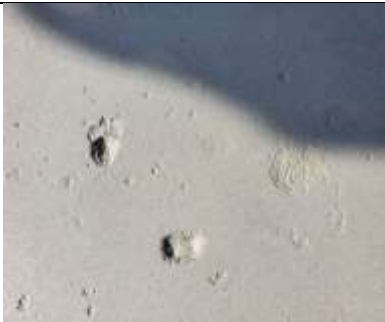
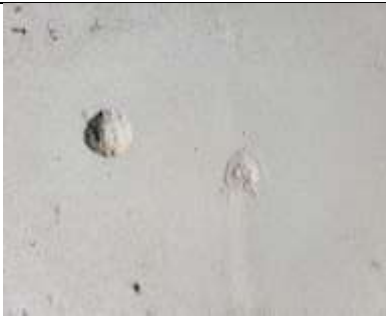
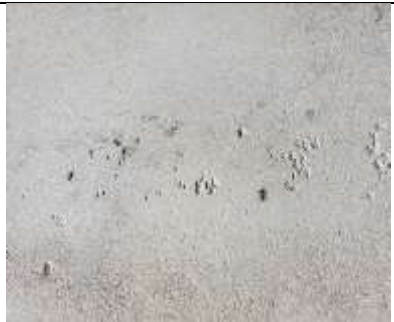
| <b>Figure 4</b> | <b>Figure 5</b> | <b>Figure 6</b> |

| <b>Smooth Rounded &amp; Cluster Pits Observed in December 2020 Cut Spools</b> | | |

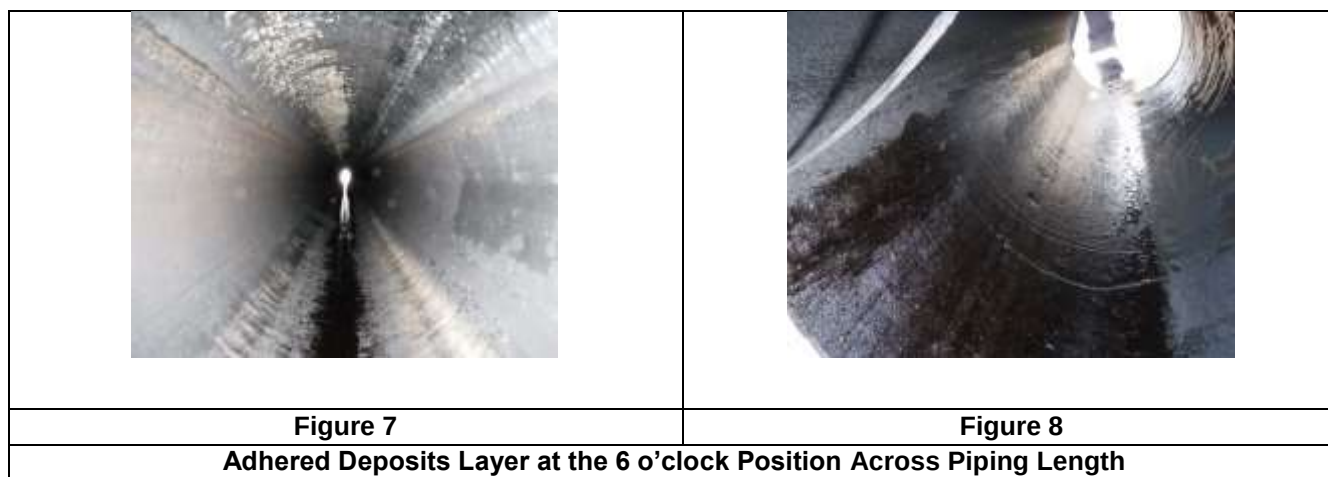
There was no significant general corrosion found in all spools (initial or replaced during the shutdown), which confirmed that all the corrosion damages are localized. All the replaced spools had deposit layer adhered at the 6 o'clock position and running across the length of the spools. The layer removal was easily done at many spots; however, was challenging at others. The adhered deposit layer suggests that pitting / localized corrosion was aggravated and accelerated under these deposits, which caused concentration corrosion cells beneath these uniform films, as seen in Figure 7, 8 and illustrated in Figure 9.

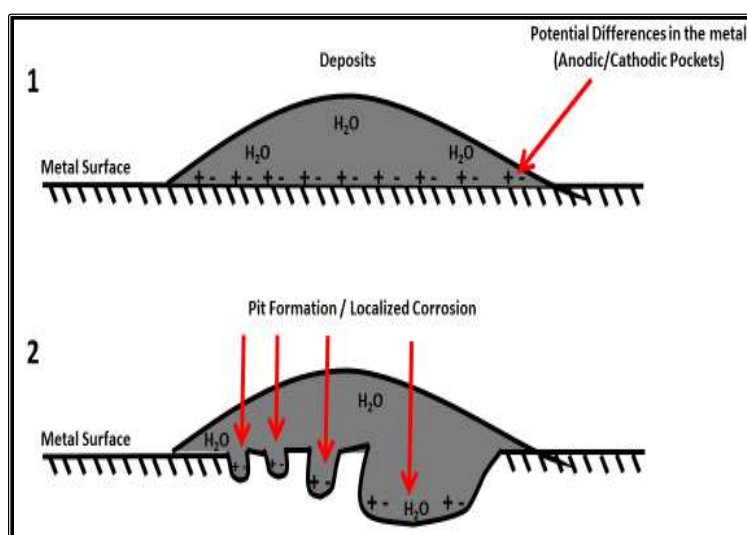
**Figure 9: Under Deposit Pit Formation / Localized Corrosion**
