## **Evaluation of Corrosion Pitting in a 317L Stainless Steel Surface Condenser Tube Bundle**

### **ABSTRACT**

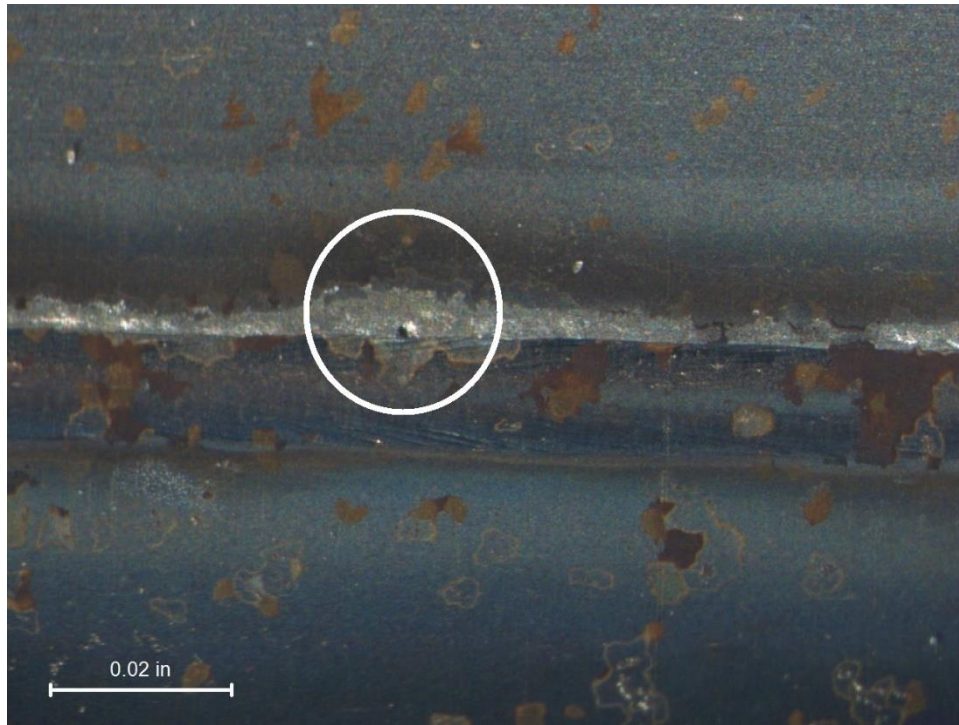
Tube samples received in the Laboratory were split longitudinally to allow visual inspection of the Internal Diameter (ID) surfaces. Pitting was clearly visible in or along the edges of the tube seam weld and along the seam weld Heat-Affected Zone (HAZ), Figures 1-3. Concentrated chlorides (2.3 wt.% Cl) were confirmed to be present in the pitted area, via Scanning Electron Microscope – Energy Dispersive X-ray Analysis (SEM-EDXA), see Table 2.

**Figure 1: Macro photograph of the internal waterside surface of an as-received tube after splitting it open, in an area that showed pitting along the seam weld HAZ.**

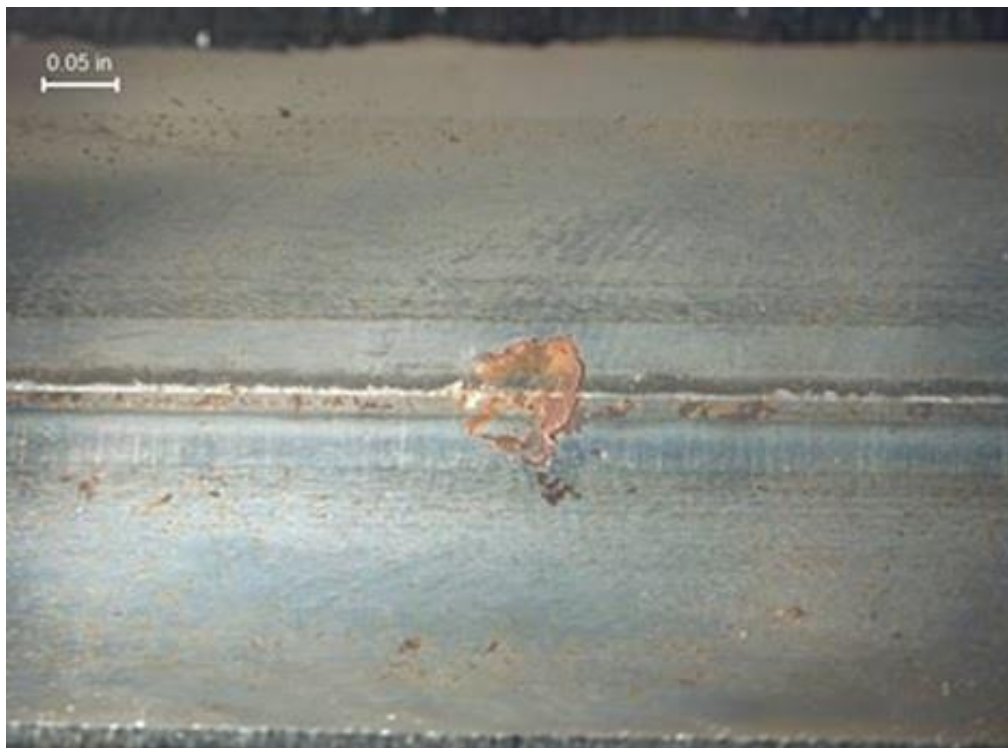
**Figure 2: Macro view of visible pitting along the seam weld in an area without any significant deposit present. The location of the tube seam weld and the associated corrosion products (rust) are visible.**

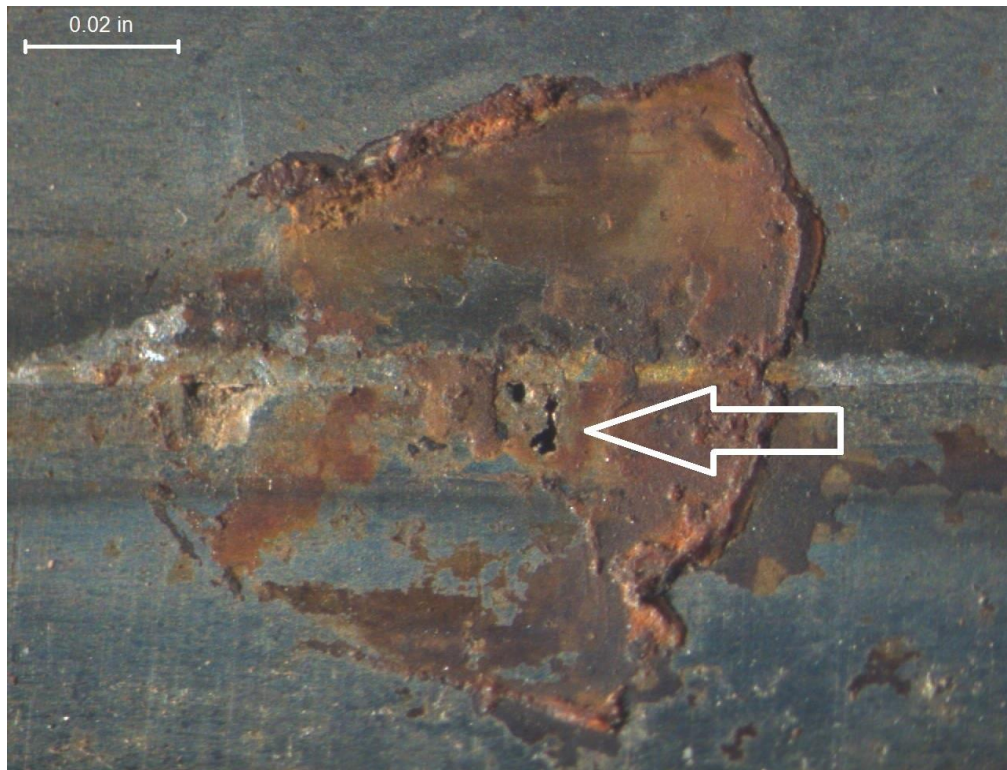
**Figure 3: Close-up view of pitting (arrow) along the center and edges of the seam weld.**
