## **A recent case of intermetallic precipitations in super duplex stainless steel**

This article is based on a failure analysis, where a pressurized 4" super duplex (UNSS32760) elbow from a hydrocarbon system suddenly leaked during service, due to a 90 mm long crack.

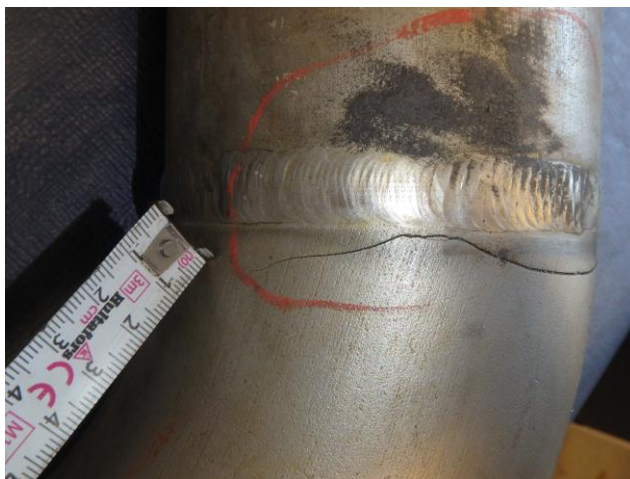
On an early morning in March 2017, an offshore technician was working below the cellar deck on a well head platform. Suddenly a bump was heard followed by a wheezing sound. A visual inspection revealed that a 4" super duplex elbow had cracked near a weld, and the flowline was shut down immediately. A review of the material certificate showed that the elbow was cold bent from pipe and afterwards solution annealed. The operating pressure was 90 bar and the operating temperature was approximately 40° C. The elbow has been in service for approximately 10 years. During operation, periods with slug flow were reported to occur. Figure 1 below provides an overview of the elbow with crack.

**Figure 1: Overview of elbow with crack**

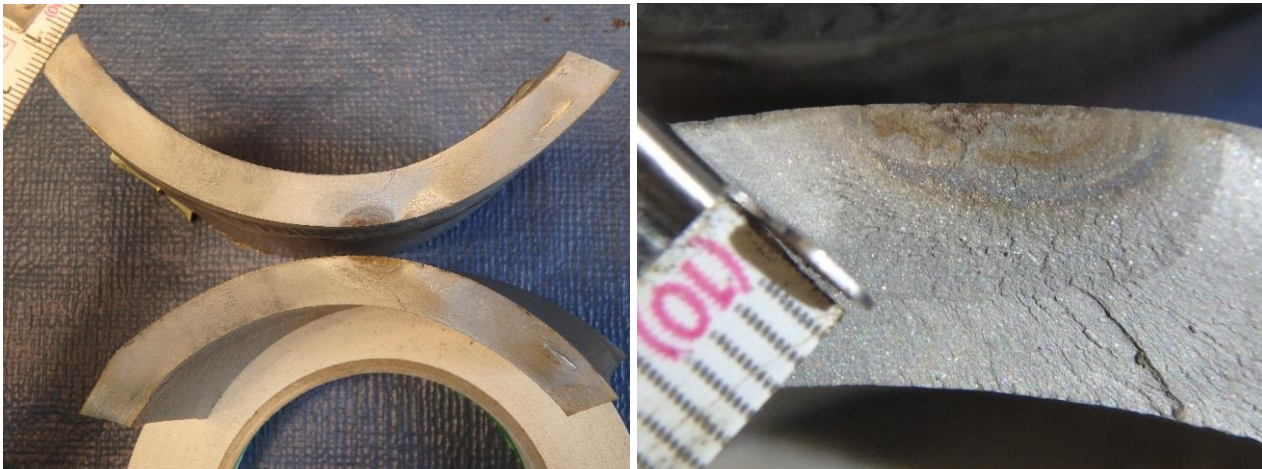
The cracked elbow was sent onshore for root cause analysis. The fracture surfaces were laid free in the laboratory revealing two different morphologies. The appearance of the initiation area showed a local corrosion pit, corrosion products and stepwise crack growth. The remaining fracture surface appeared with a brittle morphology and had propagated as a sudden fracture, cf. figure 2. Detailed examination of the fracture initiation area in SEM (Scanning Electron Microscope) confirmed material loss caused by corrosion. This corrosion pit has initiated on the outside surface - probably due to a local surface imperfection or possible local iron contamination. The saline marine environment leads to chloride contamination on the outside surface of the elbow. Due to the operating temperature of 40° C, water will slowly evaporate leading to an increased chloride content on the outside surfaces. which normally would not initiate pitting corrosion on super duplex material. Once the corrosion pit has initiated the corrosion reaction causes a very low pH value in the pit and the corrosion process becomes self-sustained. The corrosion process will also develop hydrogen that may promote crack growth if the material is sensitive towards hydrogen induced cracking (HIC).

Based on the above findings, it can be concluded that the root cause of the fracture was inadequate heat treatment which has reduced the corrosion resistance and toughness of the material. A local corrosion attack has initiated and propagated until the critical flaw size was exceeded. The dynamic impact loads from service have caused the crack to propagate to a length of approximately 90 mm in a sudden fracture causing a severe gas leak.

**Figure 2: Overview and close-up of fracture surface**

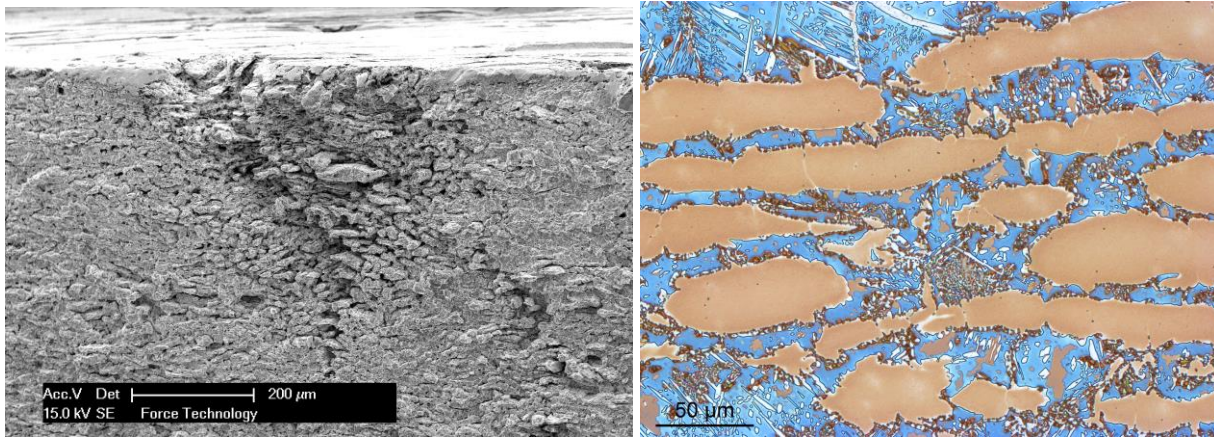
A metallographic cross section perpendicular to the fracture surface was examined in light optical microscope after electrolytical etching in 20% sodium hydroxide. This revealed a microstructure with austenite, ferrite and severe precipitations of intermetallic phases in the grain boundaries, indicating inadequate heat treatment, c.f. figure 3. The ferrite content is normally specified to be between 35 and 65 % for super duplex material but the ferrite content in the area here with precipitations was measured by a hand-held ferrite scope to be approximately 20 %, thus confirming inadequate heat treatment. This has resulted in a part of the ferrite phase having been transformed to intermetallic phases and secondary austenite. Precipitations of intermetallic phases are well known to reduce the toughness, corrosion resistance, fatigue strength and make the material sensitive towards hydrogen induced cracking. The opposite area of the fractured area appeared with a ferrite content within the specified range and free from intermetallic precipitations. Thus, the area with inadequate heat treatment and precipitations was local.

**Figure 3: SEM image of fracture initiation and photo of microstructure with sigma phase – amber colored precipitations at grain boundaries.**
