## **Corrosion And Corrosion Protection of Water Wells**

Mohammed Ali, P.E.  
J. Darby Howard, P.E.  
JDH Corrosion Consultants, Inc.  
1100 Willow  
Pass Court  
Concord, CA  
94520 USA

Elmer Cheung, P.E.  
San Francisco Public Utility Commission (SFPUC)  
525 Golden Gate Avenue  
San Francisco, California 94102  
USA

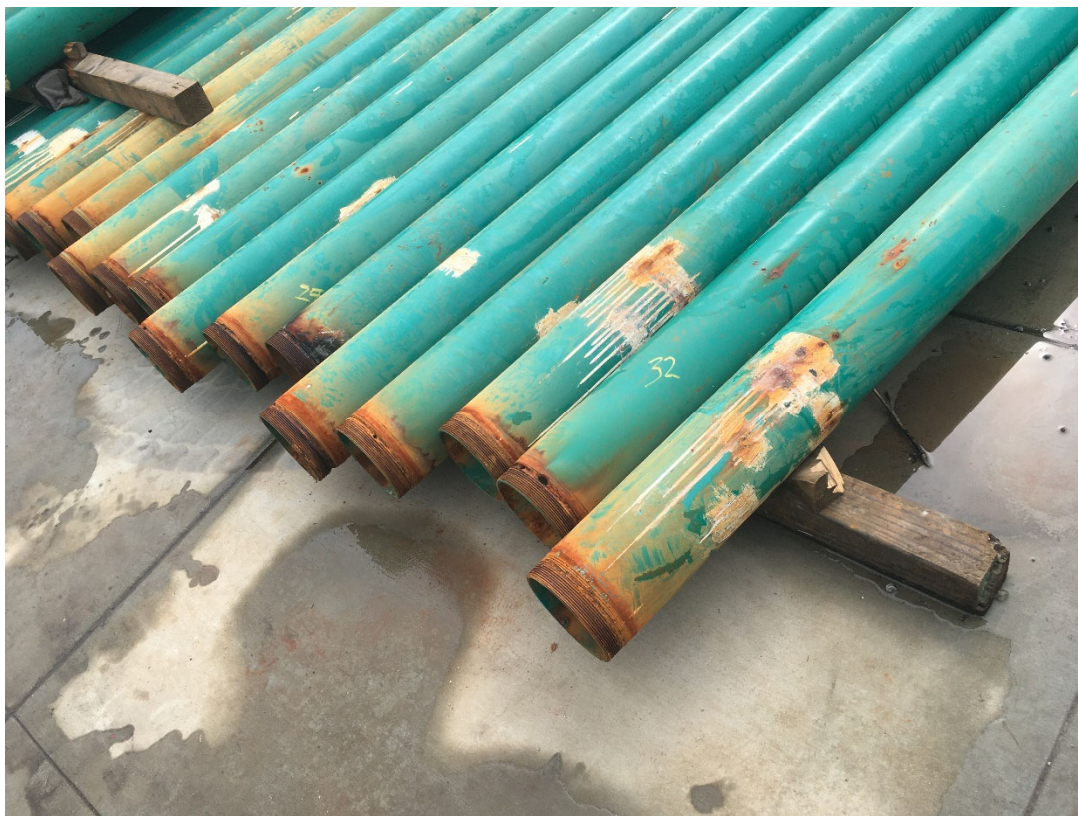
Severe external localized corrosion was observed on the pump column with several through-wall penetrations at the threaded areas of the pipe. The corrosion was located where there was coating damaged (i.e. holidays), most probably a result of tool damage as well as at the threaded section of the pipe. Attempts were made to repair coating damage during pump installation but apparently the coating repairs were not very successful. Moderate corrosion was also observed on the pipe internal diameter (ID) of the pump column. This appears to be due to coating failure and exposure to corrosive waters. However, the corrosion may have been exacerbated by the galvanic effect between the stainless steel shaft which runs inside the pump column in wells with above grade motors, and the coated carbon steel pump column ID. Galvanic corrosion cells will always find the weak spots in the coating to initiate and accelerate corrosion damage. These weak areas could result from coating holidays that originate at the factory where the coating is applied to coating damage that occurs during transit and installation.

**Figure 3 – Corrosion on Pipe Outer Diameter (OD) at Threaded Areas and at Coating Defects Due to Possible Tool Damage**
