## **Localized Pipe Damage in SAGD Steam Distribution Lines**

Haixia Guo ; Saravanan Meyyappan ; Basil Perdicakis;  
Neil Fricke; Yasin Suzuk; Simon Yuen, Duane Serate

Suncor Energy Inc.  
150 6 Ave SW  
Calgary, Alberta, T2P 3E3  
Canada

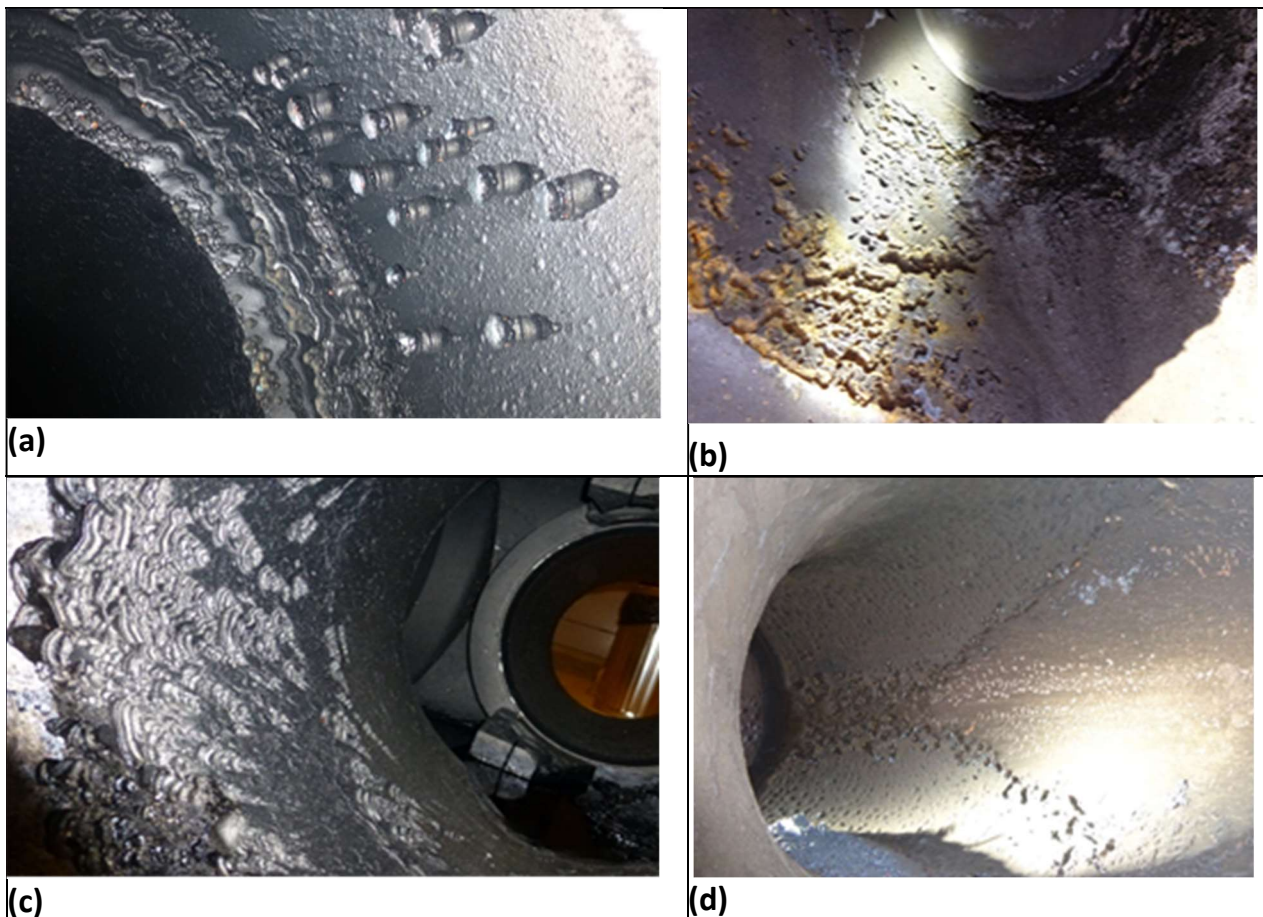
Typical damage pictures are detailed in Figure 2 - 5. The damage in the piping sections between the boilers and the HP Steam Separators is shown in Figure 2. As mentioned previously, the damage in this piping section was observed in the past, and material upgrading to 2.25Cr-1Mo low alloy steel has been completed at some locations.

**Figure 2: Damage on inlet piping to HP steam separators: (a) Damage found in boiler outlet piping and girth welds connected to gate valve; (b) Damage to stop valves at inlets to HP steam separators; (c) Damage to check valve body; (d) Damage to elbow to steam header**

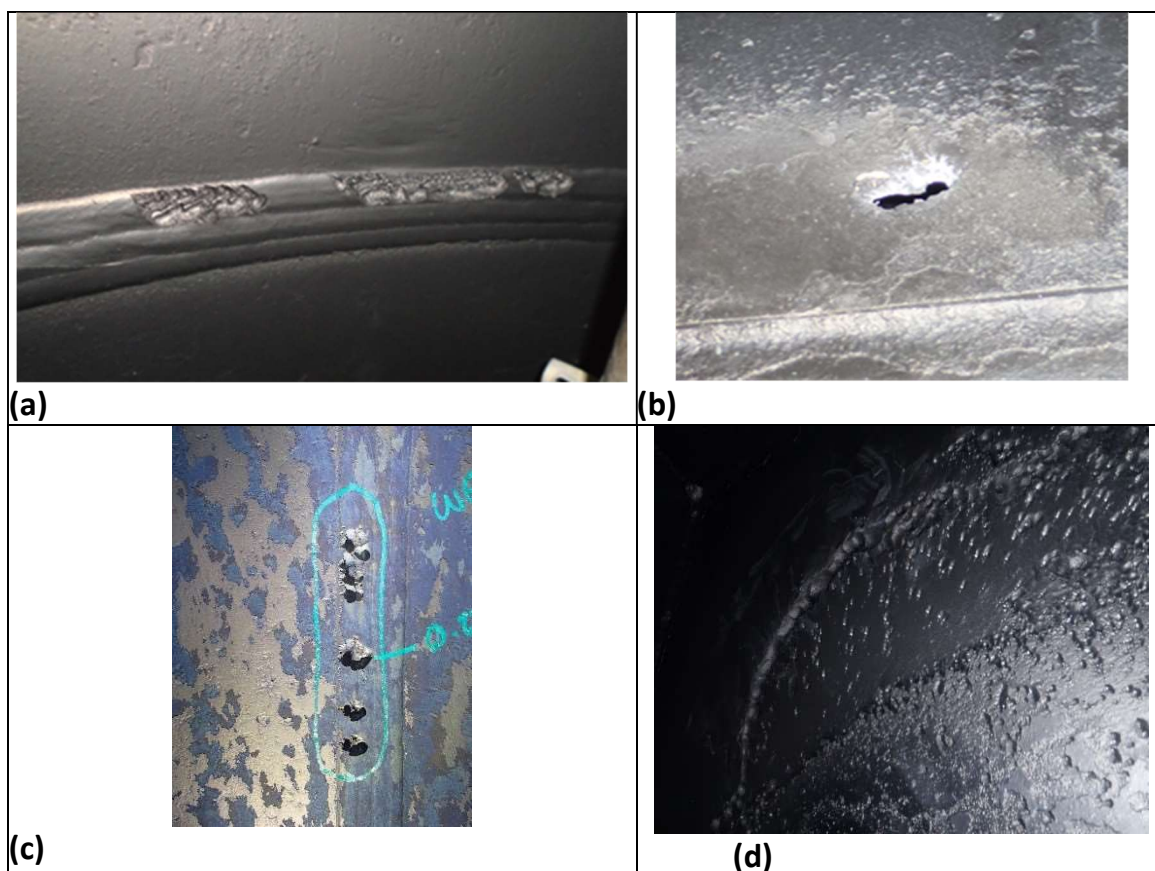
Damage to HP steam separators is found in vessel areas exposed to flow from tangential inlet nozzles where likely the liquid-vapor separation occurs, and also in areas above inlet nozzle of the vessel (vapour portion). The affected internals include the inlet diverter plates, longitudinal and circumferential shell welds (only in vessel portion vertically above inlet nozzles), outlet nozzles, shell welds and vane pack top plates. Damage morphology found is similar to the damage in the inlet piping to separators and the steam headers. Typical damage pictures are shown in Figure 3.

**Figure 3: HP steam separators damage pictures: (a) Circumferential weld damage; (b) Hole through on top vane pack plate; (c) Damage to longitudinal weld; (d) Damage to inlet diverter plate.**

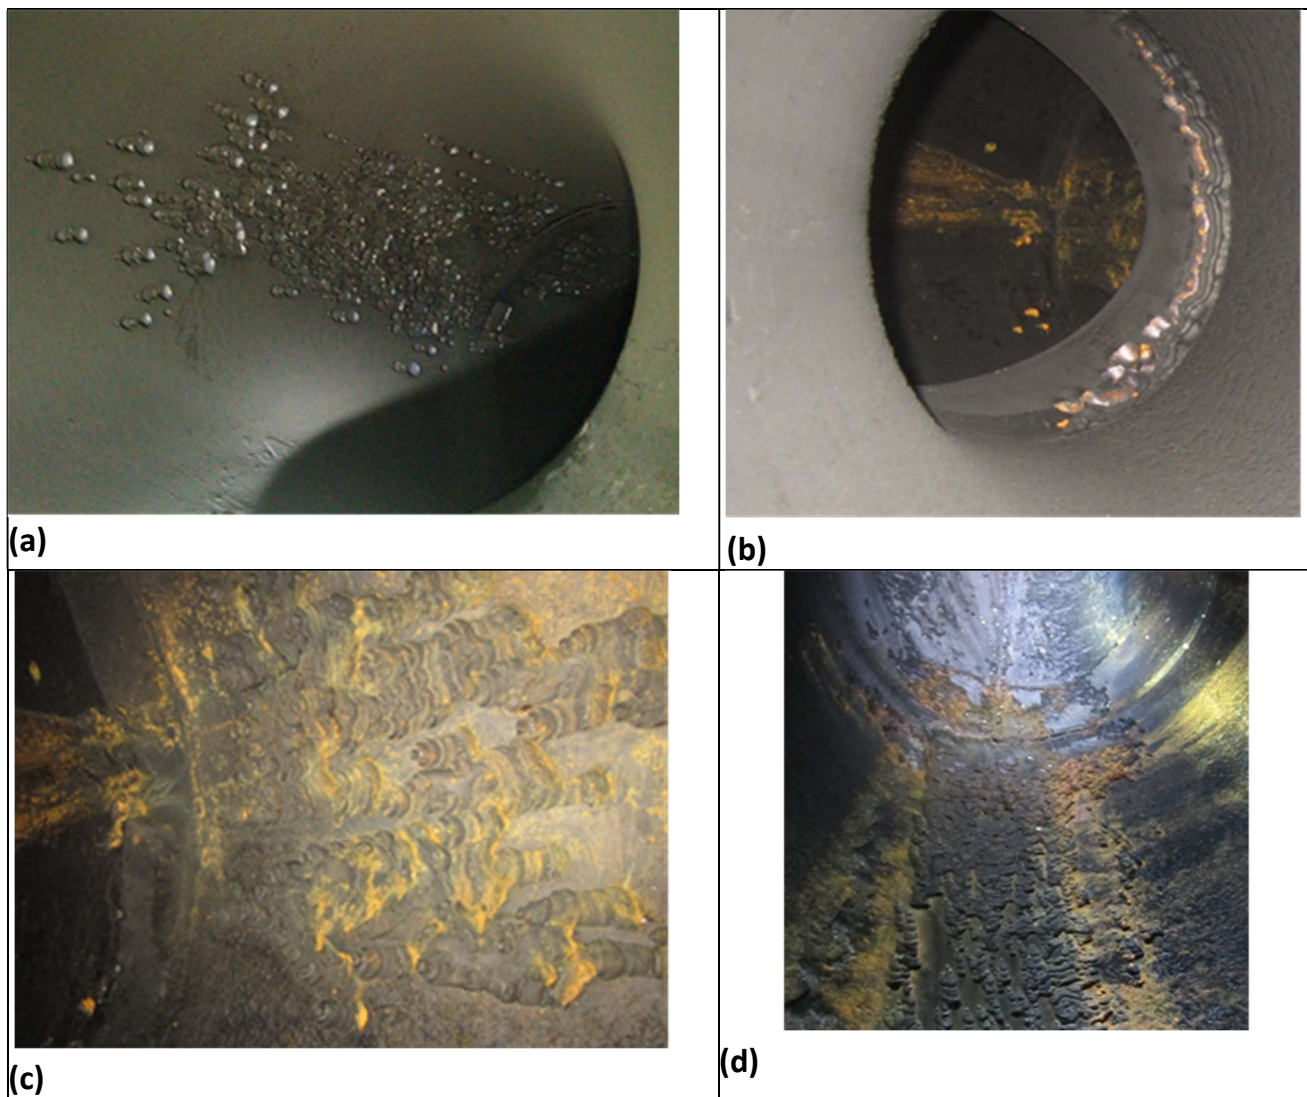
Figure 4 shows the significant damage recently found at the steam lines downstream of the steam separators. Localized, uneven damage are found at fittings, pipe sections adjacent to fittings and some circumferential welds. The estimated highest corrosion is in the range of 30-50 mpy (0.75-1.25 mm/y). Typically for elbows, the damage is more concentrated at the bottom section, i.e. 6 o'clock position, and can go up to 9 or 10 o'clock location at the extrados side. In general the damage is more at the bottom, elbow extrados, and impingement areas of tees and downstream pipe.

**Figure: 4 HP steam separator outlet pictures: (a) Steam separator outlet elbow damage; (b) Circumferential weld damage at steam header tie-in; (c) Pipe damage downstream of a steam tie-in; (d) Vertical elbow and downstream pipe damage**

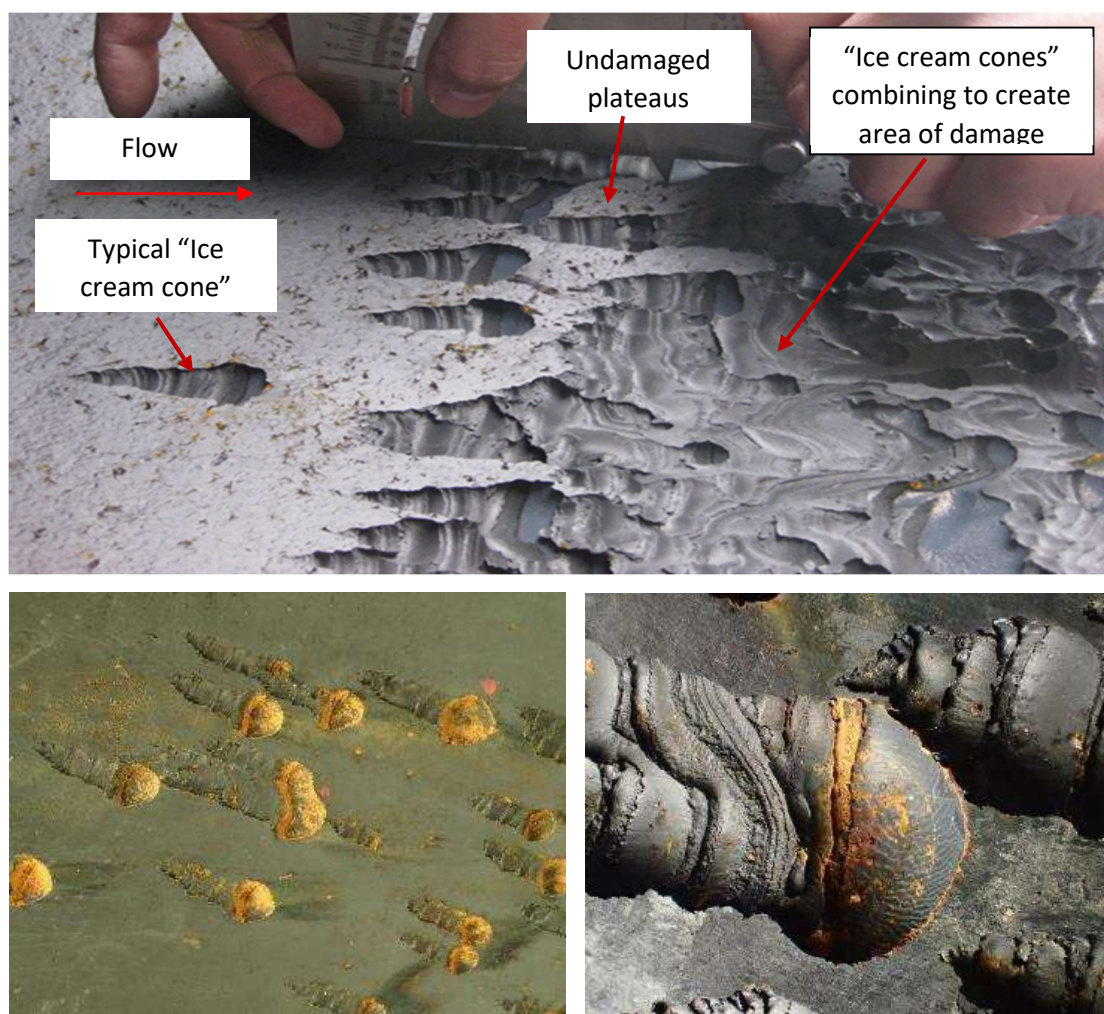
Figure 5 provides a close look of the unique morphology of the localized damage observed at different areas of the HP steam system. A typical pattern of the damaged area consists of wide directional gouges with sharp edges, referred to as “ice cream cones”. The flow direction is typically from the “cone” to the “ice cream top” – this is consistent for most of the damage locations. There are a couple of locations where it seems opposing ice cream cones exist, which is likely related to reverting flow at eddies. In significantly damaged locations the ice cream cones are observed to combine to form extended areas of damage and leave behind undamaged plateaus as shown in Figure 5. Also, the ice cream cones are found to be deeper at the “head” part (downstream end) when compared to the “tail” part (upstream end). The “cone” area contains parallel circular feature – growth rings that appear to increase in size and depth with flow direction. The head of the “ice cream cone” often exhibit “fingerprints” or “ripples”, suggesting of flow-related damage mechanisms.

**Figure 5: Close look of the damage morphology**

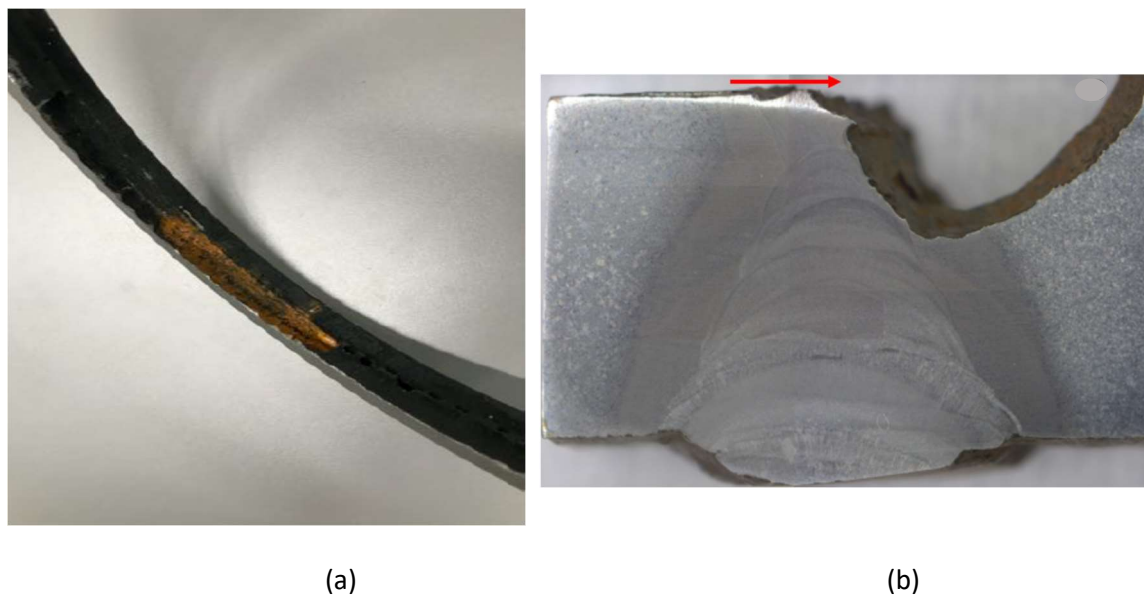
Figure 6 shows the typical damage at a circumferential weld at pipe bottom section. From the cross section picture it can be clearly seen that the damage occurs at the weld and downstream pipe base metal. The original  $\sim 1/8$  (3mm) root weld protrusion has been completely removed. It should be pointed out that some circumferential welds are damaged 360° around the pipe. This is likely related to the flow regime at the location.

**Figure 6: Typical damage at bottom section of a circumferential weld: (a) damage at 6 o'clock position and (b) cross section look**
