## **Failure Cases of Super Duplex Stainless Steel Pump Components**

Janardhan Rao Saithala, Amjad Kharusi, Mohammed Ghafri, Ossama  
Mohammed, Abdul Majeed, Manish Kulkarni, Talal Nabhani

Petroleum Development Oman  
PO Box 81, Muscat  
Sultanate of Oman

### **Case Study #1: Failure Investigation of SDSS Pump Casing**

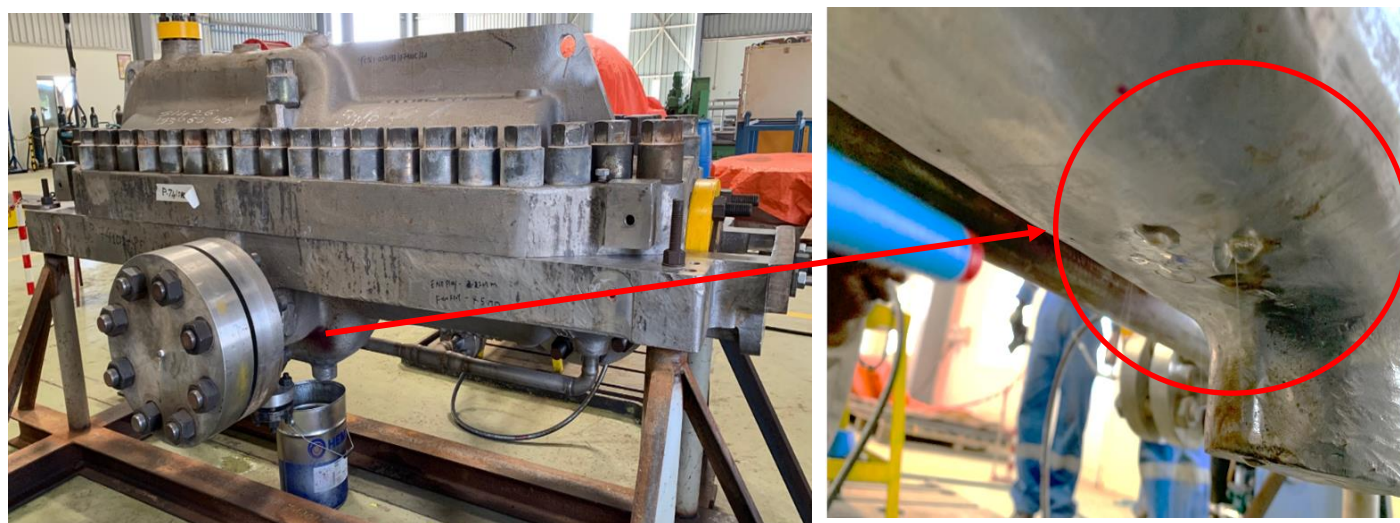
SDSS water injection pump constructed in 2010 failed after 10 years in operations. The pump was procured in accordance with ASTM A995<sup>(1) 4</sup> equivalent to UNS J93380 grade. Under pressure, what appeared to be a pinhole failure was identified on the underside of the SDSS casted pump casing. The operating suction pressure of this pump is approximately 20 barg, whereas the operating temperature range was between 20 to 50 °C. The maximum value of H<sub>2</sub>S reported from the water analysis was 10 ppm and the chloride levels were less than 170000 ppm, which indicates that SDSS is operating within the integrity operating window of the company standards.

**Figure 2: Pump Casing Failure Location**

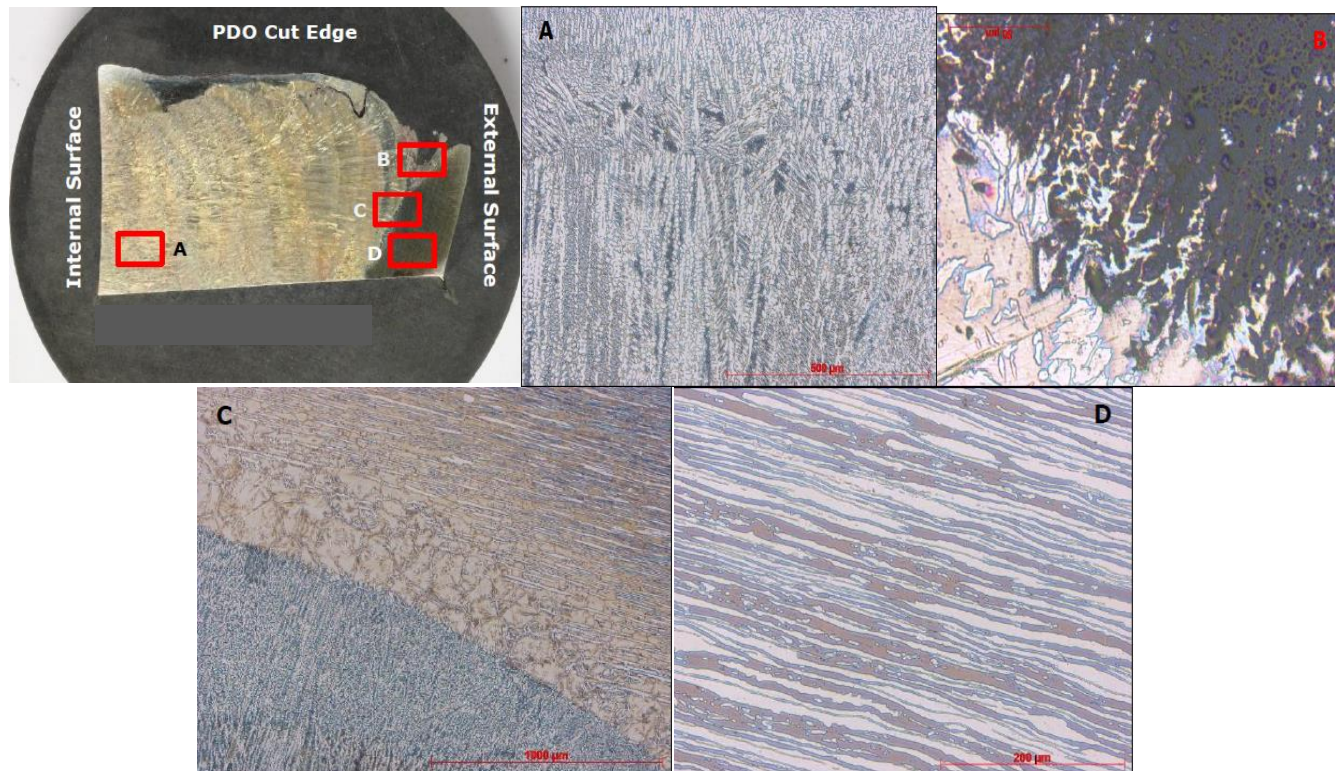
Two circular sections of material were extracted from the failed section of the casing. The microstructure of J93380 should consist of islands of austenite in a matrix of ferrite, and once etched the ferrite phases take on a darker appearance. However, immediately after etching it was clear that the microstructure of majority of the samples had a distinctly different appearance. This could be identified visually as weld material. The two cross sections of samples are shown in Figure 3 after etching. These samples clearly showed that weld material is present in the casted material, which could have been used as a repair method for casing material defect.

**Figure 3: Micrographs from the cross section of the failed sample. A - Weld microstructure. B - corrosion around sample edges. C - Weld heat affected zone. D - Super Duplex Stainless Steel microstructure.**

Phase balance analysis was conducted using the methods described in ASTM E562-19.<sup>6</sup> A. The parent material phase count showed that the Volume Fraction (VV) of the ferrite phase was  $52.5 \pm 7.2$  %, and for the weld material Volume Fraction (VV) of the ferrite phase was  $48.6 \pm 6.7$  %. The acceptable range of ferrite is between 30 and 60%, and so both the parent material and the weld have an acceptable phase balance.
