## **After 30 Years of Duplex Stainless Steel Experience in Oil & Gas - Do we still face challenges?**

Janardhan Rao Saithala, Amjad Kharusi, Mohammed Ghafri, Talal Nabhani  
Manish Kulkarni, Nasser Behlani,

Petroleum Development Oman  
PO Box 81, Muscat  
Sultanate of Oman

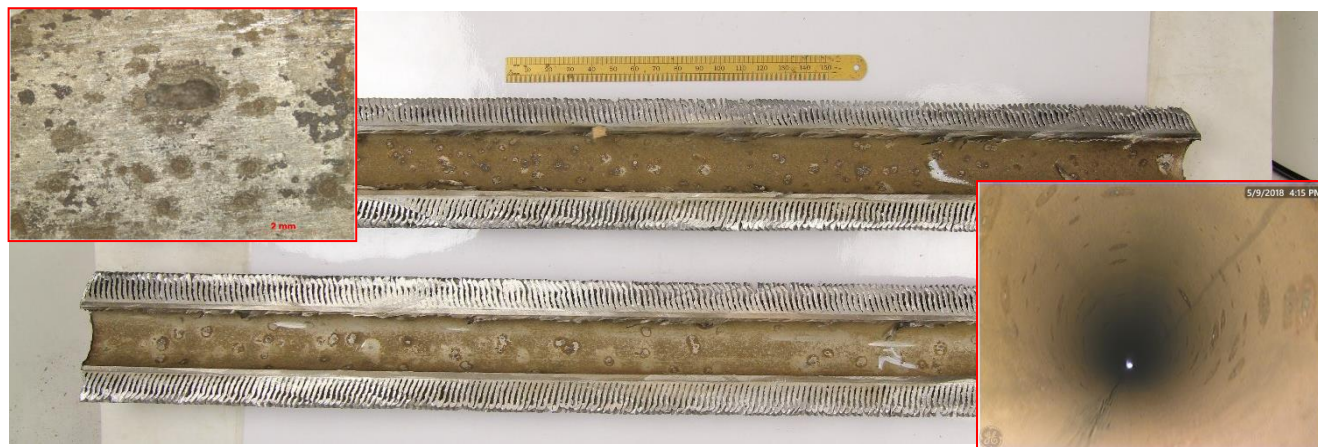
The damage mechanism attributed to the failure of DSS tubes was pitting corrosion (Figure 3 and Figure 4). The laboratory analysis has shown that all the mechanical properties (Hardness, tensile strength, impact etc.), composition and the microstructure analysis were typical with material standards.

**Figure 3: Visual observation of pitting and localized corrosion across the tubes**

The boroscopic inspection of the first-top inlet tubes witnessed pitting along all the tubes. However, the bottom discharge tubes of the cooler did not suffer corrosion. The carryover of salts and chloride deposition during upset and stagnant conditions was the primary cause of the premature failure of the

cooler. The ingress of oxygen in the system during shut down condition could have contributed to the pitting corrosion.

- DSS tubes procurement shall comply with the most recent changes to ASTM A789 with the additional quality control tests such as ASTM G48.
- Comply with hydrotest procedures & test water quality ensuring draining and drying requirements are in place prior to operational service.
- Inspection of the tubes with boroscope after hydrotest – e: g 10% of the tubes. Robust compliance to hydrotest procedure is mandatory.
- Monitor chloride levels in upstream of coolers to avoid upset scenarios.
- Create plan to mitigate Integrity Operating Window (IOW) excursions and quarterly review of sampling of upstream of the cooler against IOW need to be reported.
- Conduct boroscopic inspection inside header box & tubes during shutdown for to confirm no presence of salt deposition.
- Avoid stagnant conditions during shutdown.
- Ensure correct preservation of coolers to avoid oxygen ingress.

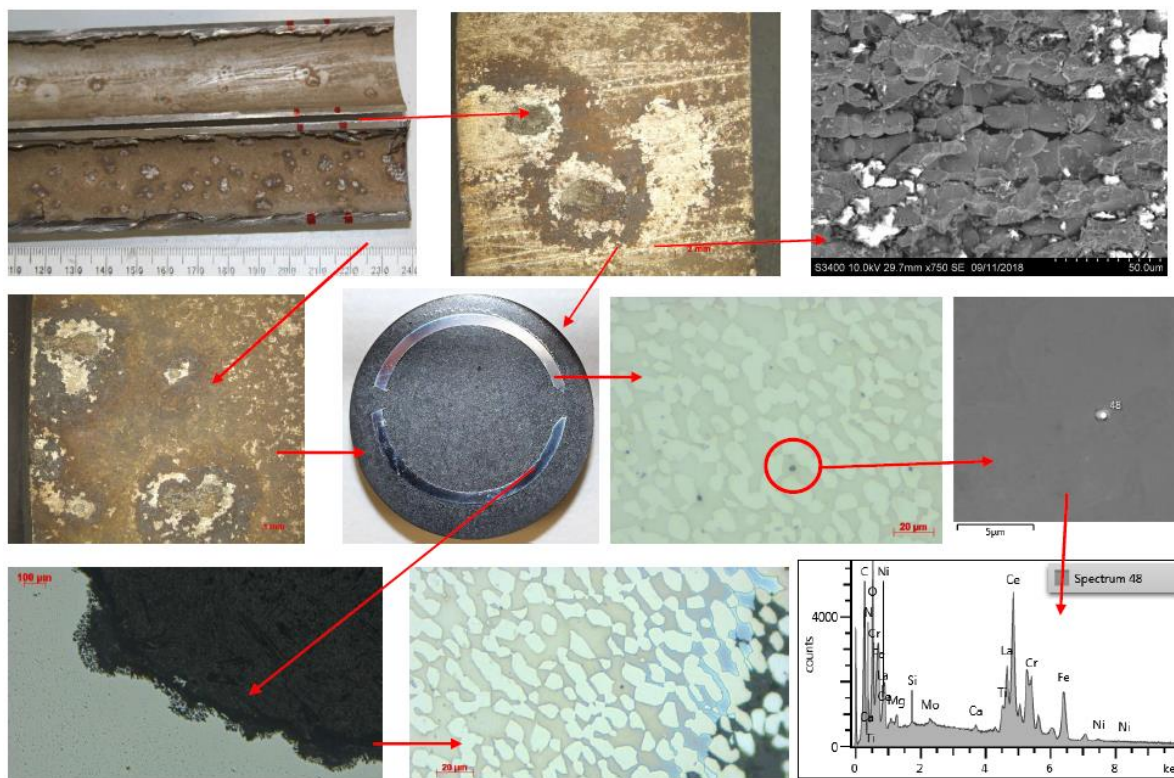
A detailed inspection task was carried to cover the full process loop from the upstream compressor to the inlet of the “finfan” cooler. The inspections of the compressor rotor showed salt deposition as a result of carry over from the upstream scrubbers.

**Figure 4: Overview of failure analysis of the pitting corrosion**
