## **Corrosion Perforation Failure Analysis of Inside Coating Sewage Pipeline**

Key words: Sewage pipeline; Inside coating; Bacterial corrosion; Failure analysis

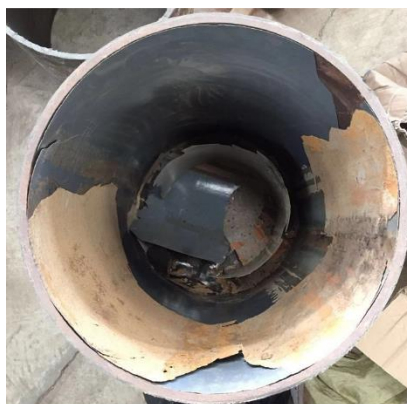
Corrosion according to the field investigation, there is no obvious corrosion outside the L290m pipeline, mainly manifested as the internal perforated corrosion of the pipeline (as shown in Figure 1). It can be seen from the field feedback pipeline perforation photos (as shown in Figure 2) that there are isolated corrosion pits inside the pipeline and the pits are circular. The shape of the external corrosion pits is basically the same as that of the internal corrosion pits. The difference is that area of pits is slightly larger than internal ones. There is no obvious corrosion in other parts. The corrosion perforation position of the coating is damaged, and there are wrinkles in and around the damaged part of the coating.

**Figure 1: Corrosion morphology of field of the failure tubing**

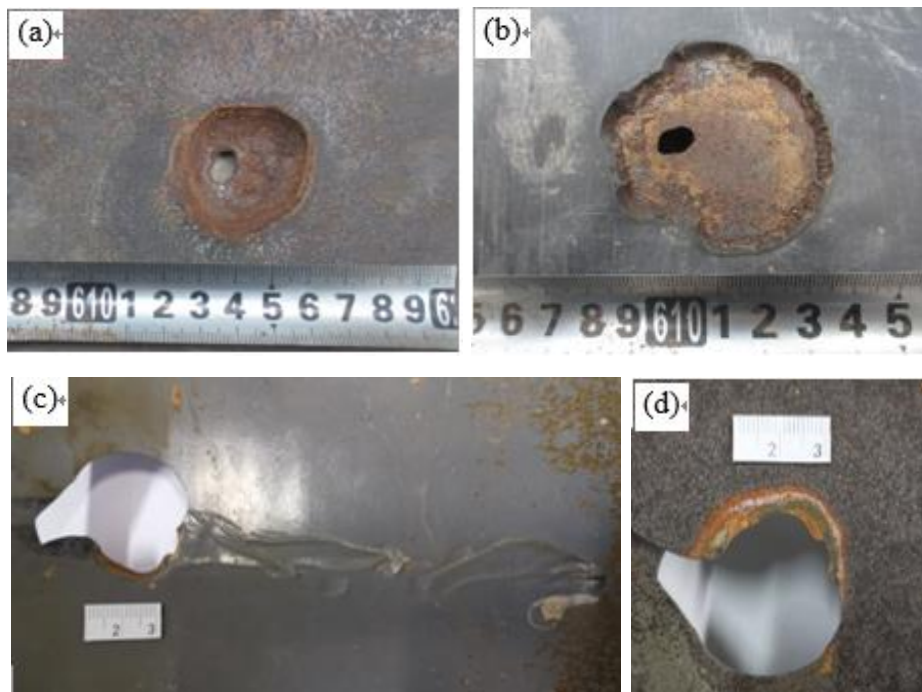
**Figure 2: Morphology of the failure tubing**

**(a) The internal surface (b) The outside surface (c) The surface of coating (d) The back of coating**
