## **Hydrogen Embrittlement Failure of Nickel Alloy UNS N07716-140 Tubing Retrievable Safety Valve Component Installed in a Sour Production Gas Well**

Iyad Al-Buraiki, Qasem Alhassan  
Saudi Aramco  
Consulting Services Department  
Dhahran 31311  
Saudi Arabia

Karthik Krishnan, Wade Meaders  
Halliburton  
2550 Country Club Dr.  
Carrollton, TX 75006-5401  
USA

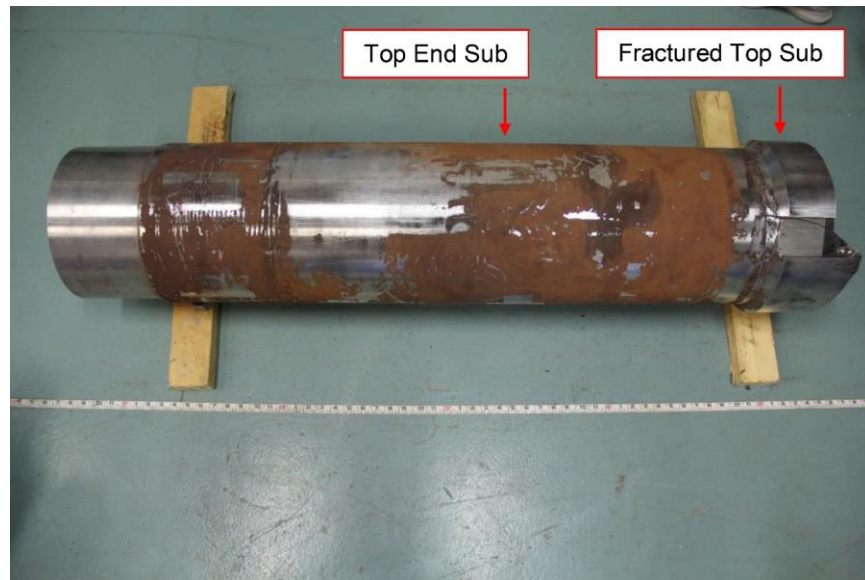
Figure 1: General as-received photograph of the failed TRSSV sample.

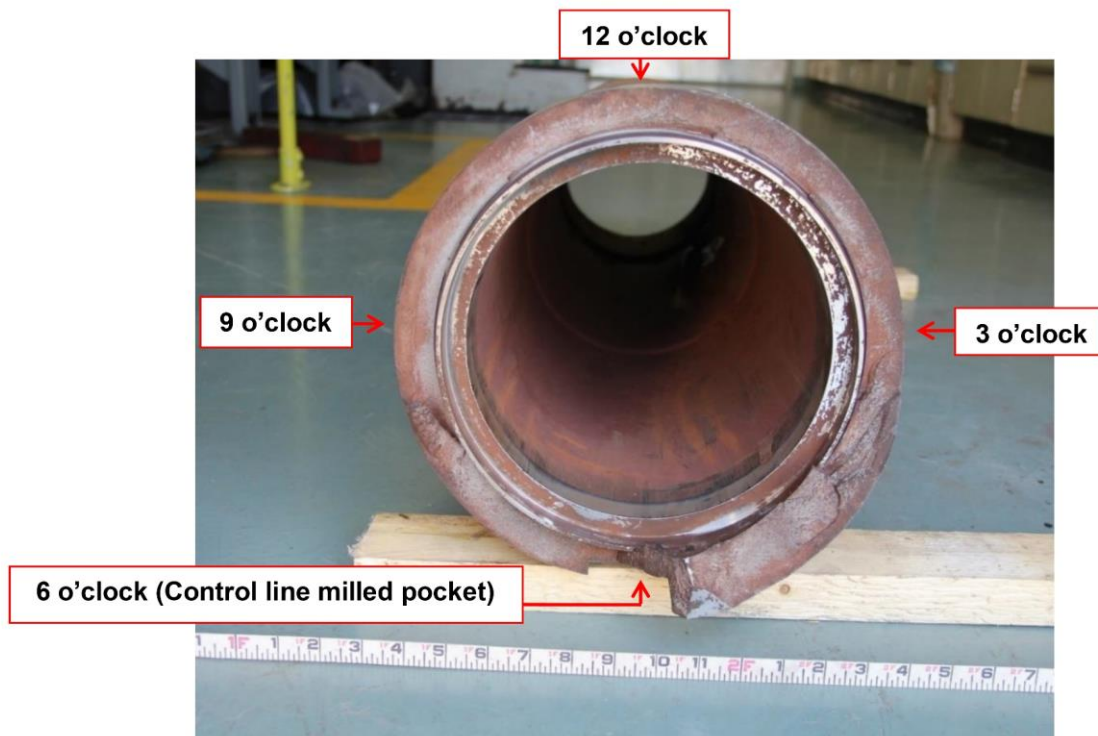
Figure 2: General as-received photograph of the upper Top Sub circumferential fracture.

Initial visual examination revealed that the Top Sub separated by a fracture mostly transverse to the valve axis (i.e. circumferential) as seen in Figure 2. A longitudinal crack was also observed running along the control line milled pocket (6 o'clock position) as shown in Figure 3. Visual examination also revealed multiple longitudinal secondary cracks on the external side running close to the fracture surface as shown in Figure 4 (3 O'clock position).

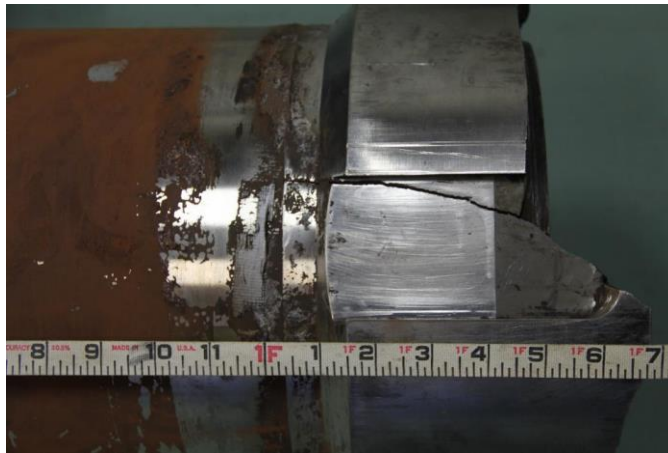
**Figure 3: Photograph of the longitudinal crack along the control line milled pocket.**

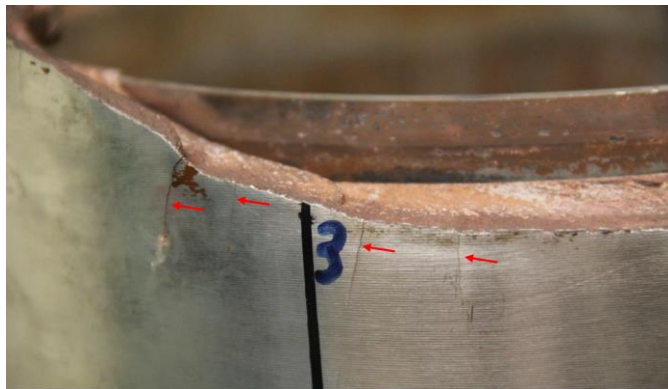
**Figure 4: Photograph showing the secondary longitudinal cracks on the OD (arrows).**

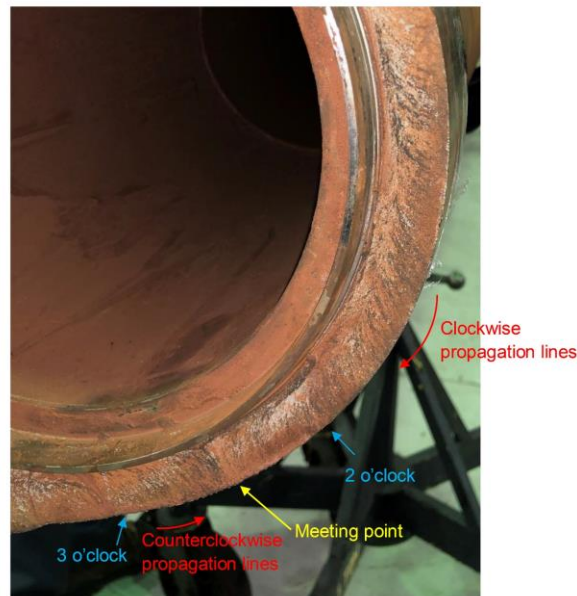
The circumferential fracture was mostly flat with no visible necking or plastic deformation observed. Two propagation lines running opposite to each other (clockwise and counterclockwise) were observed on the fracture surface that met between the 2 o'clock and 3 o'clock positions, see Figure 5 for illustration.

**Figure 5: Close up photograph of where the fracture propagation lines meet.**

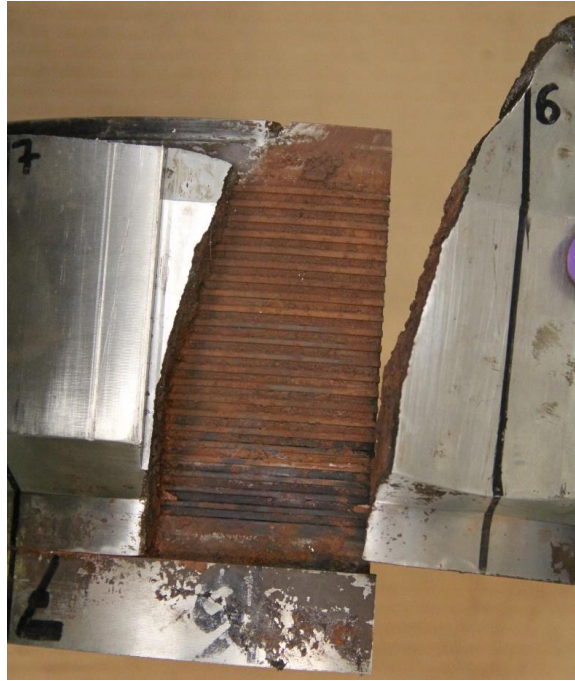
Further examination revealed signs of wear damage with directional patterns which were observed on the Top Sub near the longitudinal crack on the control line milled pocket side (6 o'clock position). Upon further sectioning of the Top Sub, it was revealed that the longitudinal crack shown earlier in Figure 3 was running through the thickness as seen in Figure 6.

**Figure 6: Photograph of the longitudinal control line milled pocket crack after sectioning**

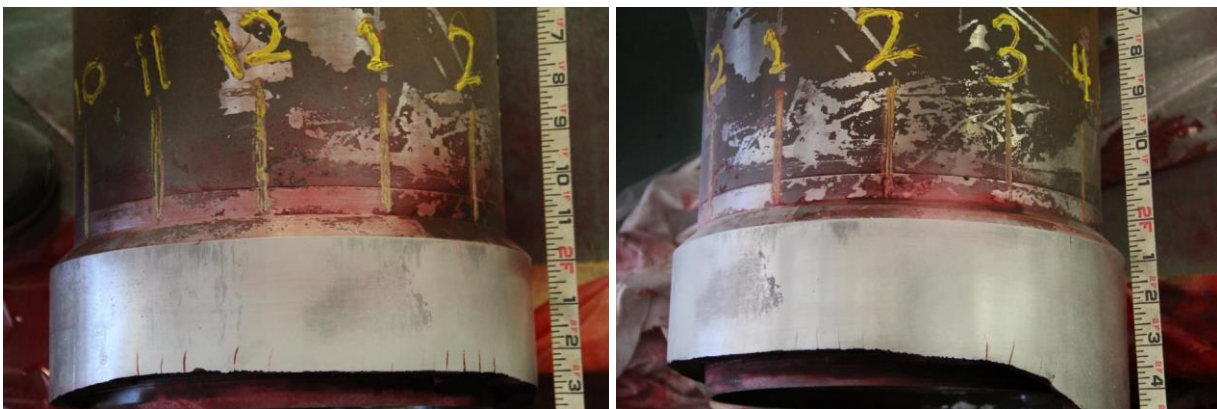
Dye penetrant testing (PT) was conducted on the external side of the Top Sub around the circumference (OD side). Examination revealed a series of parallel secondary cracks longitudinal to the valve axis and close to the fracture surface as shown in Figure 7 mainly from the 9-3 o'clock positions.

**Figure 7: Photographs of the PT examination on the Top Sub external surface.**

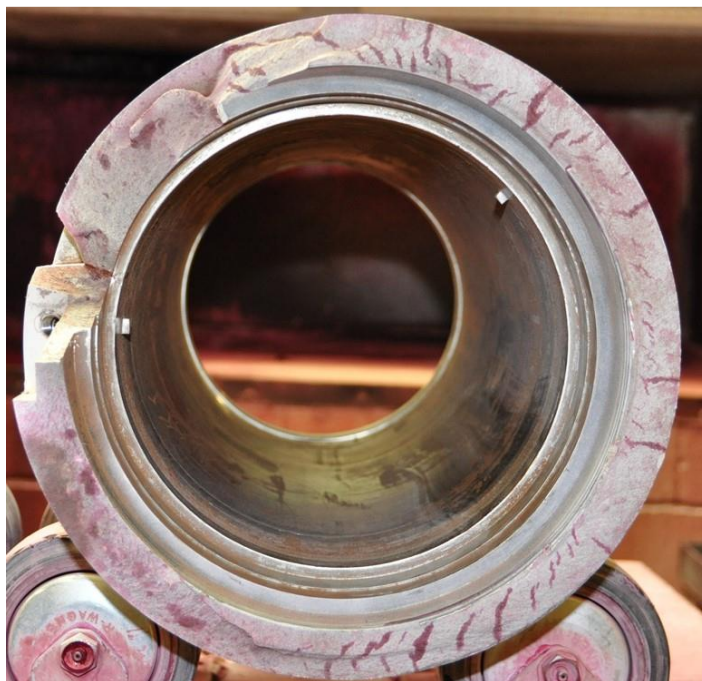
Further PT (Figure 8) revealed a series of non-surface breaking cracks in the Top Sub mid-wall along with the surface breaking cracks that were initially observed during the external surface PT examination.

**Figure 8: NDE evaluation of long section of fracture Transverse Cross-section showing multiple secondary cracks**

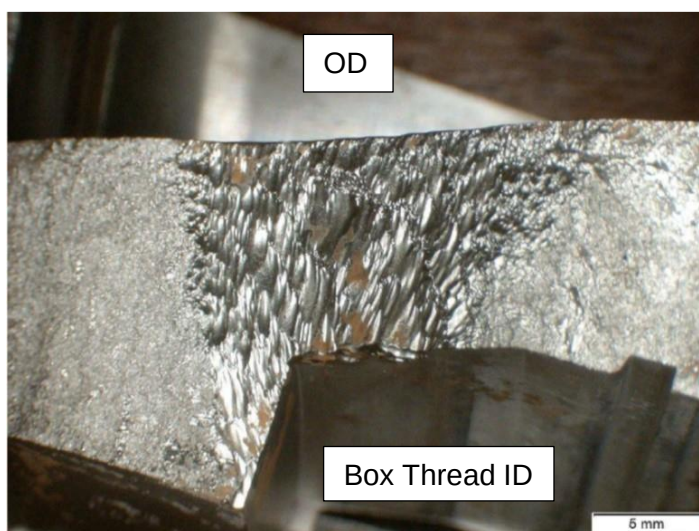
The fracture surface of the Top Sub was examined under low magnification stereo-microscope after ultrasonic cleaning. Control line milled pocket (box thread) location was further evaluated at higher magnification after cleaning. The examination showed a very smooth surface with directional wear patterns from the internal surface (ID) toward the external surface (OD) of the upper Top Sub as seen in Figure 9.

**Figure 9: Stereomicroscopy images showing erosion damage pattern from box thread ID to OD**

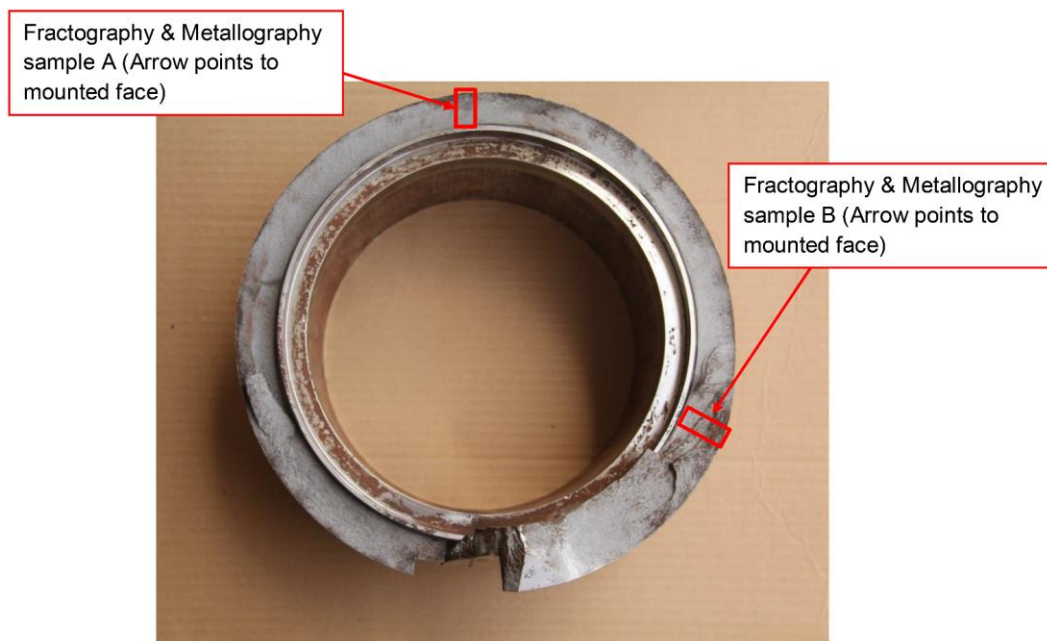
**Figure 10: Annotated photograph showing the locations of the extracted samples.**

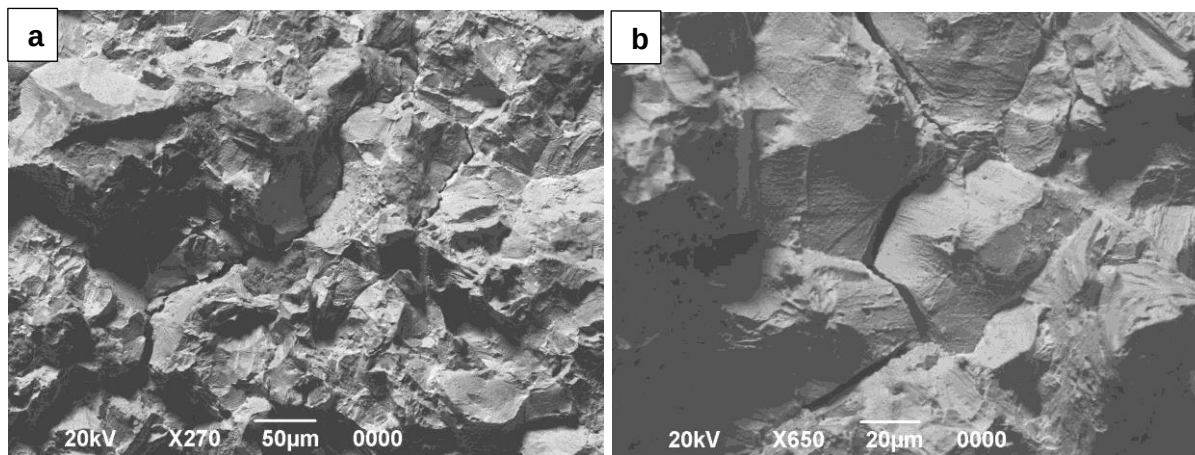
Examination revealed the fracture of sample A to be mainly transgranular. However, the longitudinal cracks (secondary cracking) intersecting this transverse fracture were intergranular. These mixed areas of intergranular and transgranular fracture modes can be seen in Figures 11. Generally, no signs of clear microvoids coalescence were observed at this location.

**Figure 11: (a) SEM micrograph of the fracture surface sample A (b) Higher magnification image**
